Wetland Delineation Report

Northern 100 Acres associated with the McKenzie Conservation Area
(Spokane County, Washington)

June 2010

Prepared by: Vincent Barthels, Biologist
J-U-B ENGINEERS, Inc.
W. 422 Riverside, Suite 304
Spokane, WA 99201
(509) 458-3727 (Office)
(509) 951-9564 (Cell)
(509) 458-3762 (Fax)
vbarthels@jub.com

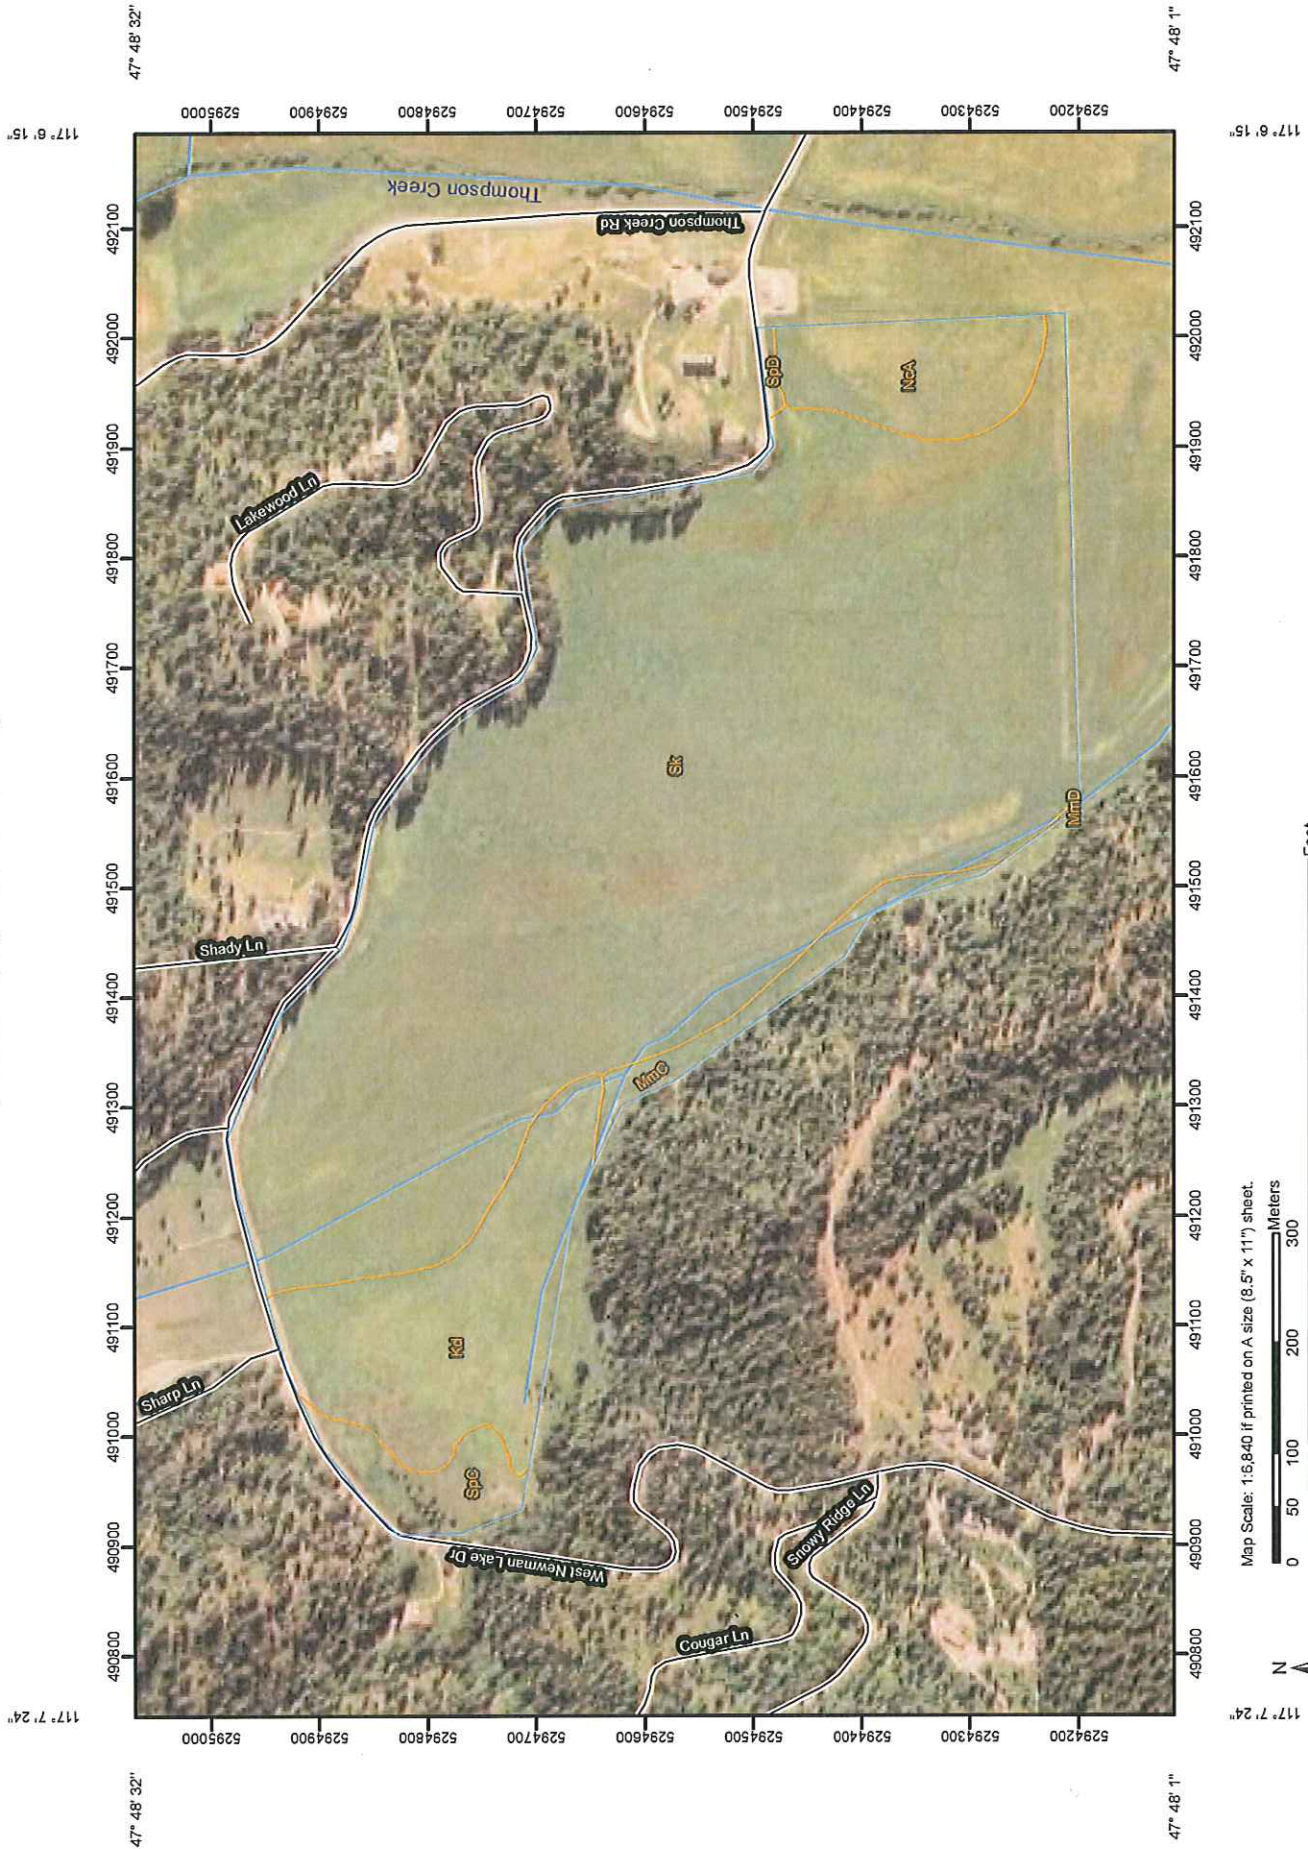
Soil Map—Spokane County, Washington
(McKenzie Property - North Newman Lake)

Spokane County, Washington (WA063)			
Map Unit Symbol	Map Unit Name	Acres in AOI	Percent of AOI
Kd	Konner silty clay loam, drained	12.2	11.6%
MmC	Moscow silt loam, 0 to 30 percent slopes	2.3	2.2%
MmD	Moscow silt loam, 30 to 55 percent slopes	0.0	0.0%
NcA	Narcisse silt loam, 0 to 5 percent slopes	5.5	5.2%
Sk	Semiahmoo muck, drained	82.1	77.9%
SpC	Spokane loam, 0 to 30 percent slopes	3.0	2.9%
SpD	Spokane loam, 30 to 55 percent slopes	0.3	0.3%
Totals for Area of Interest		105.5	100.0%

The soils found in the project area have a few similar general characteristics, which include: (1) they are either medium textured silt loams or mucks and (2) the frost-free season for each soil type falls within the ranges of 90 to 110 days (NRCS/USDA 1968 & 2009). Differences amongst the soil types are best exemplified in their texture and structure distinctiveness, by their color differences which range from yellowish to dark black, and amongst the general characteristics exemplified in Table 2.0 (NRCS/USDA 1968 & 2009).

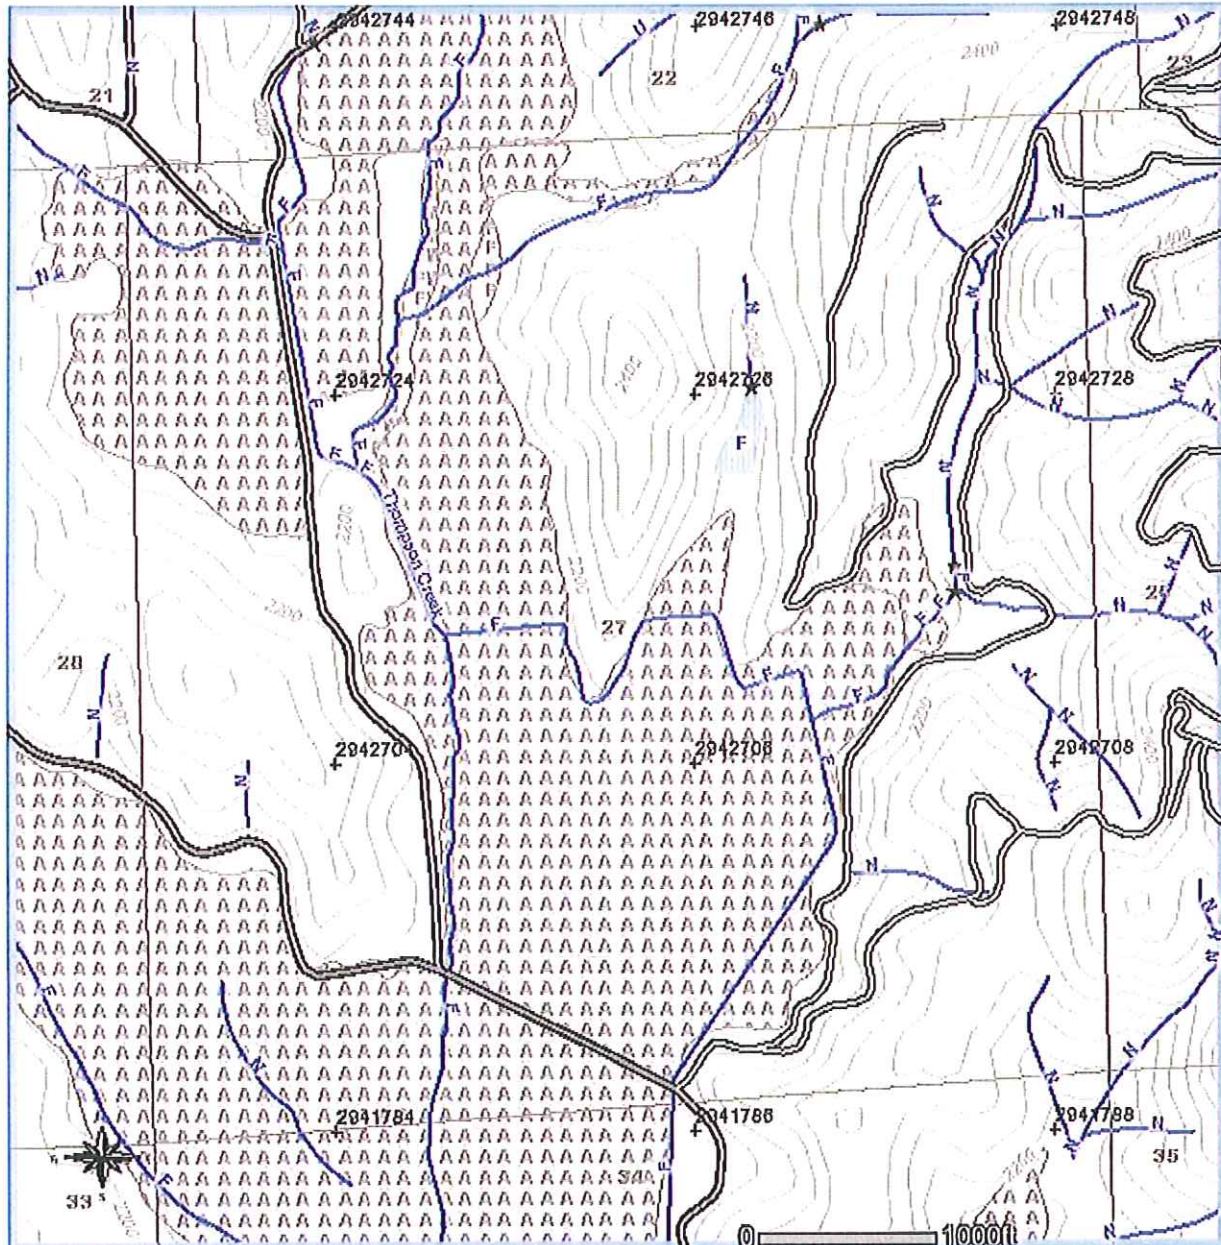
FOREST PRACTICE WATER TYPE MAP

TOWNSHIP 27 NORTH HALF 0, RANGE 45 EAST (W.M.) HALF 0, SECTION 27

The typed streams illustrated on the wetland delineation map are consistent with the DNR Water Typing Map, except for the following conditions:

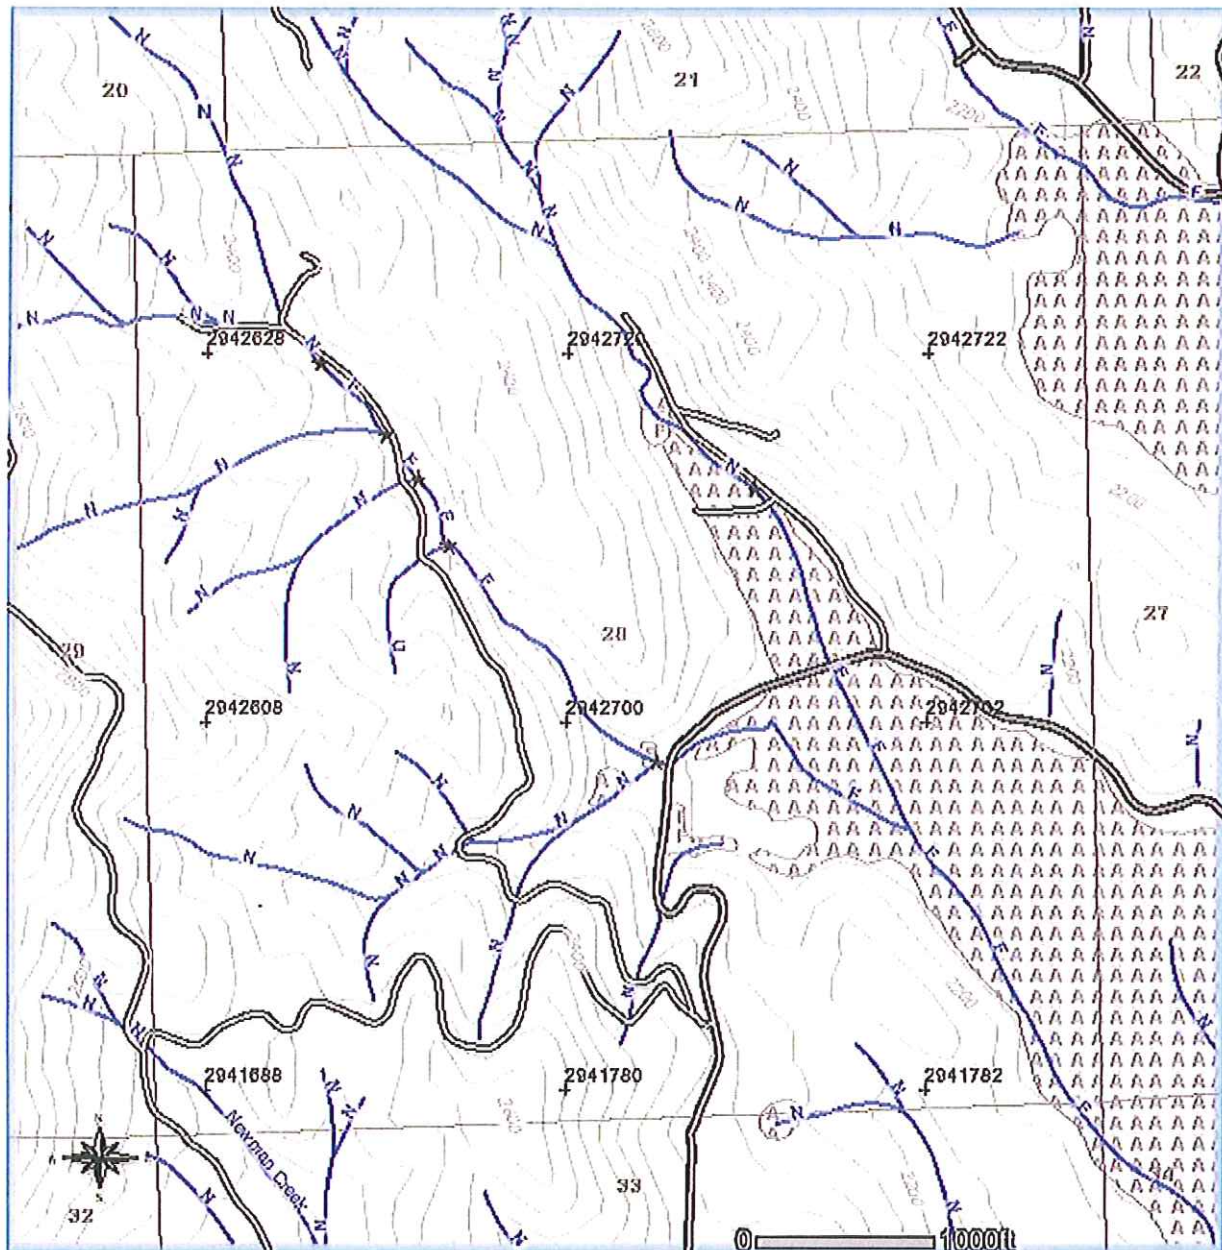
FOREST PRACTICE WATER TYPE MAP

TOWNSHIP 27 NORTH HALF 0, RANGE 45 EAST (W.M.) HALF 0, SECTION 28

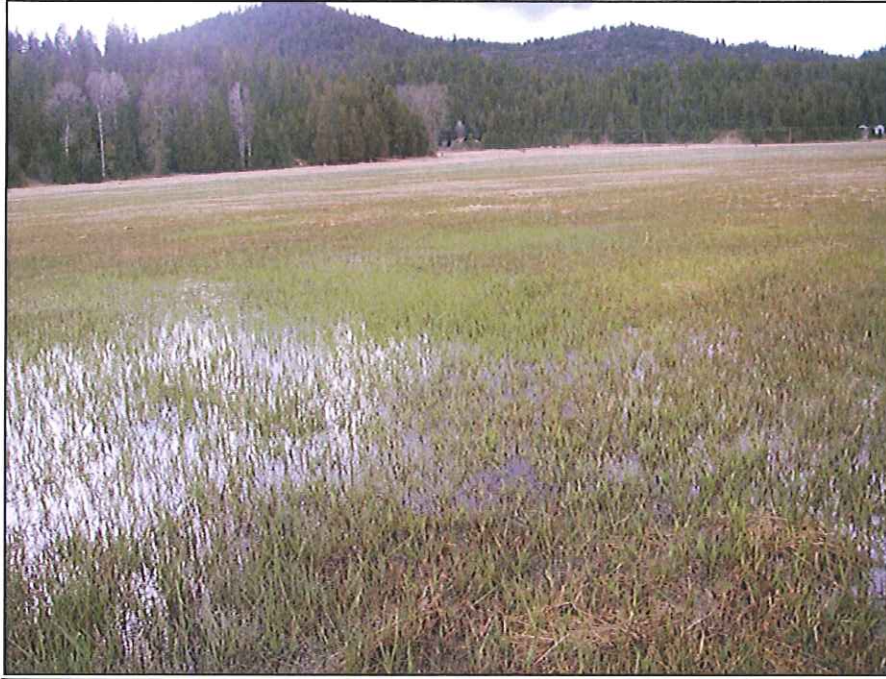
Photo 1: Standing water covers most of the wetland area early in the growing season. This photo was taken from the center of the property looking westerly.

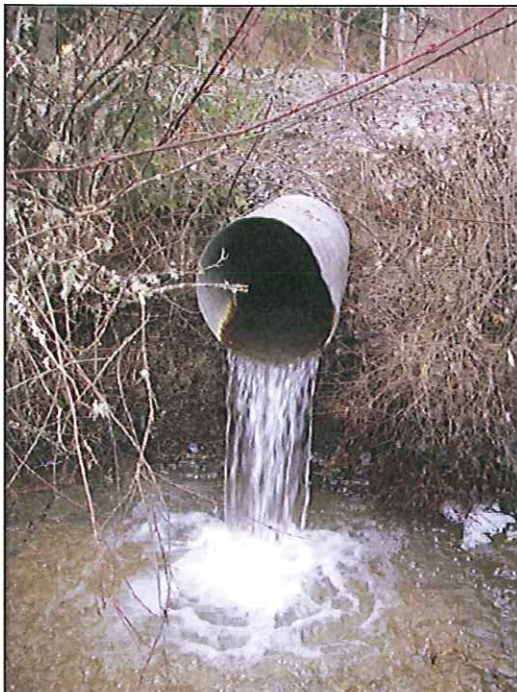
Photo 2: This 2 foot (shotgun) culvert conveys and supplies intermittent hydrology into the identified wetlands. There is a 3 foot vertical drop at this culvert outlet. In terms of potential fish habitat, this culvert represents the end of the road along this stream channel.

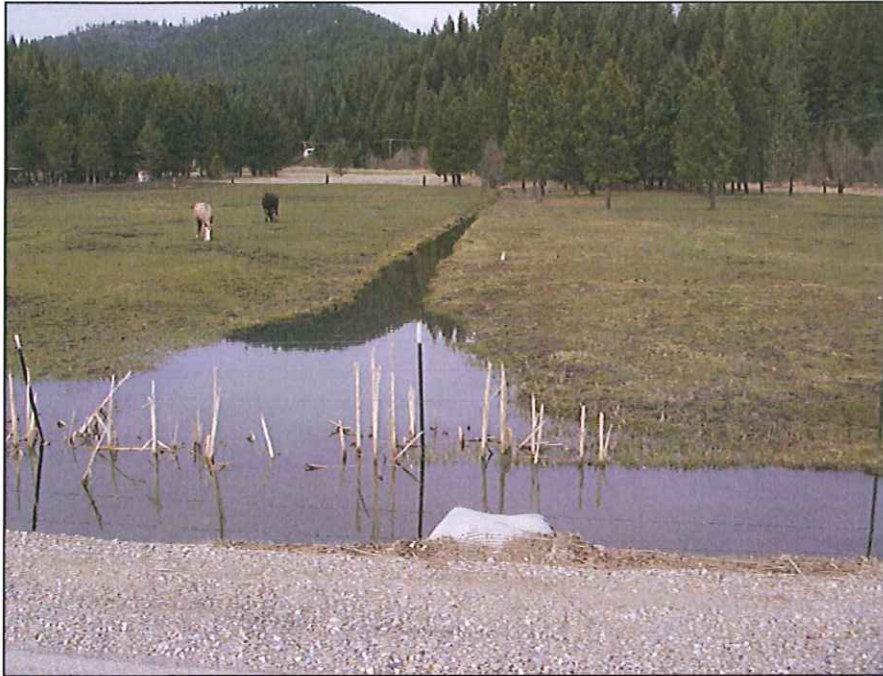
Photo 3: Looking northerly at the Type “F” stream that enters the project area via this 3 foot culvert. This stream travels under West Newman Lake Road and supplies intermittent hydrology into the identified wetlands. Some of the water is impounded by the roadway. Livestock grazing is evident on this adjacent property.

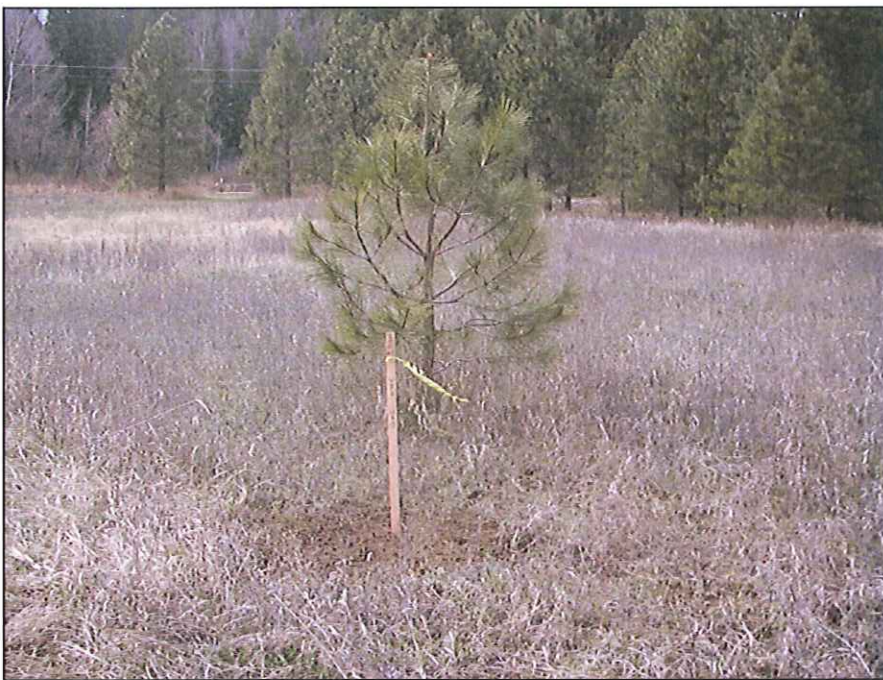
Photo 4: Looking westerly at soil test pit # 3. This soil test pit helps to define the designated upland areas (4 acres) in the western portion of the subject property. Scattered ponderosa pines and annual weeds dominate this area.

Transect 3 is located in the western portion of the subject property. Wetland parameters were fulfilled at GW # 4 and GW # 5. Hydrophytic vegetative structure consists of reed canary grass and meadow foxtail. The wetland hydrology was evidenced by the presence saturation and a high water table within the upper 12 inches of the soil profile. Hydric soil conditions were evidenced by prominent redox features in the upper 20 inches and a hydrogen sulfide smell in the upper 12 inches of the soil profile. Conversely, STP # 3 did not fulfill all of the wetland parameters and consequently received upland designation. STP # 3 can be characterized as a disturbed area (an abandoned well casing is in the area) that contains scattered and sparse ponderosa pine saplings and an understory mainly dominated by spotted knapweed.

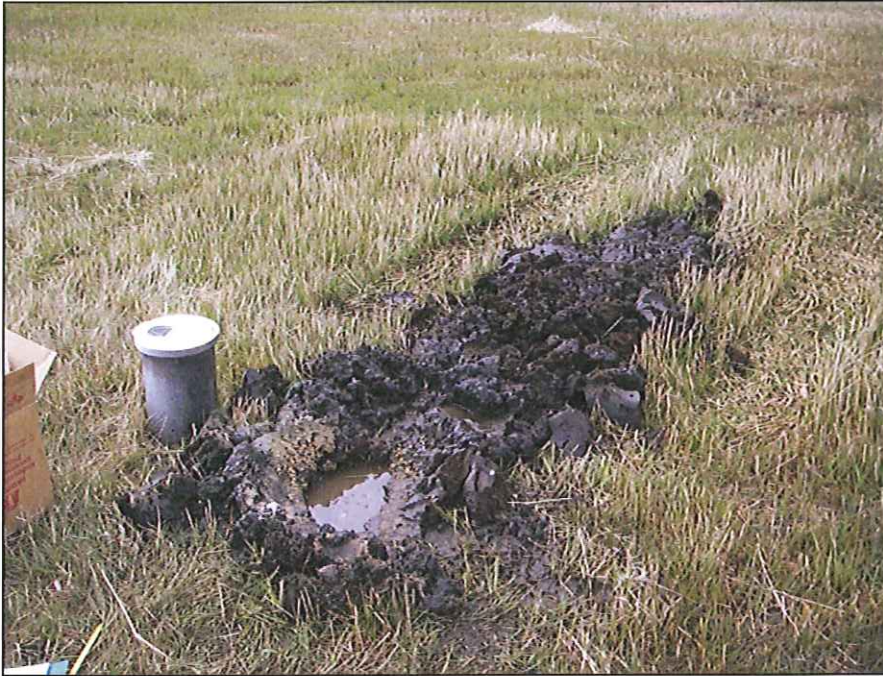
Photo 5: This photo was taken during the installation of ground water monitoring well # 3 (GW # 3). Wetland hydrology is at the surface. The darker, hydric, histosol soils contain high concentrations of organic materials (i.e. mucky peat). Cut or mowed clusters of reed canary grass and meadow foxtail are the dominant vegetative cover at this location.

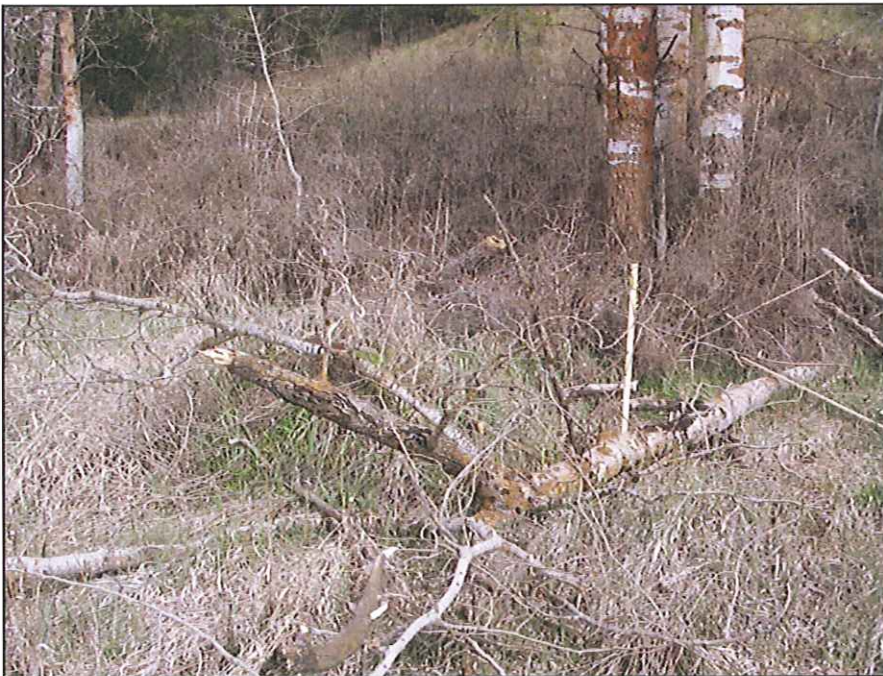
Photo 6: Looking at soil test pit # 7, which is located immediately adjacent to an active ant hill. The wetland boundary was determined to be one foot lower in elevation than the soil test pit and the active ant hill.

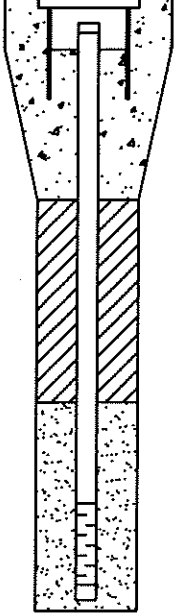
<p>Monument: Flush mount 8-inch diameter vault set in concrete to 2 feet below grade</p> <p>Riser: 2-inch schedule 40 pvc set to 5 feet below grade with locking expansion plug</p> <p>Screen: 2-inch schedule 40 pvc (0.010-inch slot) set from 5 to 6 feet below grade with end cap</p> <p>Seal: Bentonite from 2 to 4 feet below grade</p> <p>Filter pack: #20-40 silica sand from 4 to 6 feet below grade</p>	<p>Grass, weeds and water surface</p> <p>-----</p> <p>PEAT, some Silt, fine Sand and Organics (grass roots)</p> <p>(upper 1 foot of layer had more organics)</p> <p style="text-align: right;">2.5'</p> <p>-----</p> <p>3'</p> <p>SILT, some Sand, small amount to trace Clay, occasional Organics (roots)</p> <p style="text-align: right;">5.0'</p> <p>-----</p> <p>6'</p> <p>End of Boring at 6 feet</p> <p style="text-align: right;">7.5'</p>

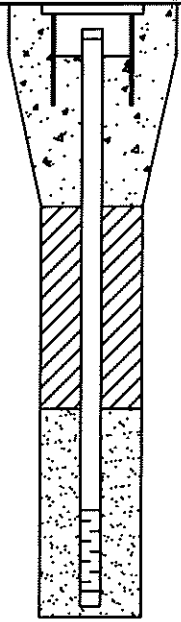
<p>Monument: Flush mount 8-inch diameter vault set in concrete to 2 feet below grade</p> <p>Riser: 2-inch schedule 40 pvc set to 5 feet below grade with locking expansion plug</p> <p>Screen: 2-inch schedule 40 pvc (0.010-inch slot) set from 5 to 6 feet below grade with end cap</p> <p>Seal: Bentonite from 2 to 4 feet below grade</p> <p>Filter pack: #20-40 silica sand from 4 to 6 feet below grade</p>	<p>Grass, weeds and water surface</p> <p>-----3'----- PEAT, some Silt, fine Sand and Organics (grass roots)</p> <p>(upper 1 foot of layer had more organics)</p> <p>-----2.5'-----</p> <p>-----3'----- SILT, some Sand, small amount to trace Chy, occasional Organics (small roots)</p> <p>-----6'----- End of Boring at 6 feet</p> <p>-----7.5'-----</p>
