FINAL PROJECT MEMORANDUM

TO: WRIA 54 WIT
FROM: THE LANDS COUNCIL
SUBJECT: WRIA 54 DEEP COULEE CREEK WATERSHED RESTORATION
PROJECT 2013 UPDATE
DATE: 7/2/2013
CC: SPOKANE COUNTY WATER RESOURCES

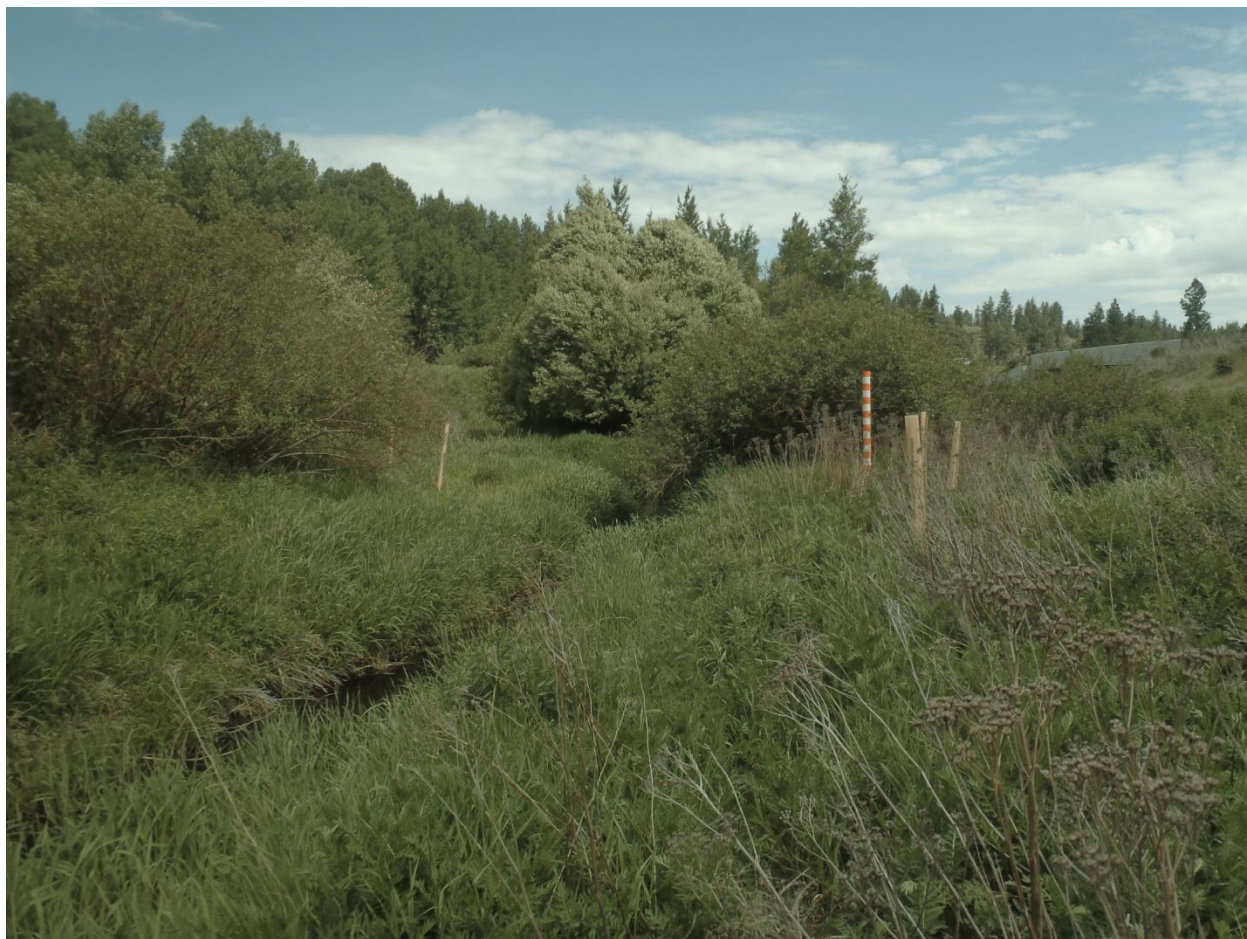
Figure 6: Photo Point, site D1.13

Photo taken 13 June 2013

Photo points were taken with a 2 meter, striped photo pole visible in each photo to show scale. These pictures can be seen in Figures 6-12. More qualitative monitoring was done at each site during maintenance, mainly assessing plant health and rate of herbivory.

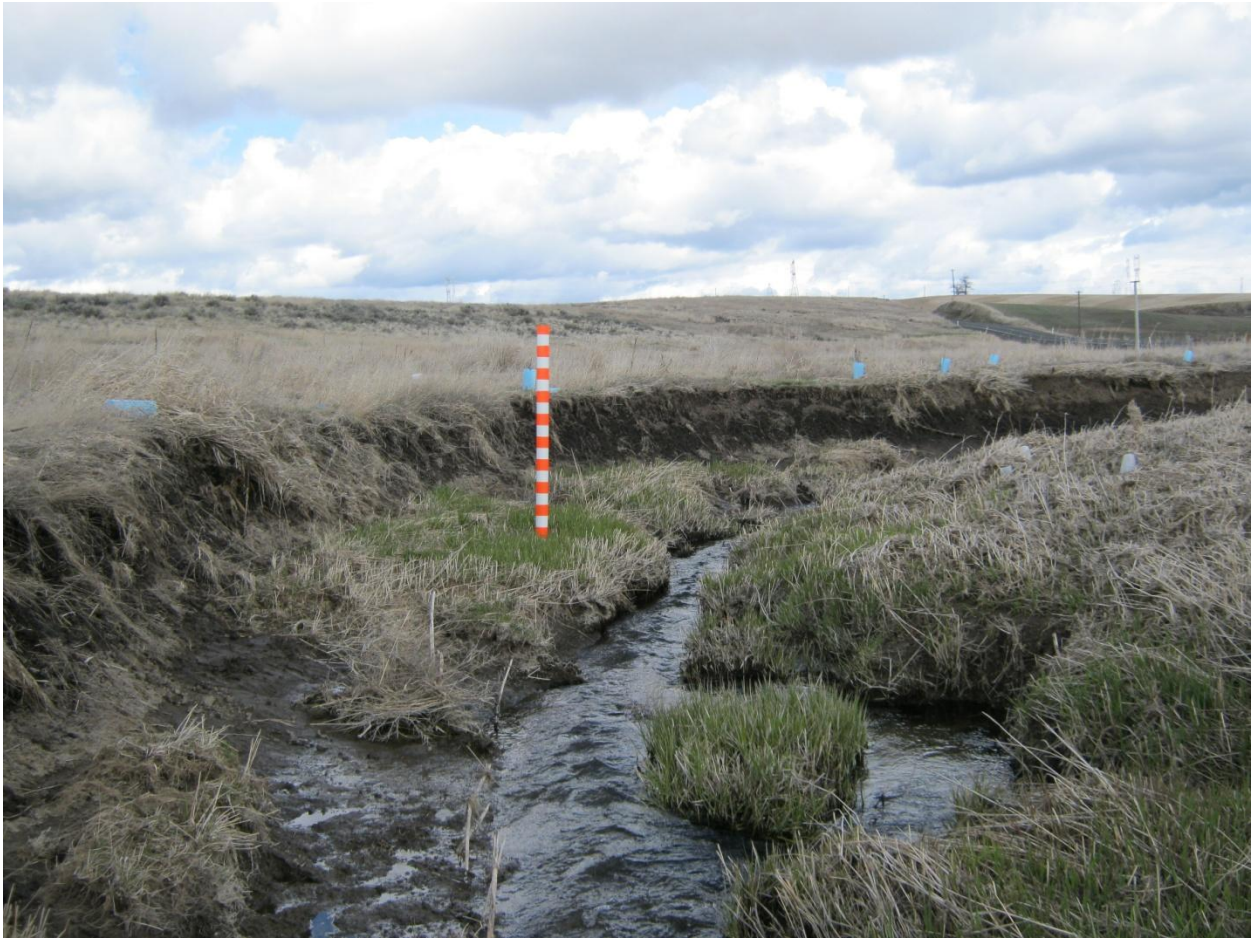
Figure 7: Photo Point, site C1.12.13

Photo taken 17 April 2012

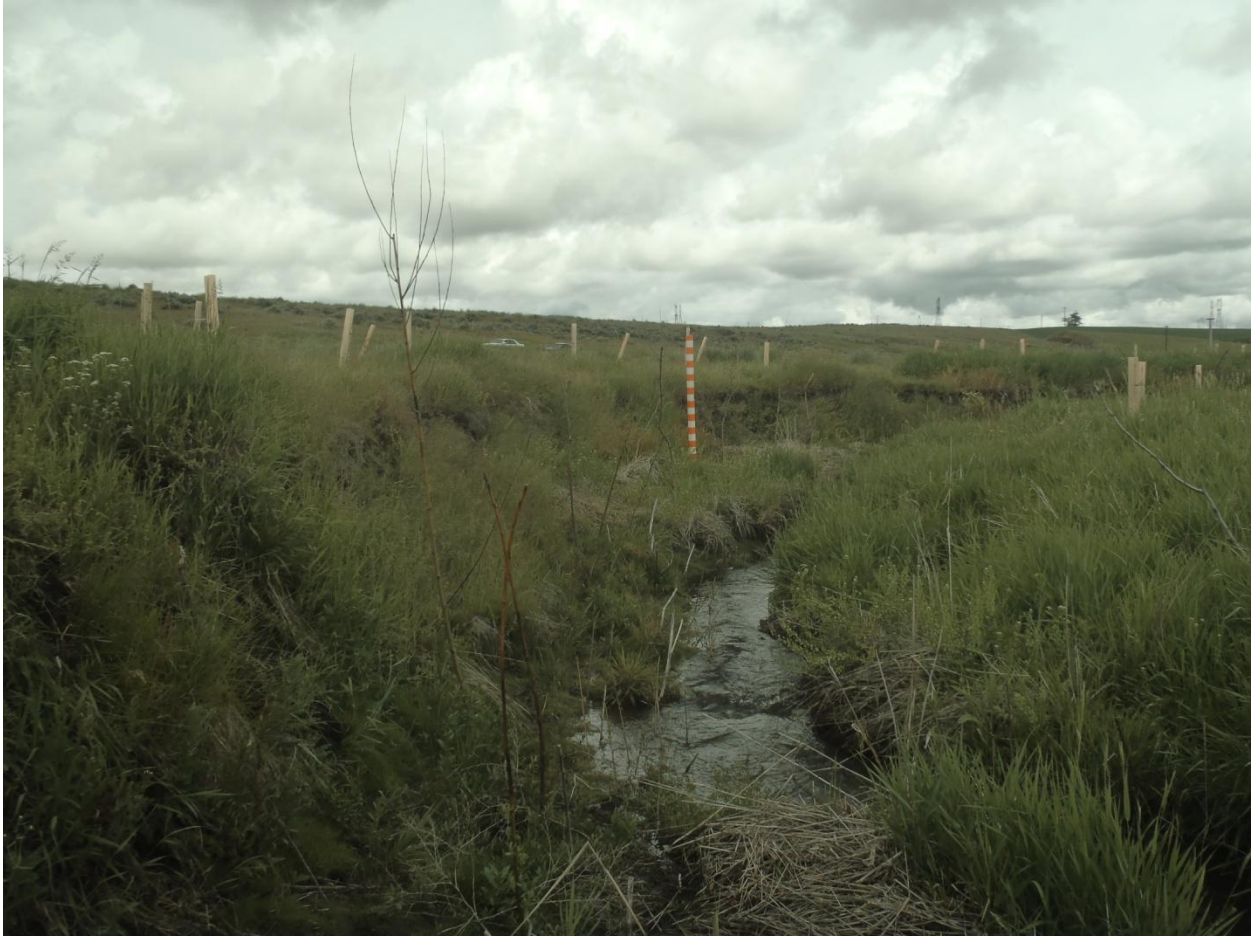
Figure 8: Photo Point, site C1.12.13

Photo taken 25 June 2013

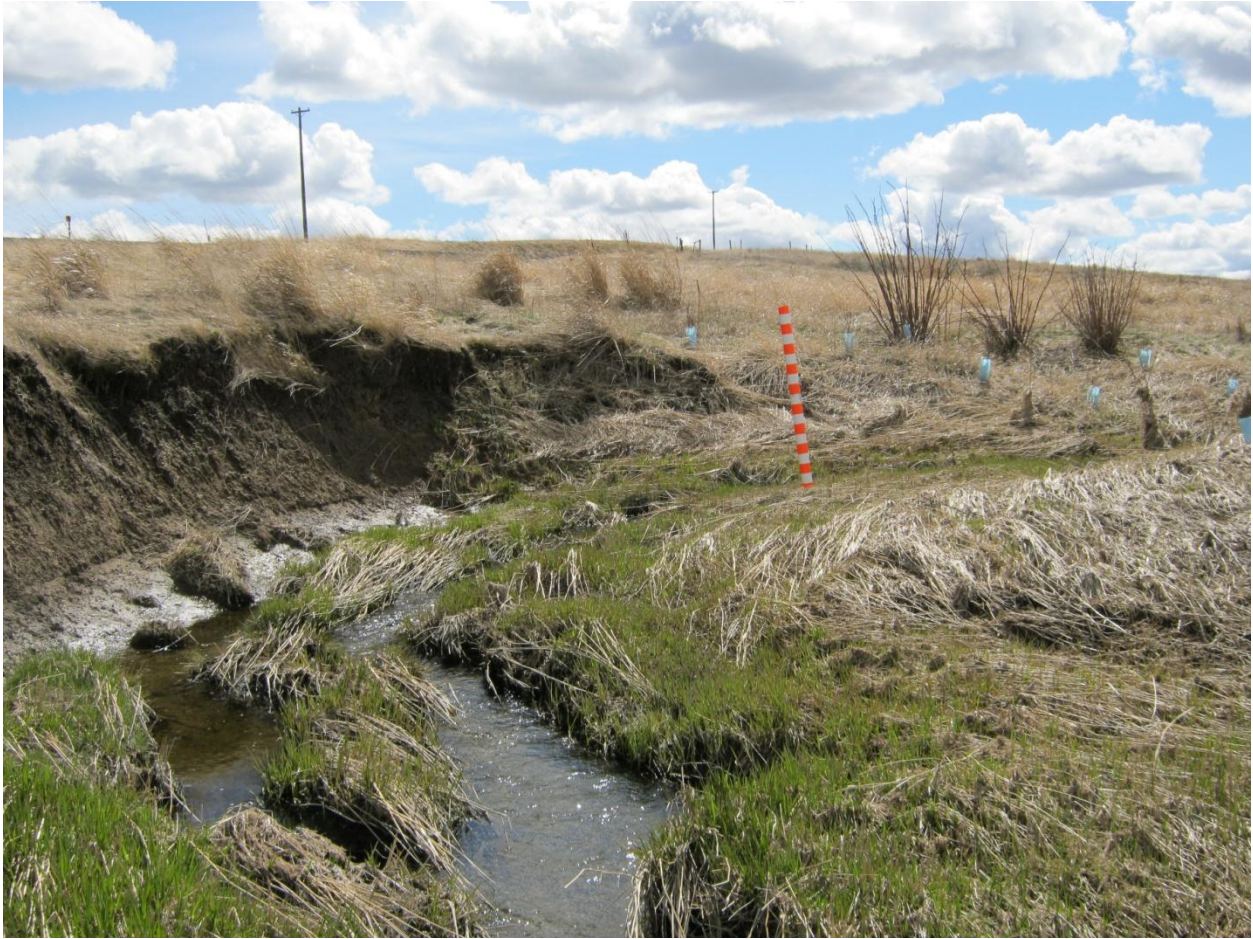
Figure 9: Photo Point, site C1.12.13

Photo taken 17 April 2012

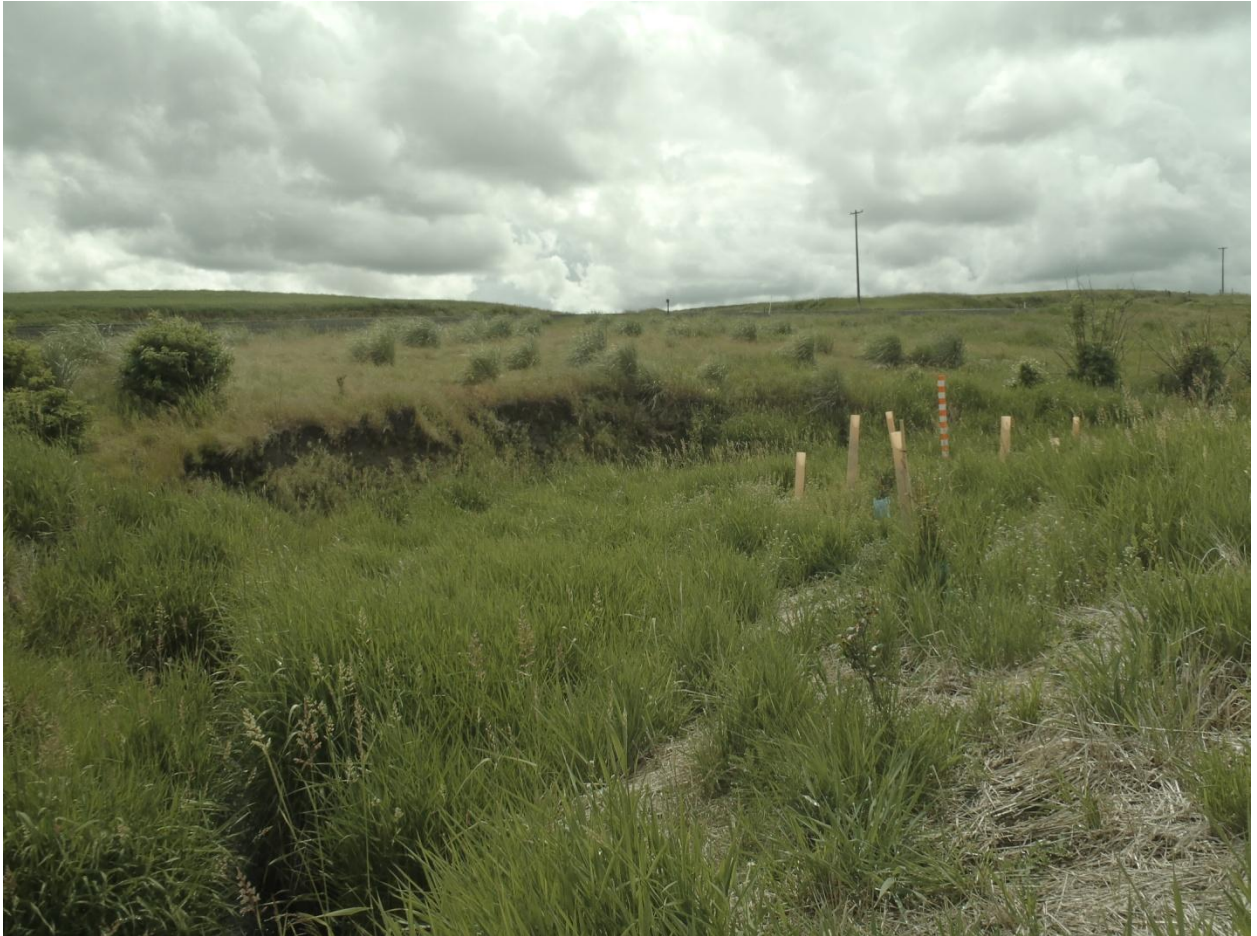
Figure 10: Photo Point, site C1.12.13

Photo taken 25 June 2013

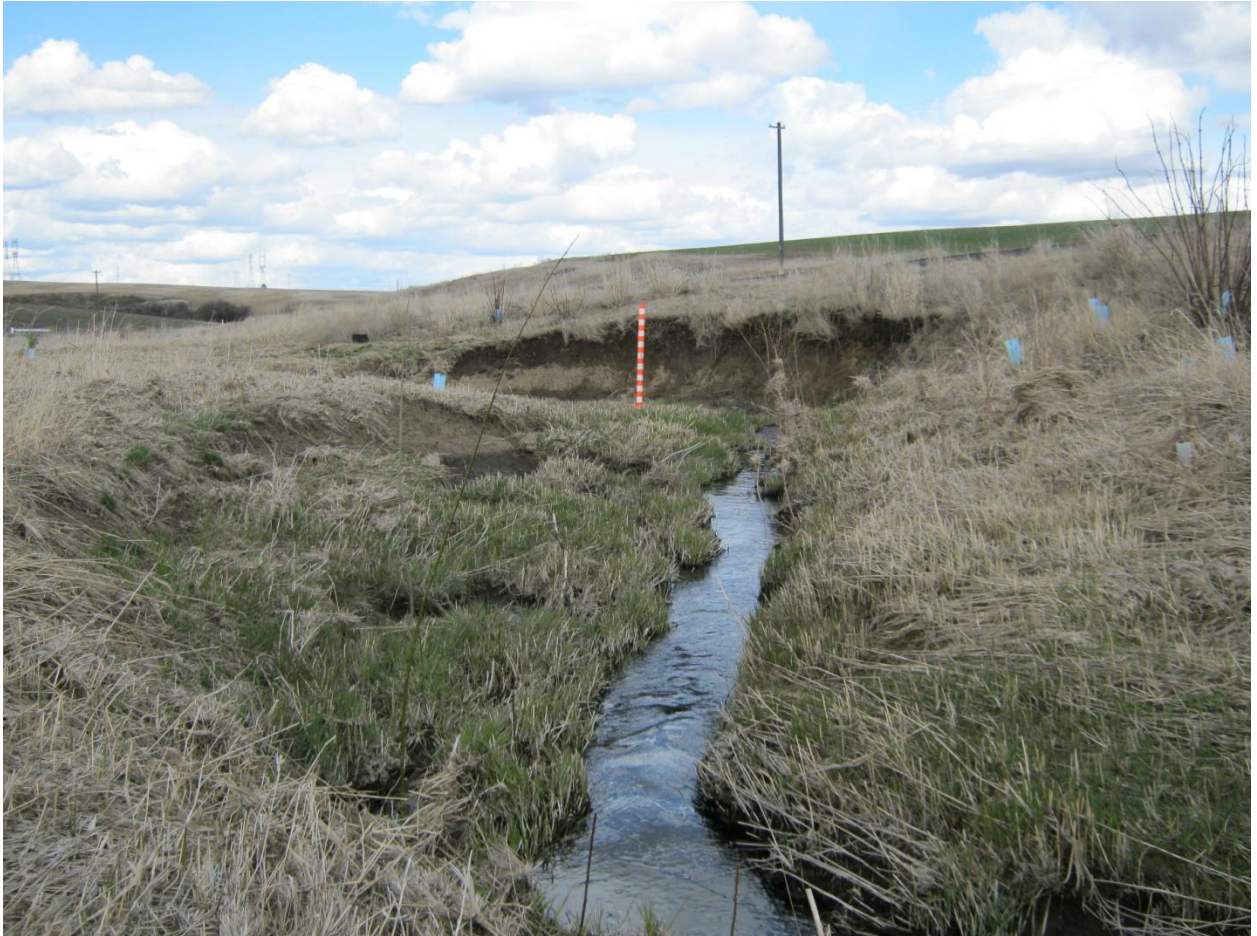
Figure 11: Photo Point, site C1.12.13

Photo taken 17 April 2012

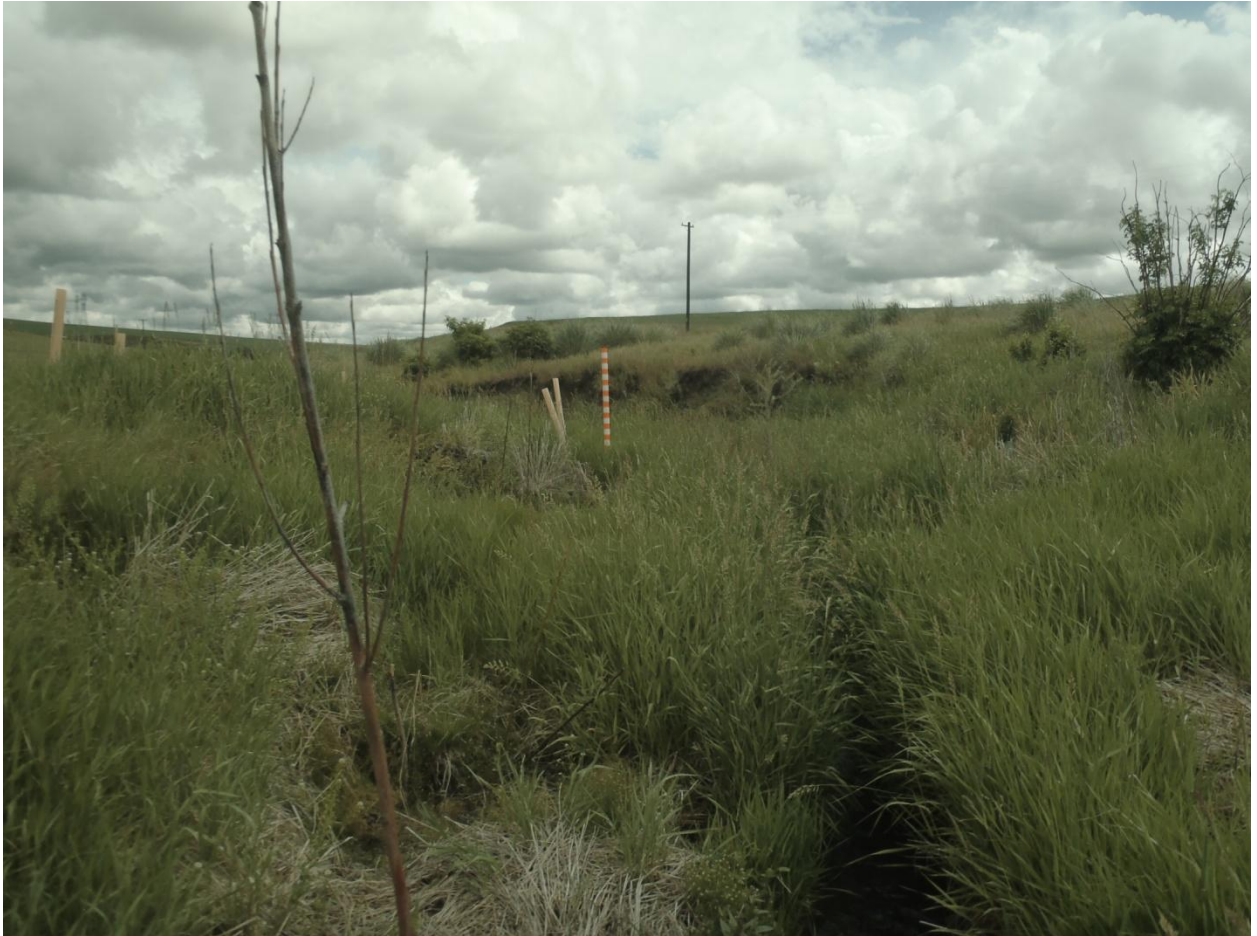
Figure 12: Photo Point, site C1.12.13

Photo taken 25 June 2013
