## FINAL PROJECT MEMORANDUM

**TO:** WRIA 54 WIT  
**FROM:** THE LANDS COUNCIL  
**SUBJECT:** WRIA 54 DEEP COULEE CREEK WATERSHED RESTORATION  
PROJECT 2012 UPDATE  
**DATE:** 7/16/2012  
**CC:** SPOKANE COUNTY WATER RESOURCES

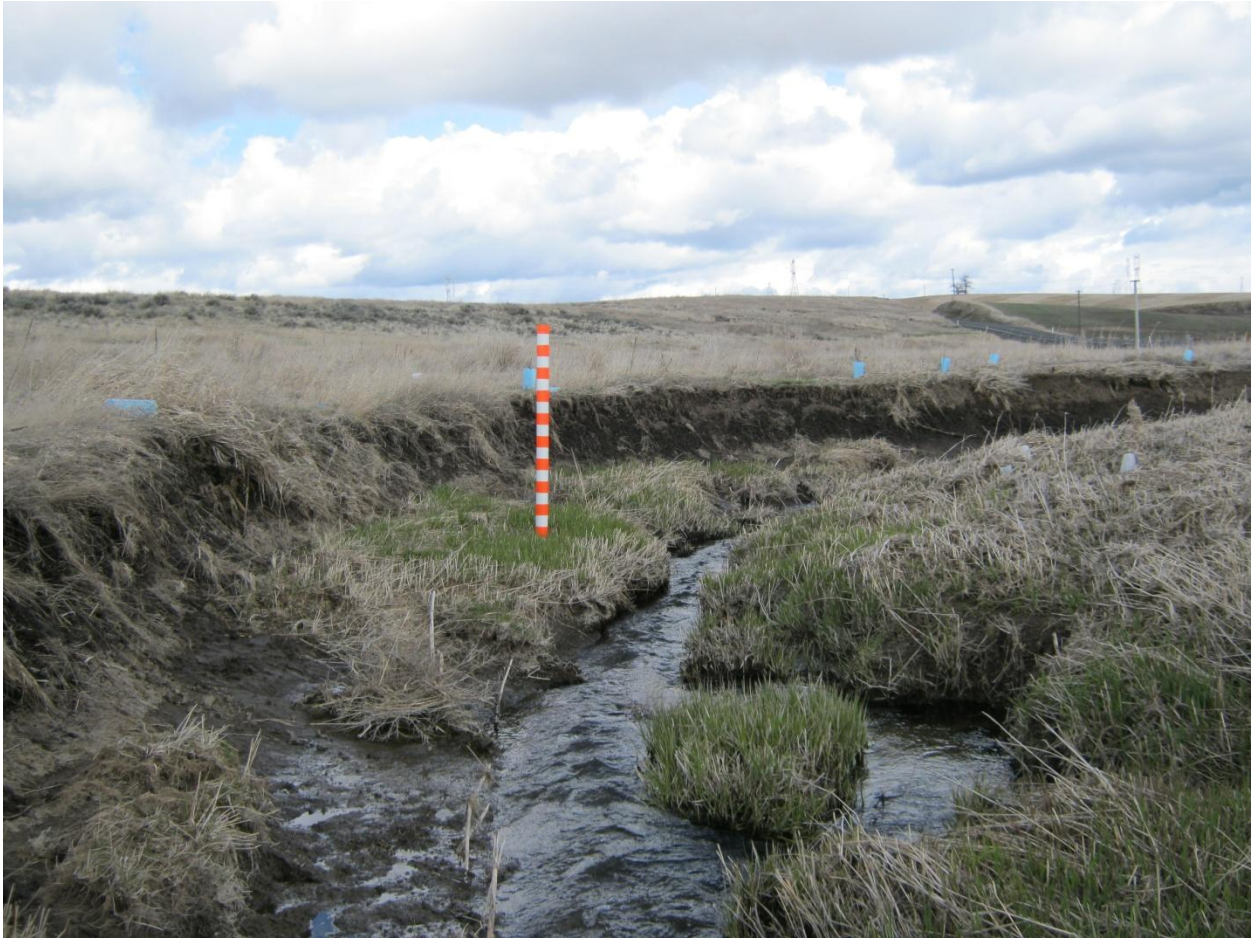
**Figure 5: Photo Point 1, Site C1**

Photo points were taken at each site, with a 2 meter, striped photo pole visible in each photo to show scale. These pictures can be seen in Figures 5-14. More qualitative monitoring was done at each site during maintenance, mainly assessing plant health and rate of herbivory.
