FINAL PROJECT MEMORANDUM

TO: WRIA 54 WIT
FROM: THE LANDS COUNCIL
SUBJECT: WRIA 54 DEEP COULEE CREEK WATERSHED RESTORATION
PROJECT 2014 UPDATE
DATE: 6/30/2014
CC: SPOKANE COUNTY WATER RESOURCES

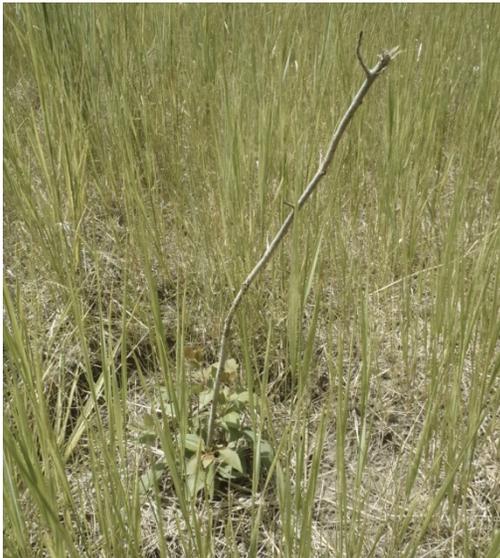
Figure 2: Example of Damaged Plant Growing from Roots

While the winter of 2013-2014 had a few cold snaps that caused significant mortality, the project is still achieving minimal survivorship goals, especially among upland plantings. Many upland plants that were damaged from cold or herbivory are growing back from the roots.

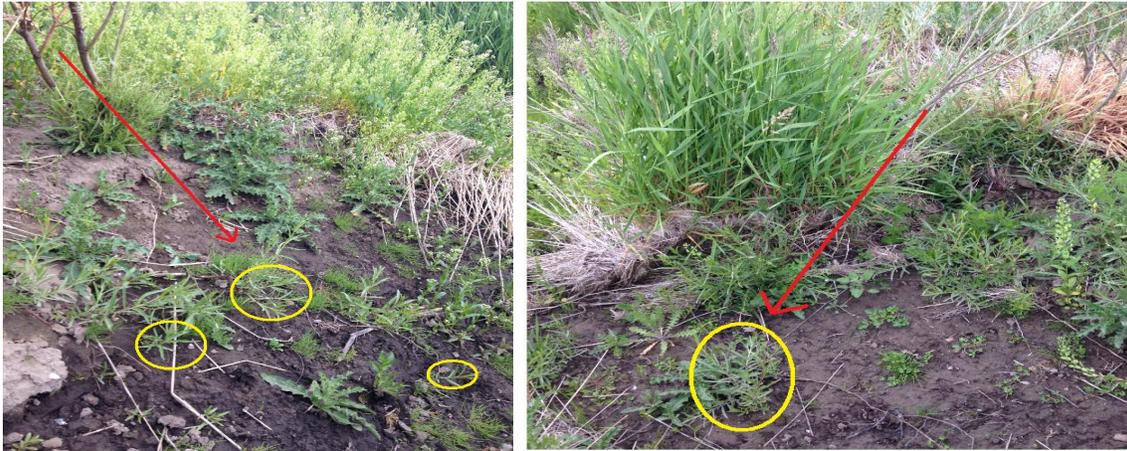
Figures 3 & 4: Examples of Clonal Coyote Willow Recruitment

Mortality was also offset by clonal recruiting from coyote willow and suckering from other species such as aspen and cottonwood that exhibit clonal recruitment abilities. These root expansion properties have great implications for stream habitat restoration success. Riparian species planted slightly upland of the greenline will send clonal shoots which can establish in the unstable substrate near the stream, in the RCG zone, and will eventually shade-out the shallow-rooting grasses. Willows planted in 2012 are also producing seed which will help recruit more native trees to the riparian zone. Clonal recruitment and seed-bearing stock will create a perpetual riparian reforestation as the system reinforces itself as seen in reference sites along Deep Creek. This is in combination with natural disturbance and apart from synthetic disturbance.

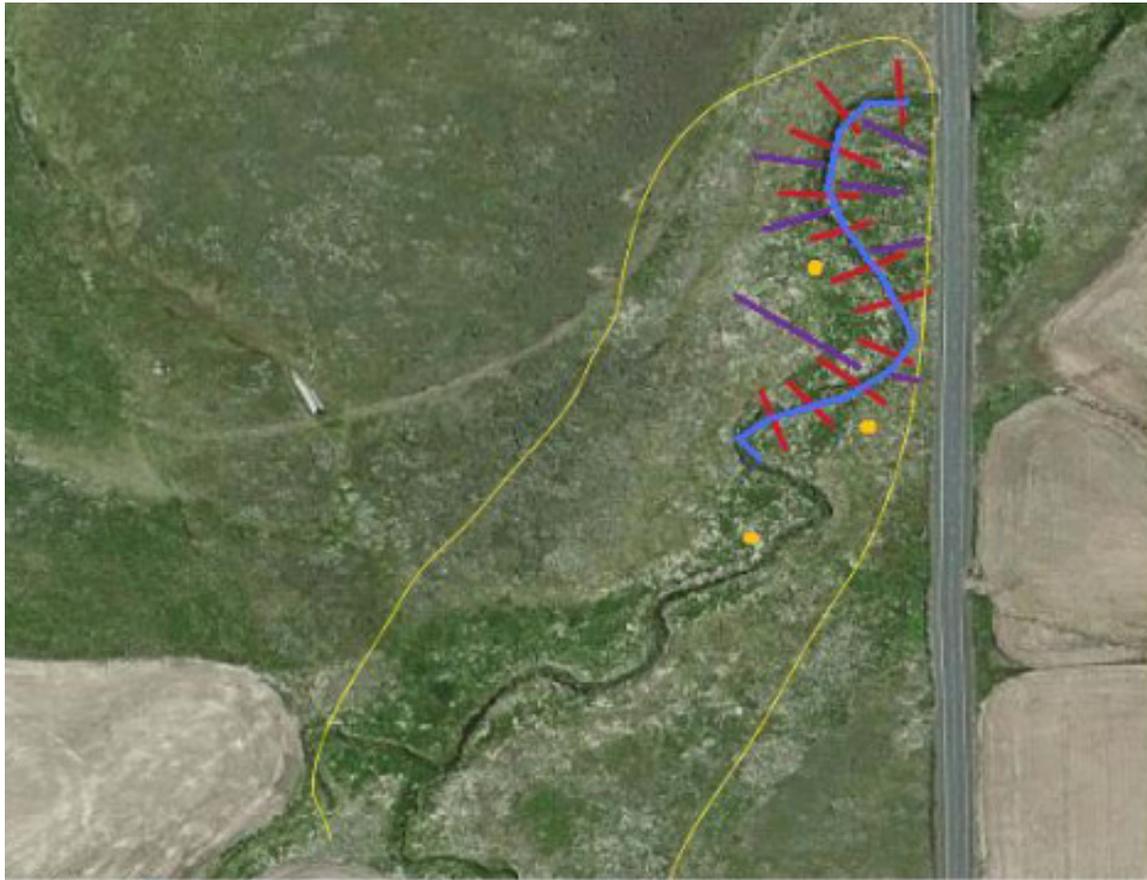
Figure 6: Depiction of Monitoring Practices at Coulee Creek Monitoring Site

Planting and monitoring boundaries
-

Baseline transect: greenline vegetation monitoring and stream assessment reach
-

Radial transects for vegetation monitoring
-

Shrub and vegetation layer assessment points
-

Photo points

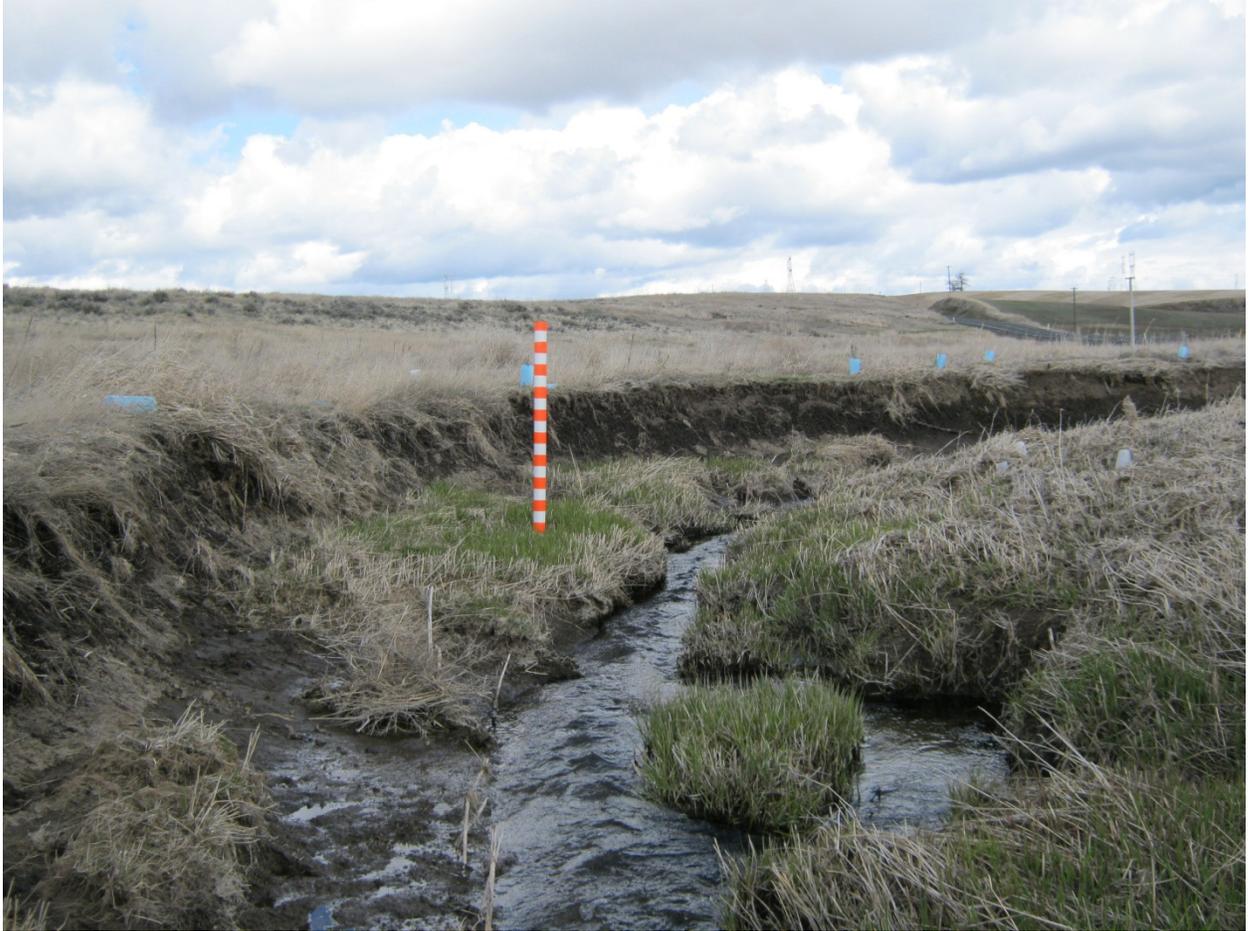
Figure 7: Photo Point, Coulee Creek Monitoring Site, 2012a

Photo taken 17 April 2012

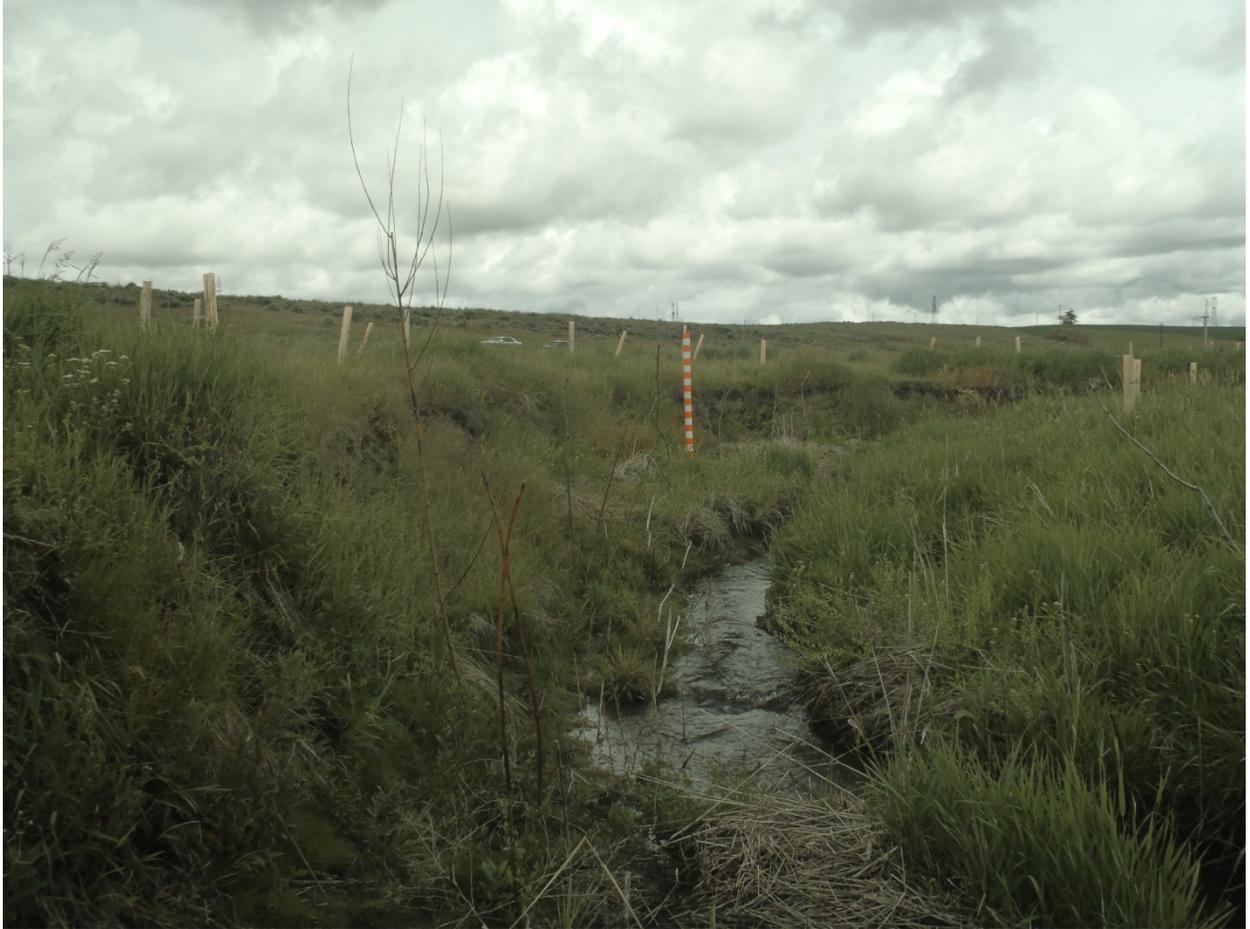
Figure 8: Photo Point, Coulee Creek Monitoring Site, 2013a

Photo taken 25 June 2013

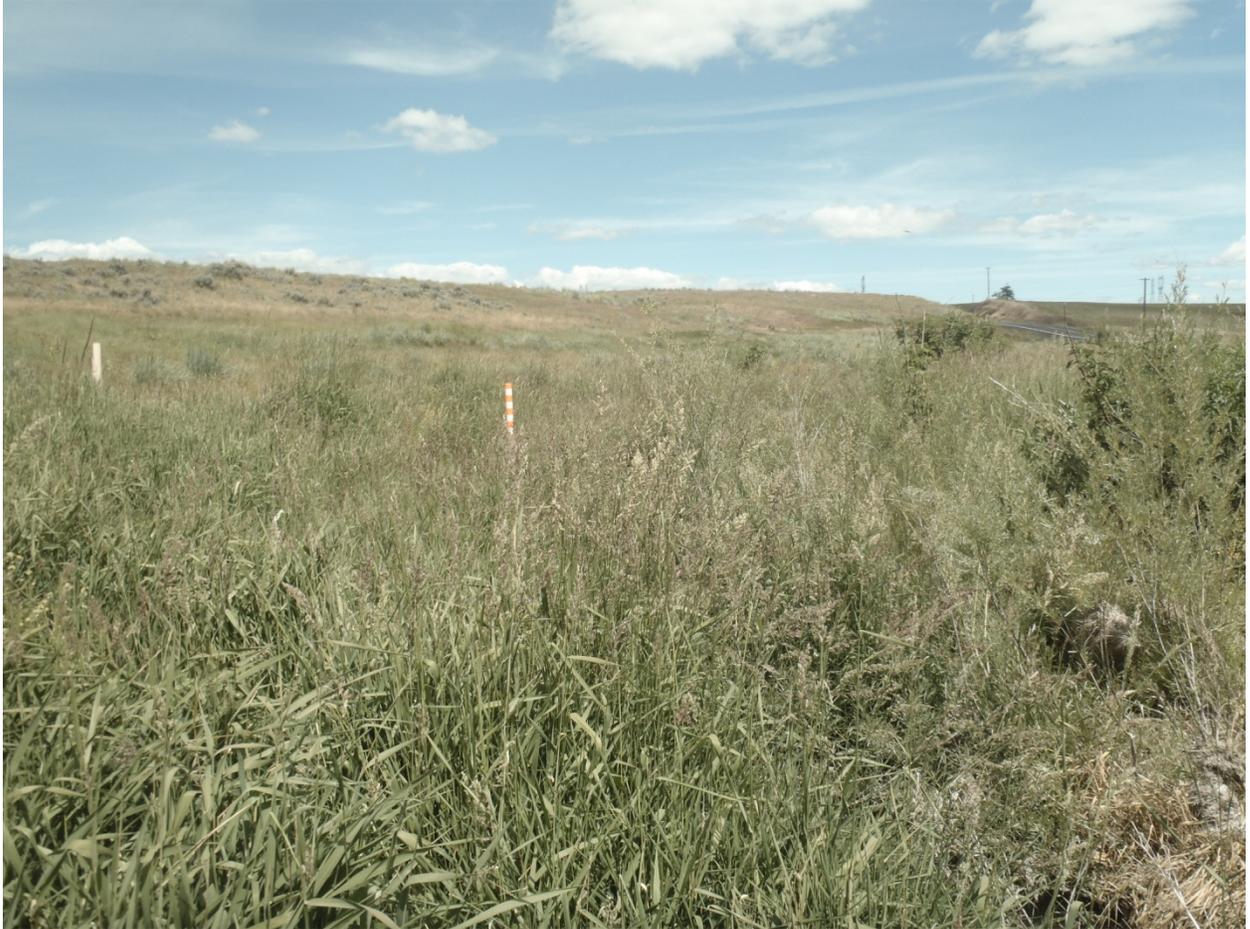
Figure 9: Photo Point, Coulee Creek Monitoring Site, 2014a

Photo taken 25 June 2014

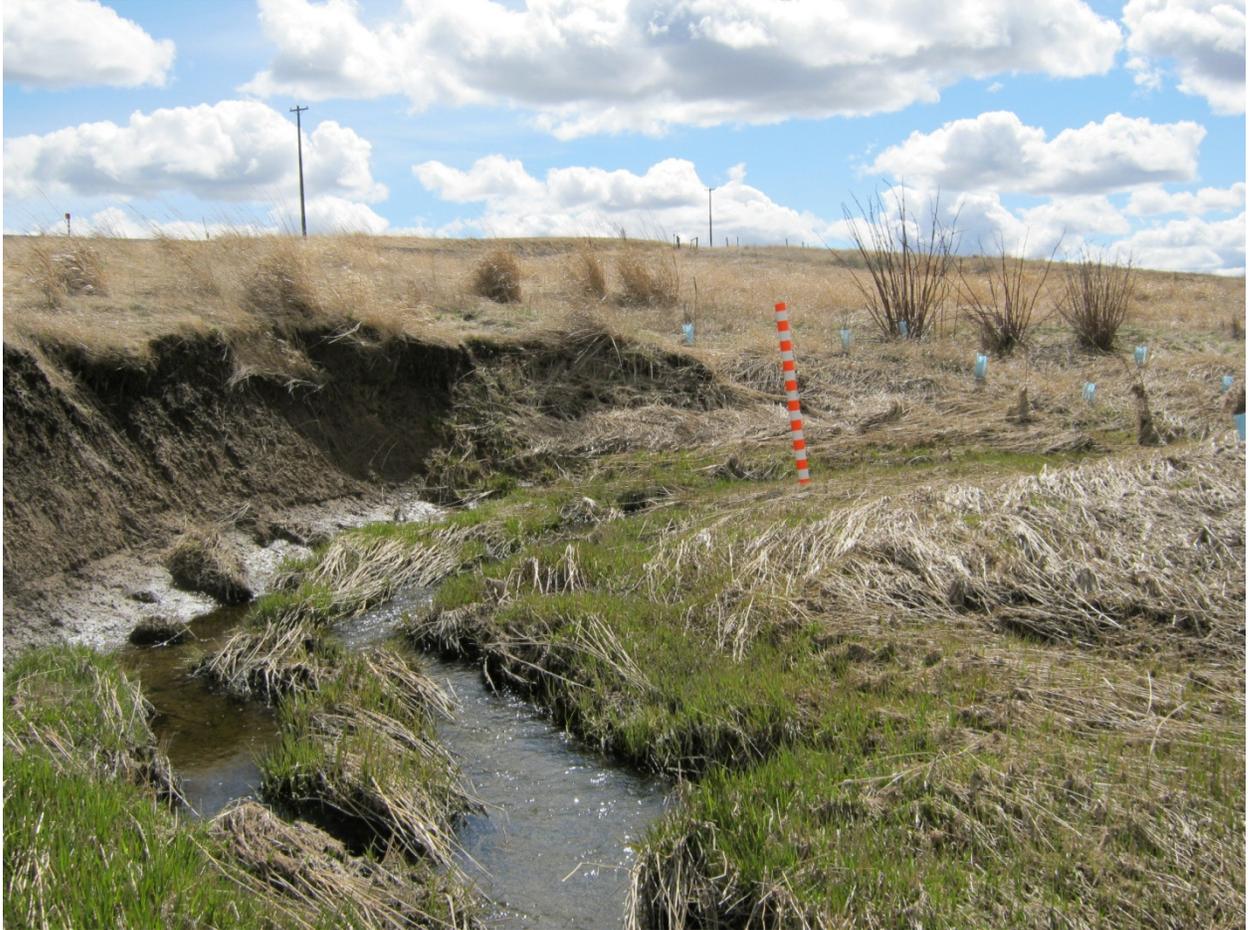
Figure 10: Photo Point, Coulee Creek Monitoring Site, 2012b

Photo taken 17 April 2012

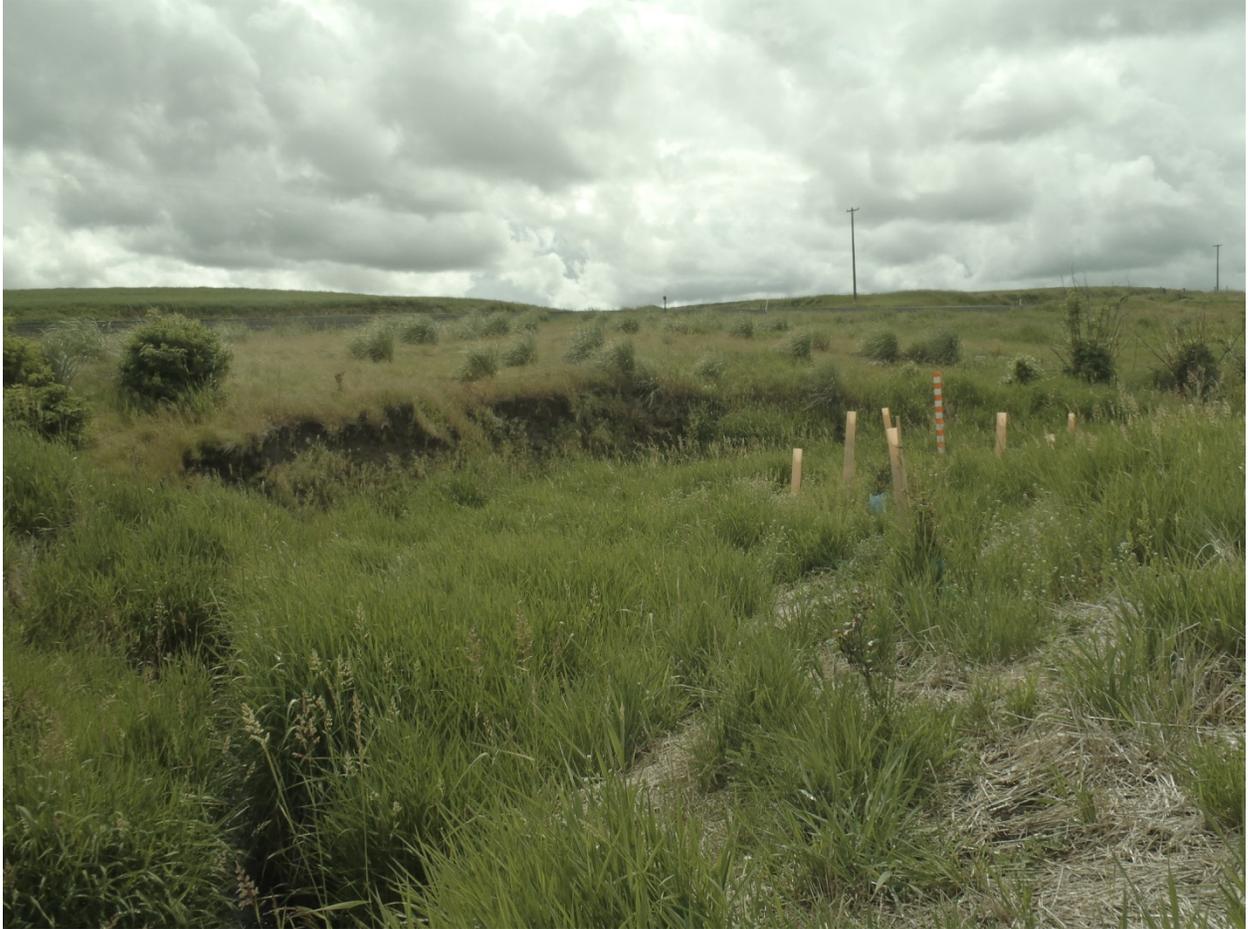
Figure 11: Photo Point, Coulee Creek Monitoring Site, 2013b

Photo taken 25 June 2013

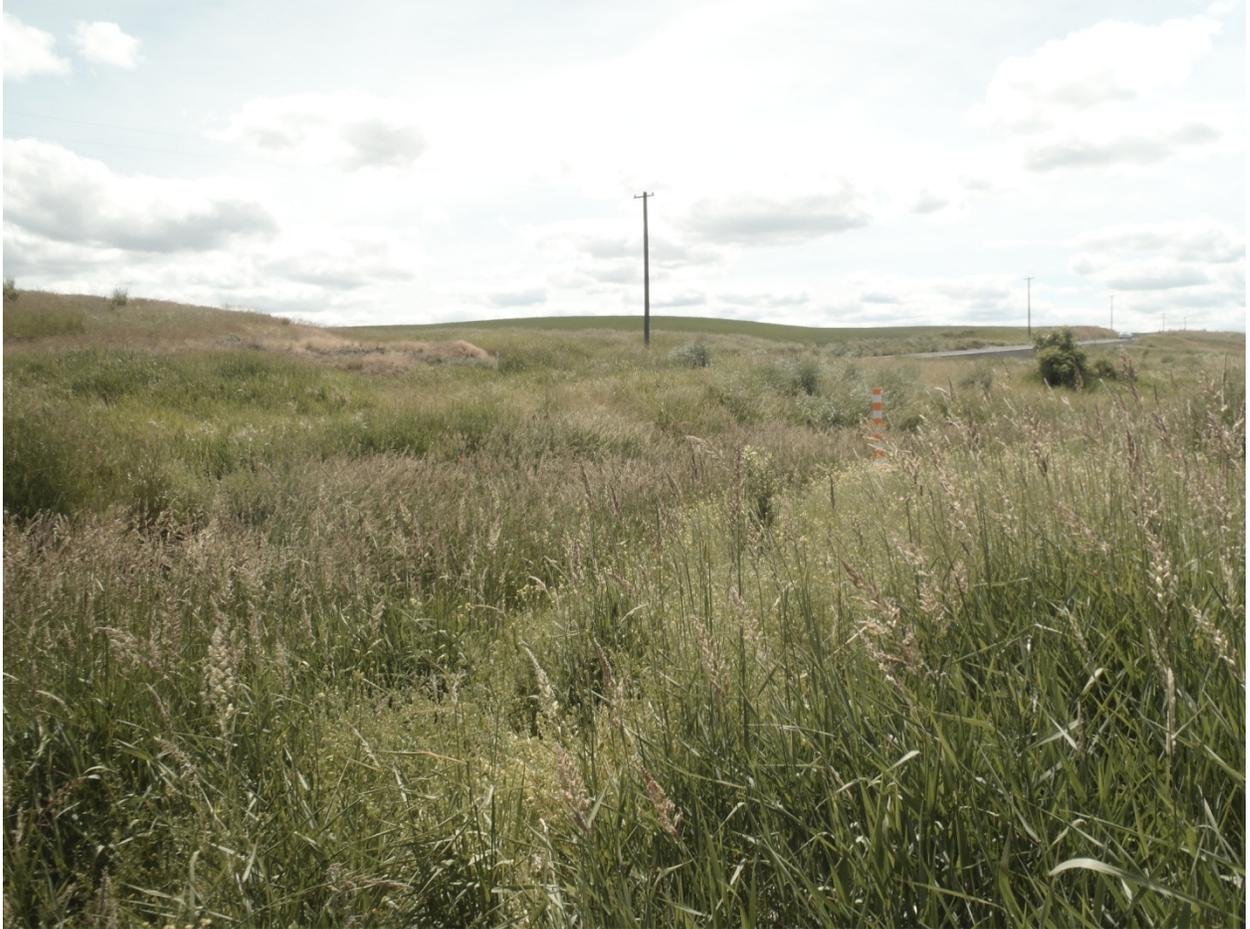
Figure 12: Photo Point, Coulee Creek Monitoring Site, 2014b

Photo taken 25 June 2014

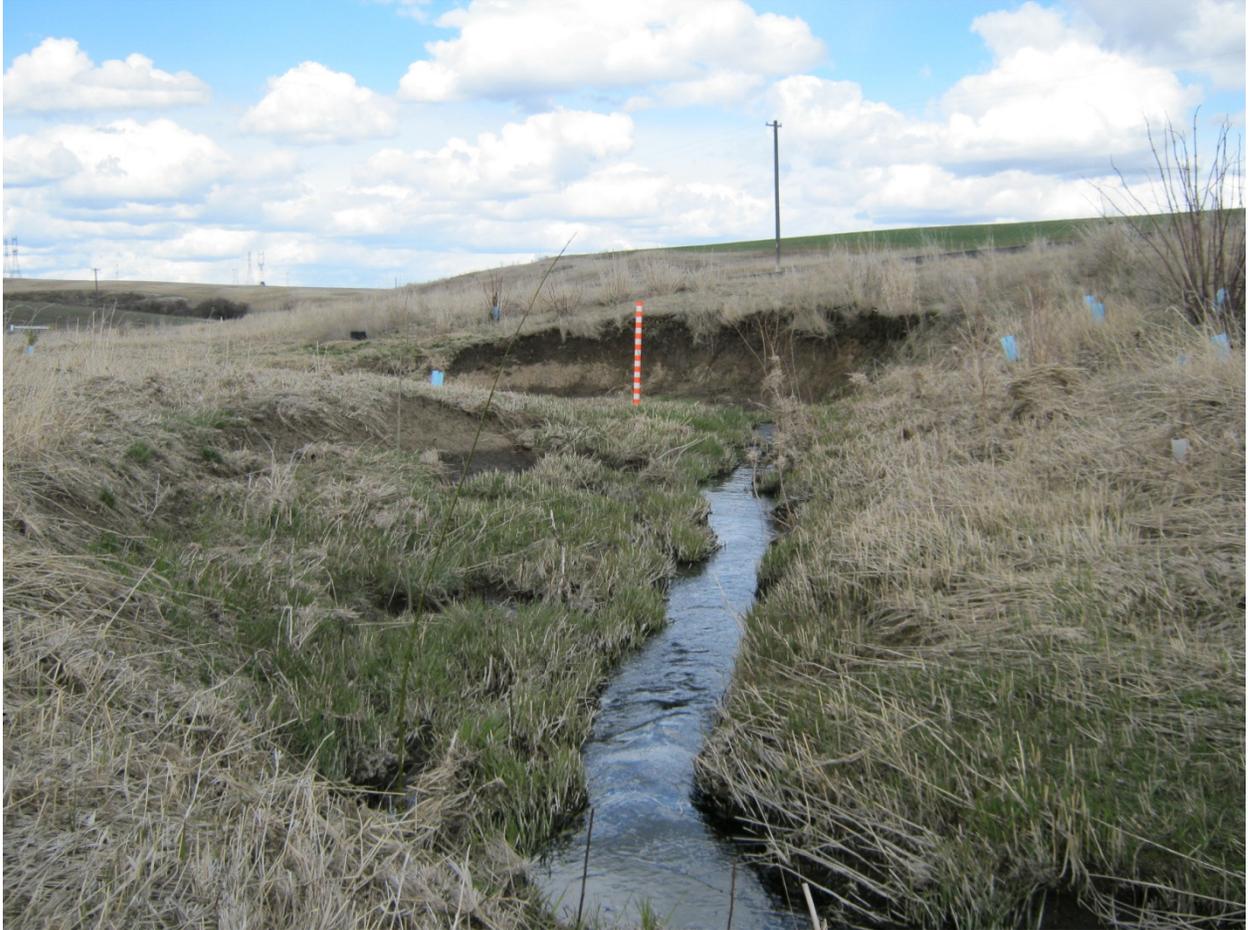
Figure 13: Photo Point, Coulee Creek Monitoring Site, 2012c

Photo taken 17 April 2012

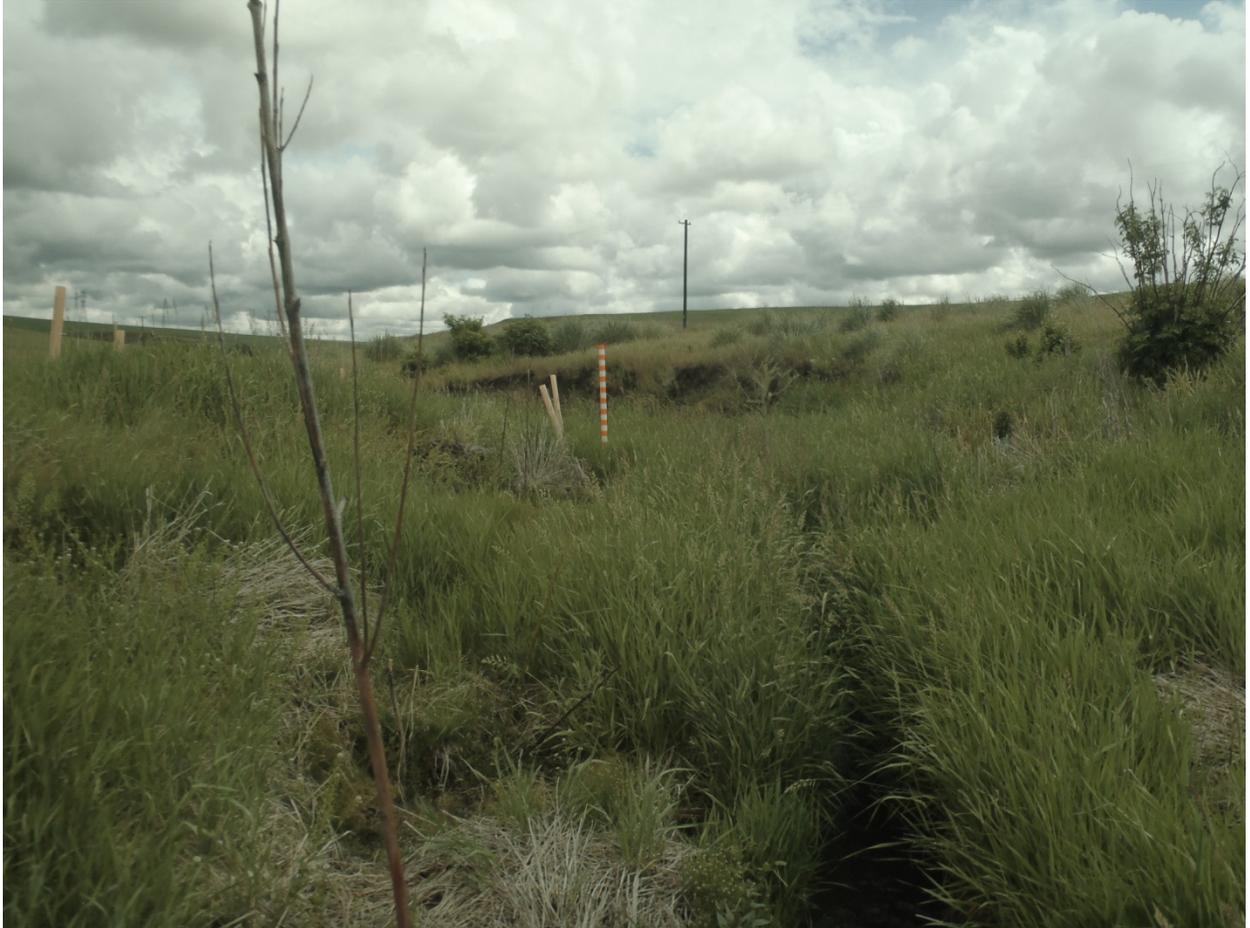
Figure 14: Photo Point, Coulee Creek Monitoring Site, 2013c

Photo taken 25 June 2013

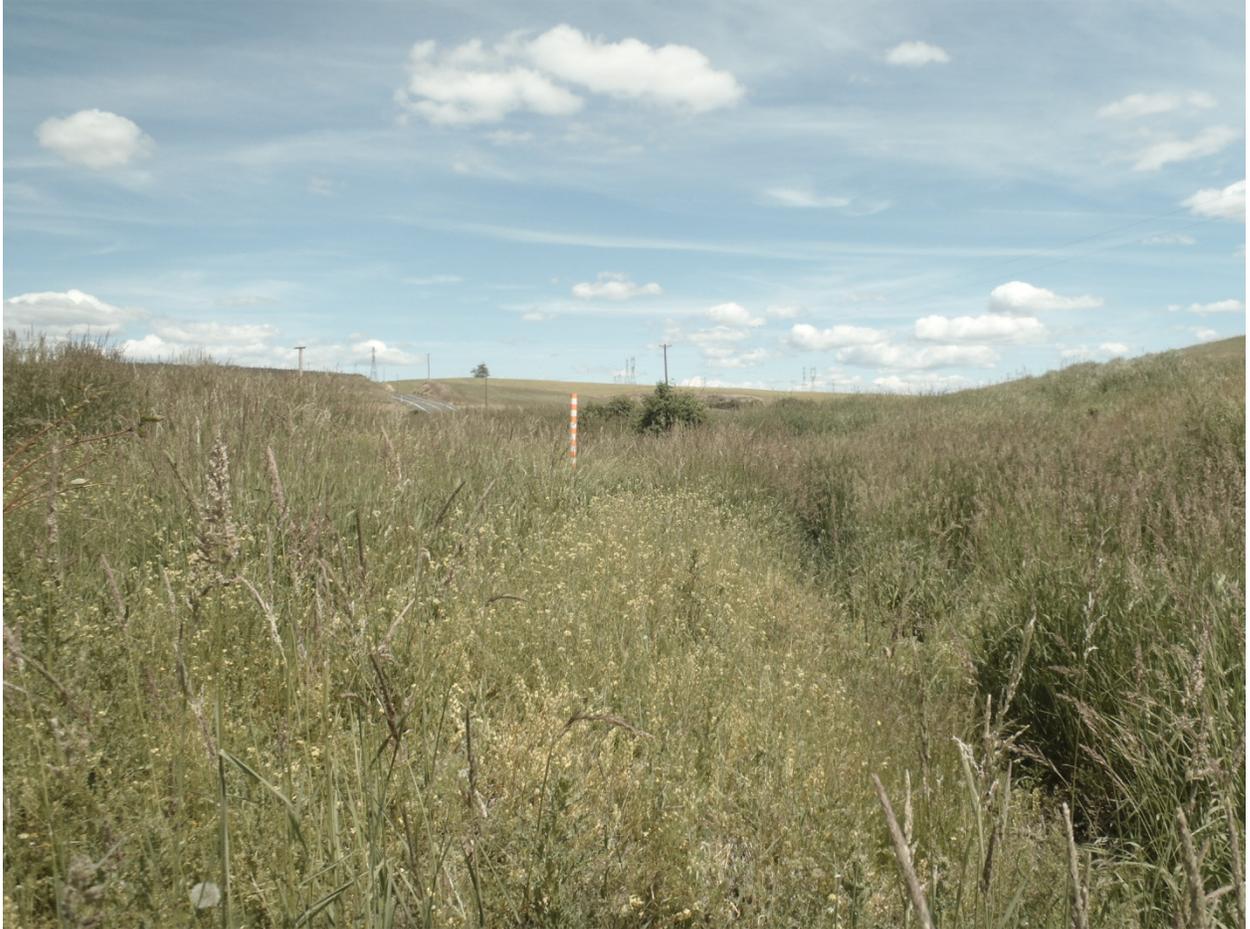
Figure 15: Photo Point, Coulee Creek Monitoring Site, 2014c

Photo taken 25 June 2014
