7.7 Figures

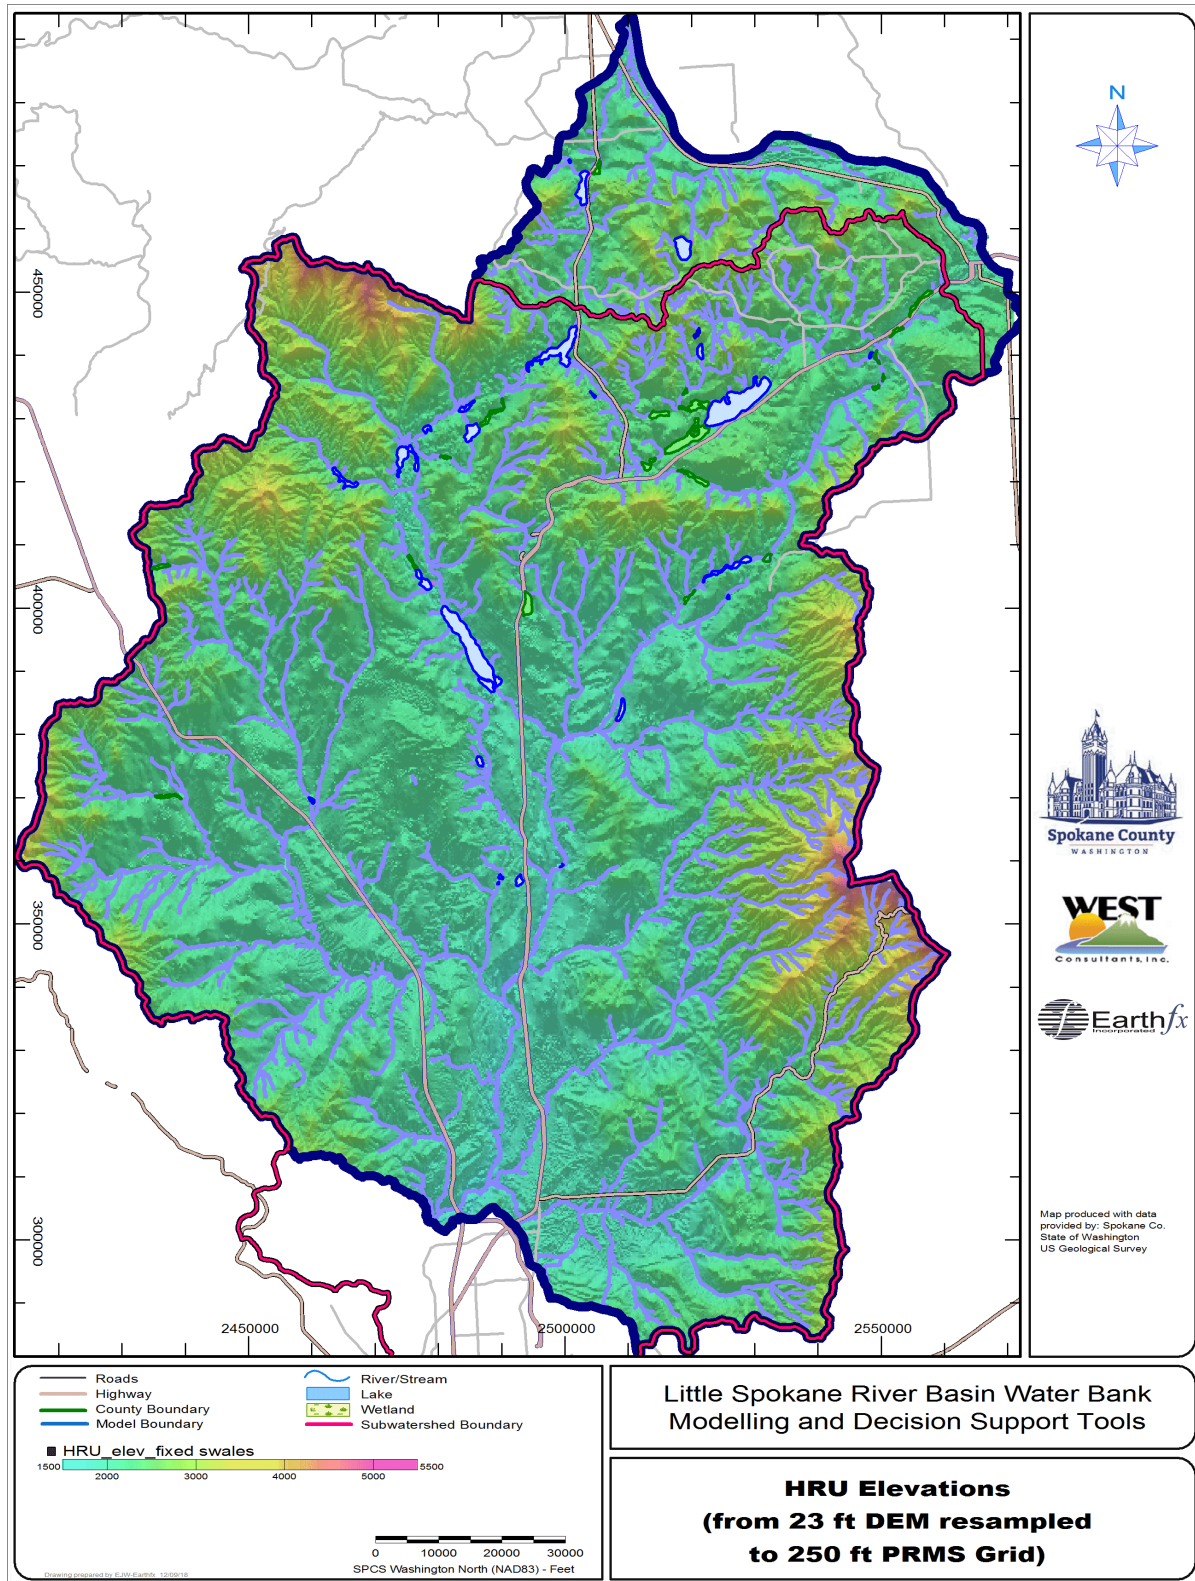
Figure 7.7: HRU elevations (from USGS 23 ft DEM resampled to PRMS grid).

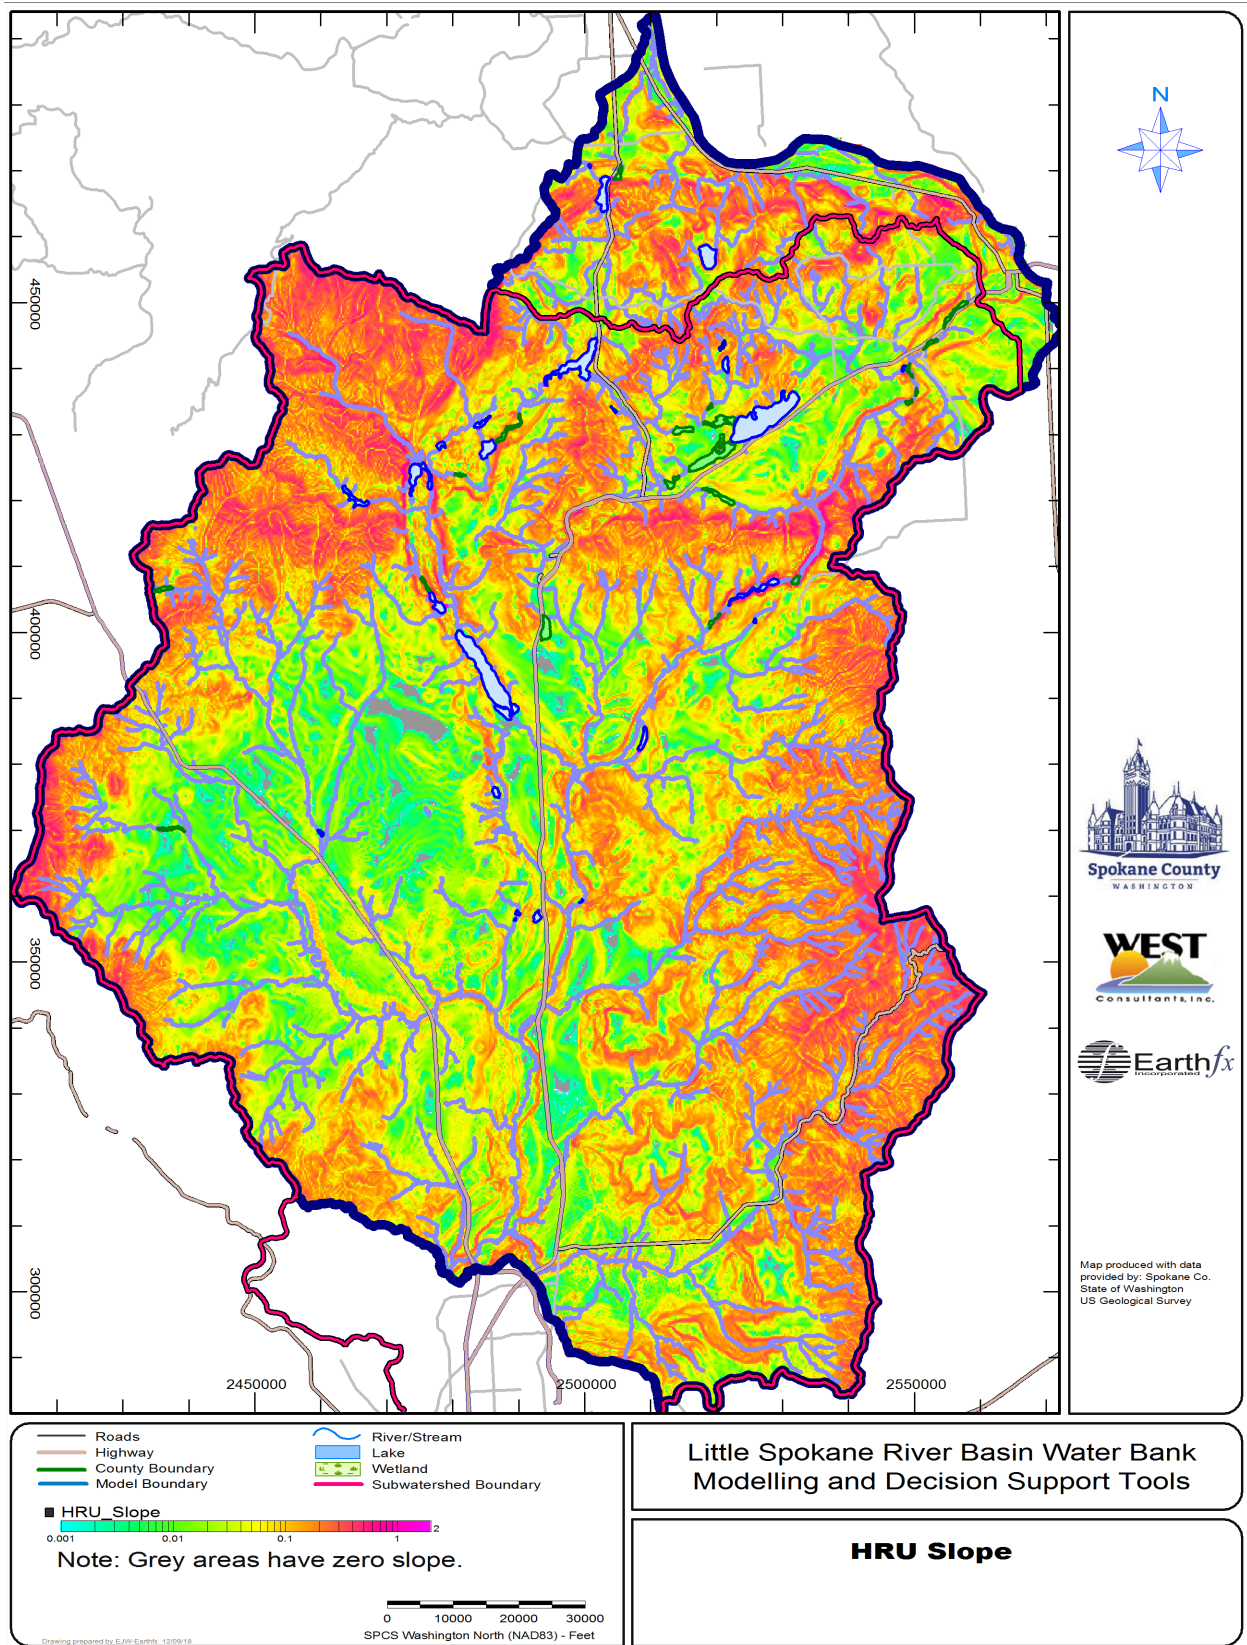
Figure 7.8: Distribution of slope (in ft/ft). Large grey areas with zero slope are artifacts of original DEM.

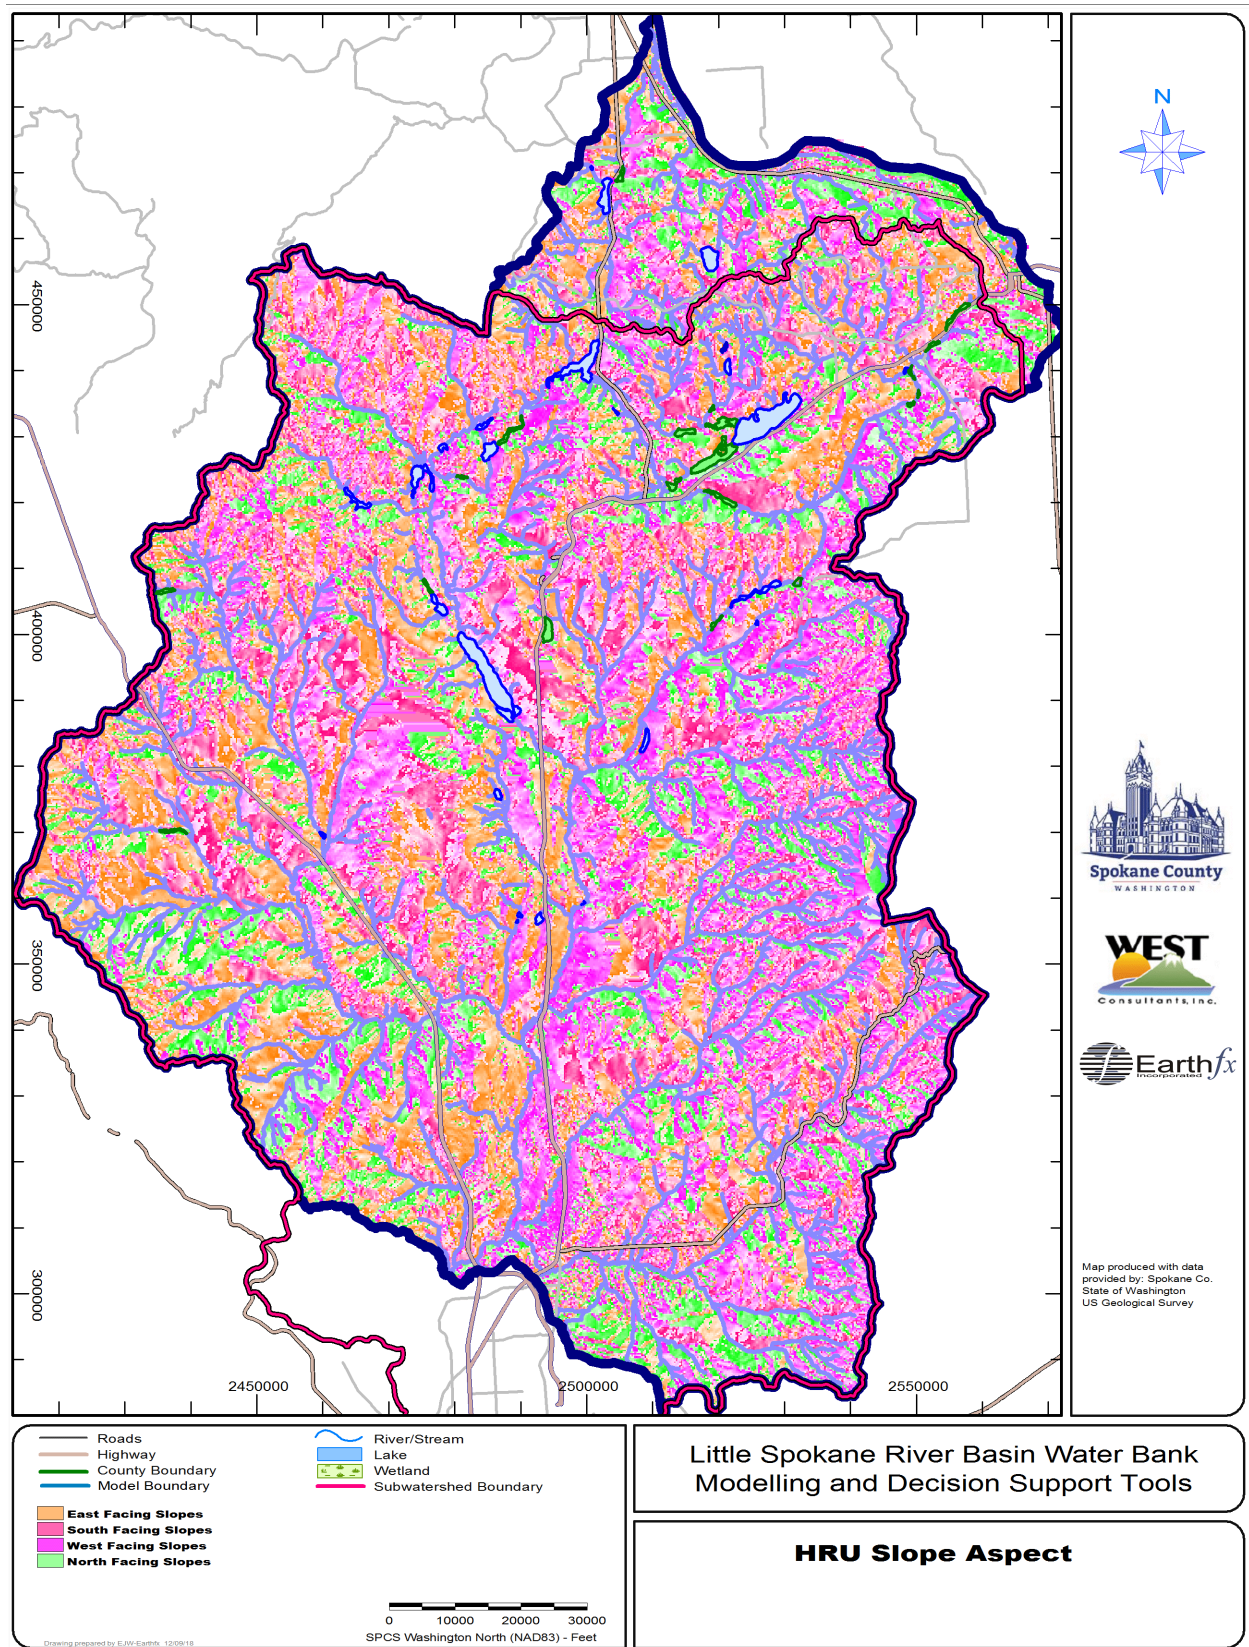
Figure 7.9: Distribution of slope aspect (value of 0 or 360 indicates cell is facing due north).

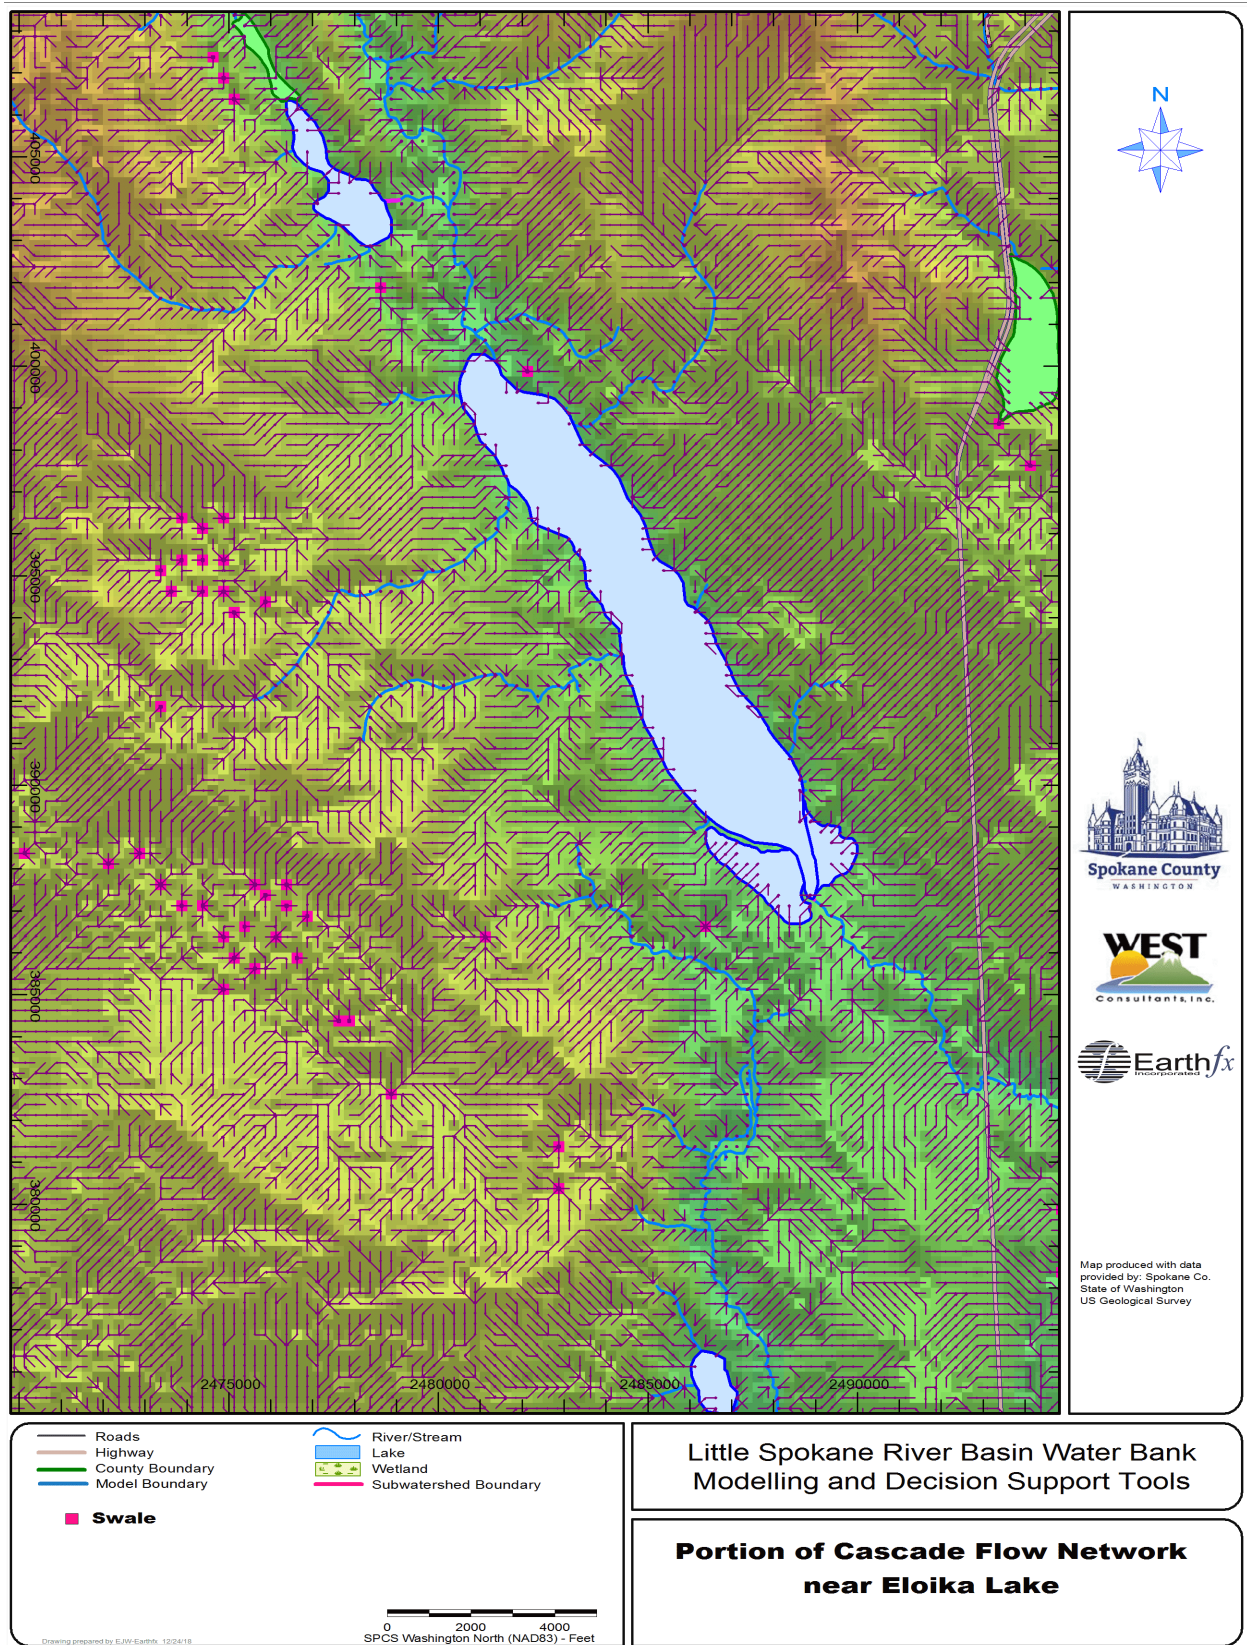
Figure 7.10: Topography and resulting cascade flow network near Eloika Lake

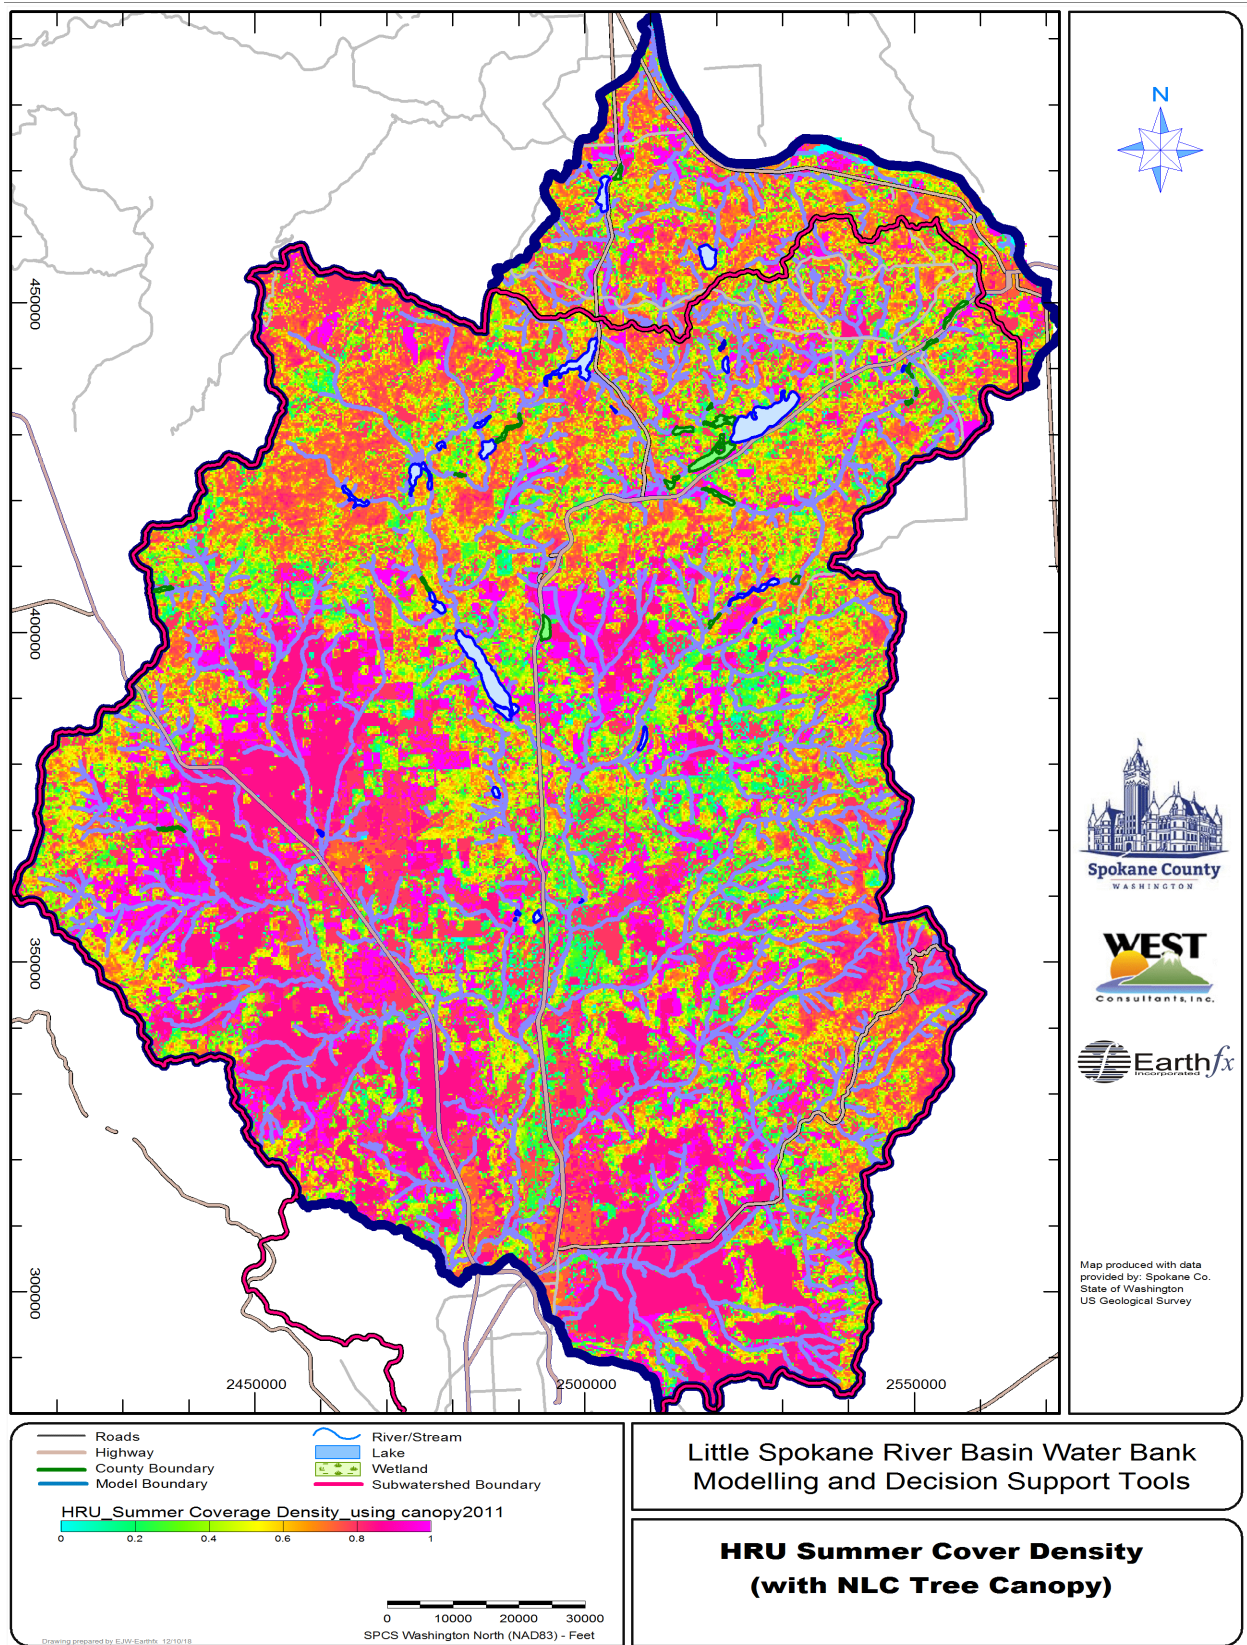
Figure 7.11: Distribution of summer vegetation cover density.

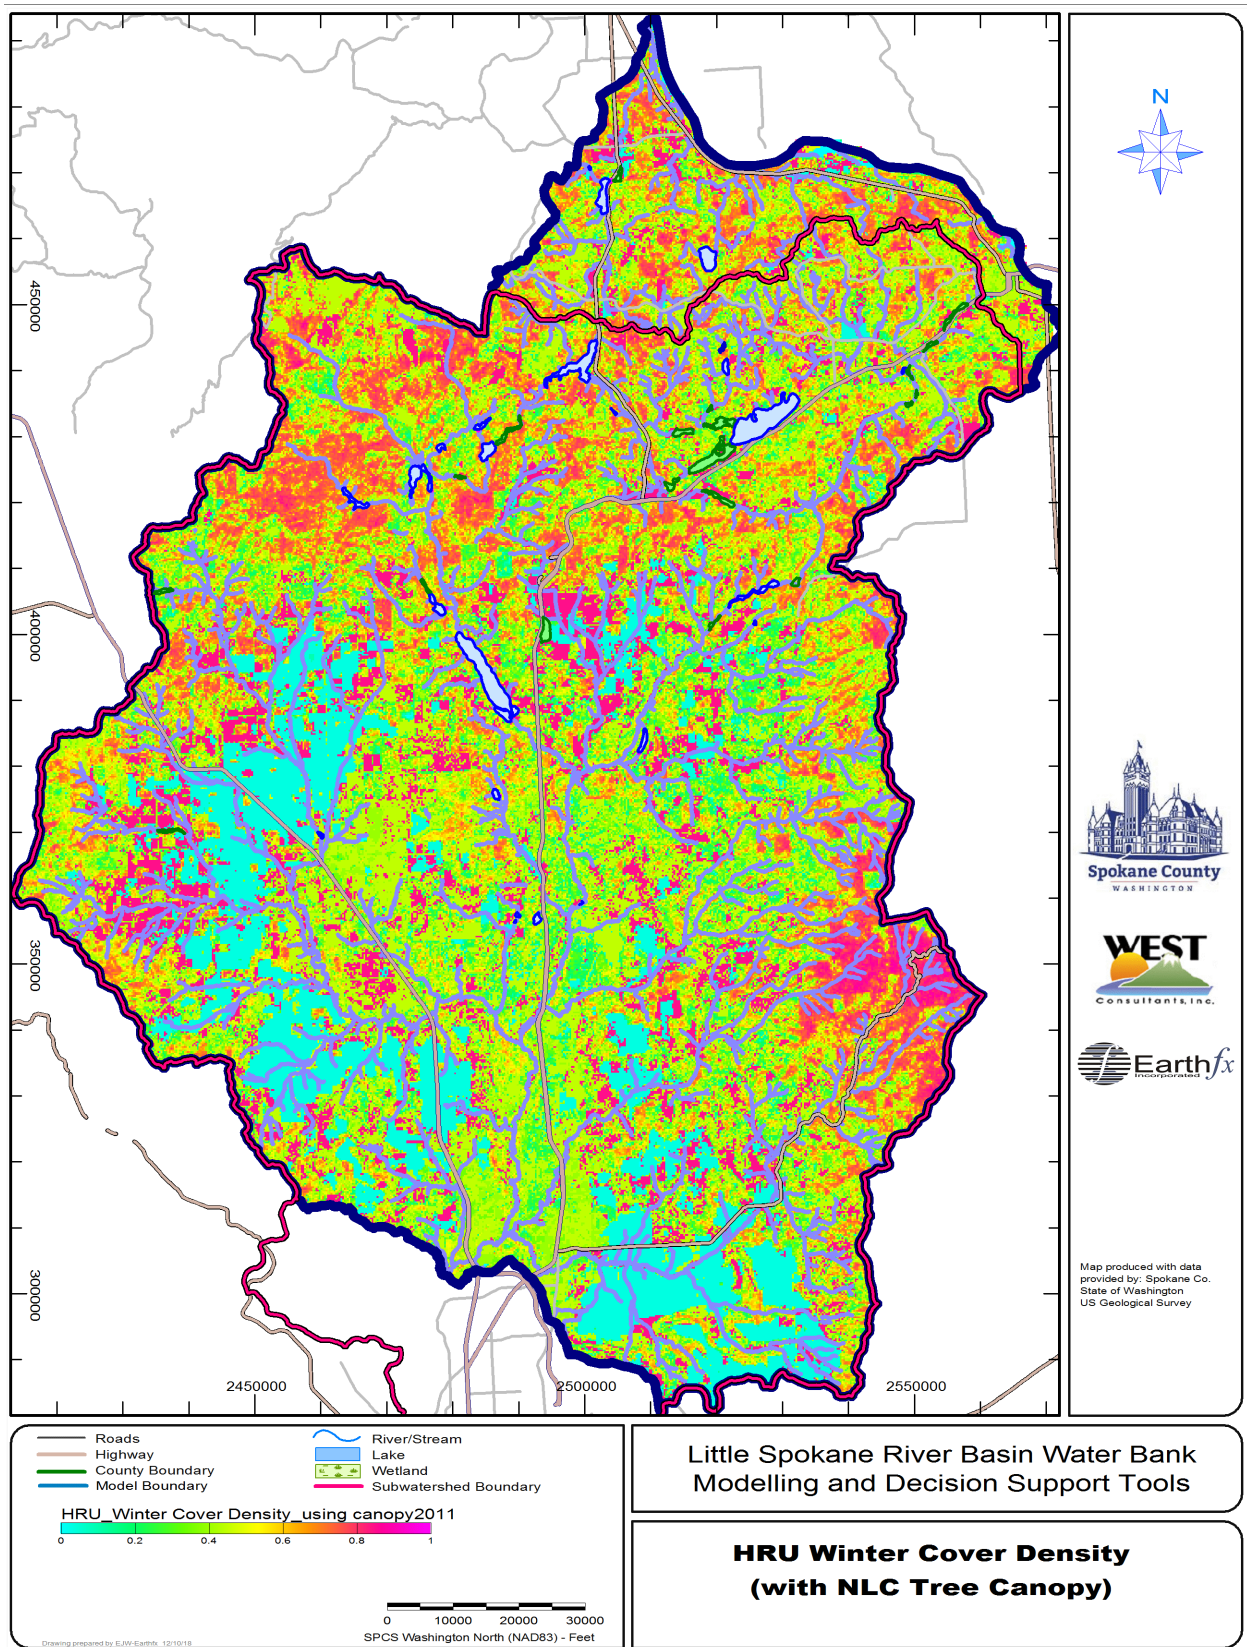
Figure 7.12: Distribution of winter vegetation cover density.

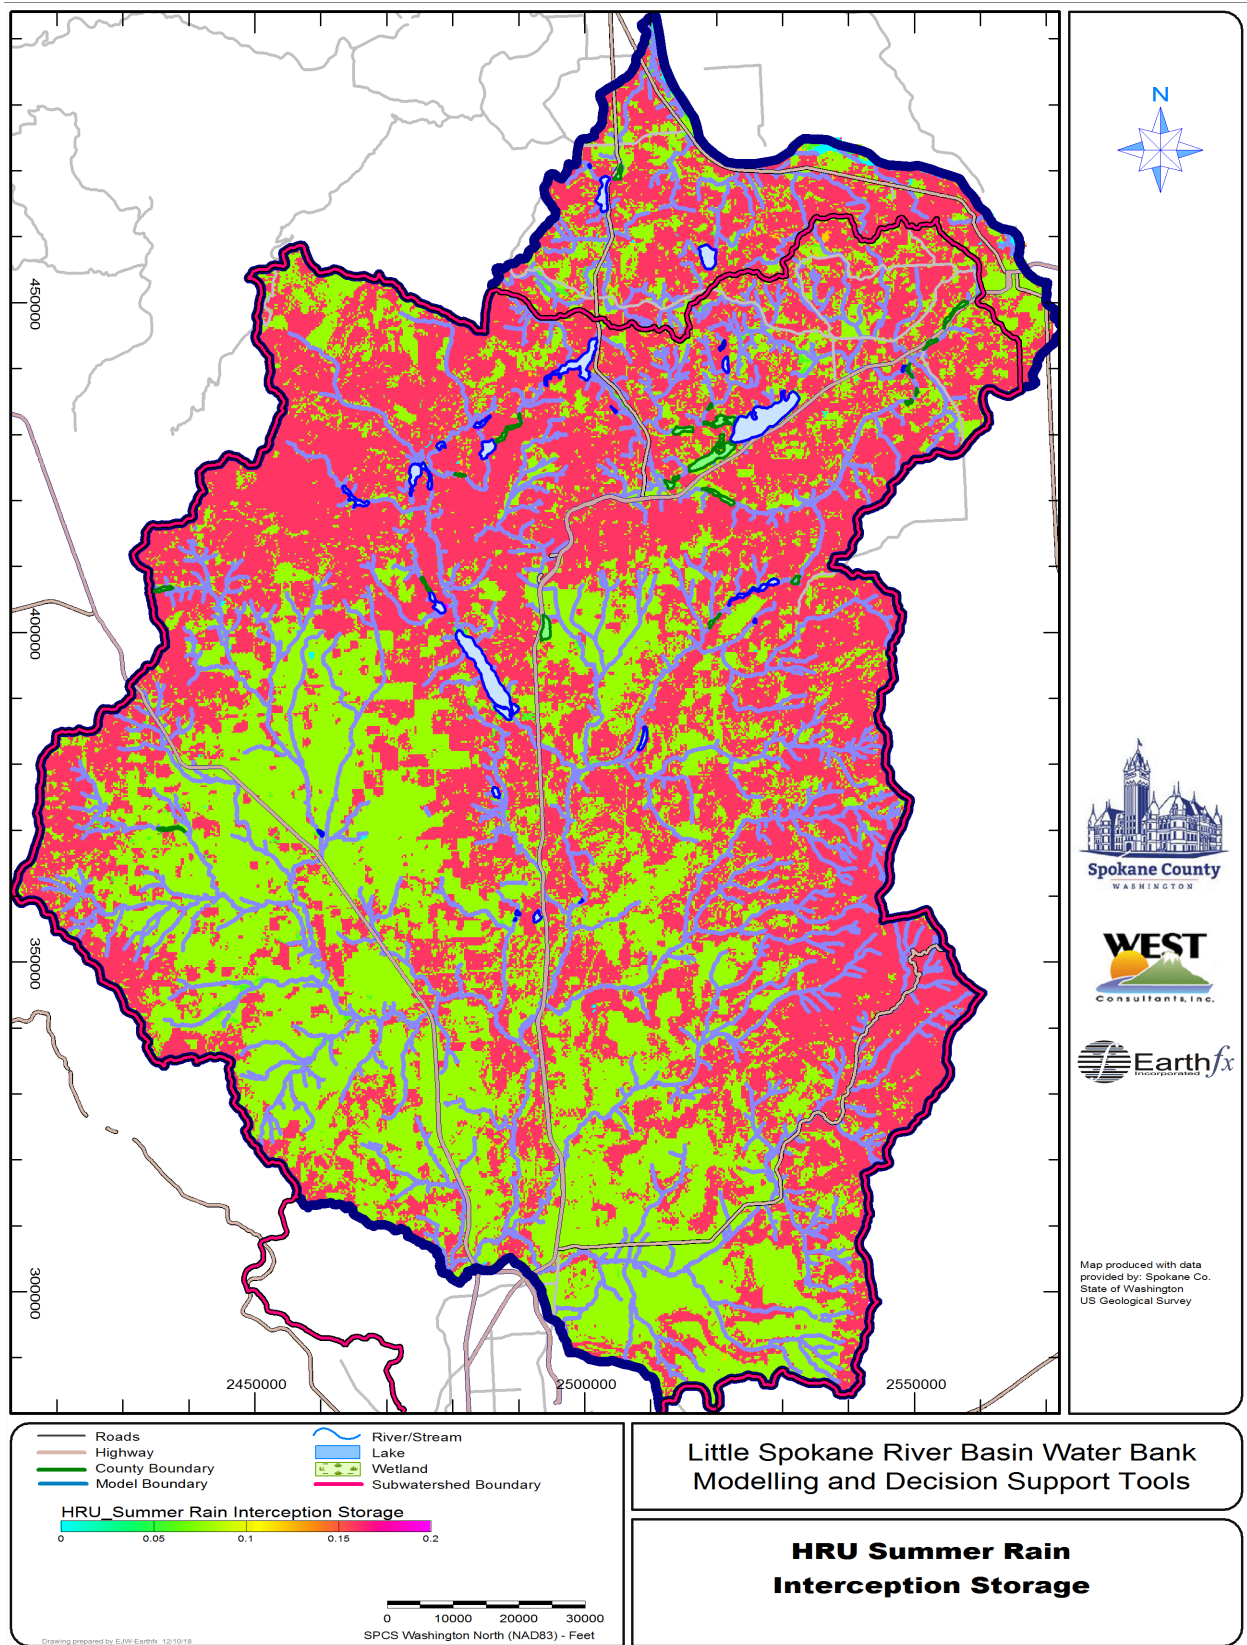
Figure 7.13: Distribution of summer rain interception storage.

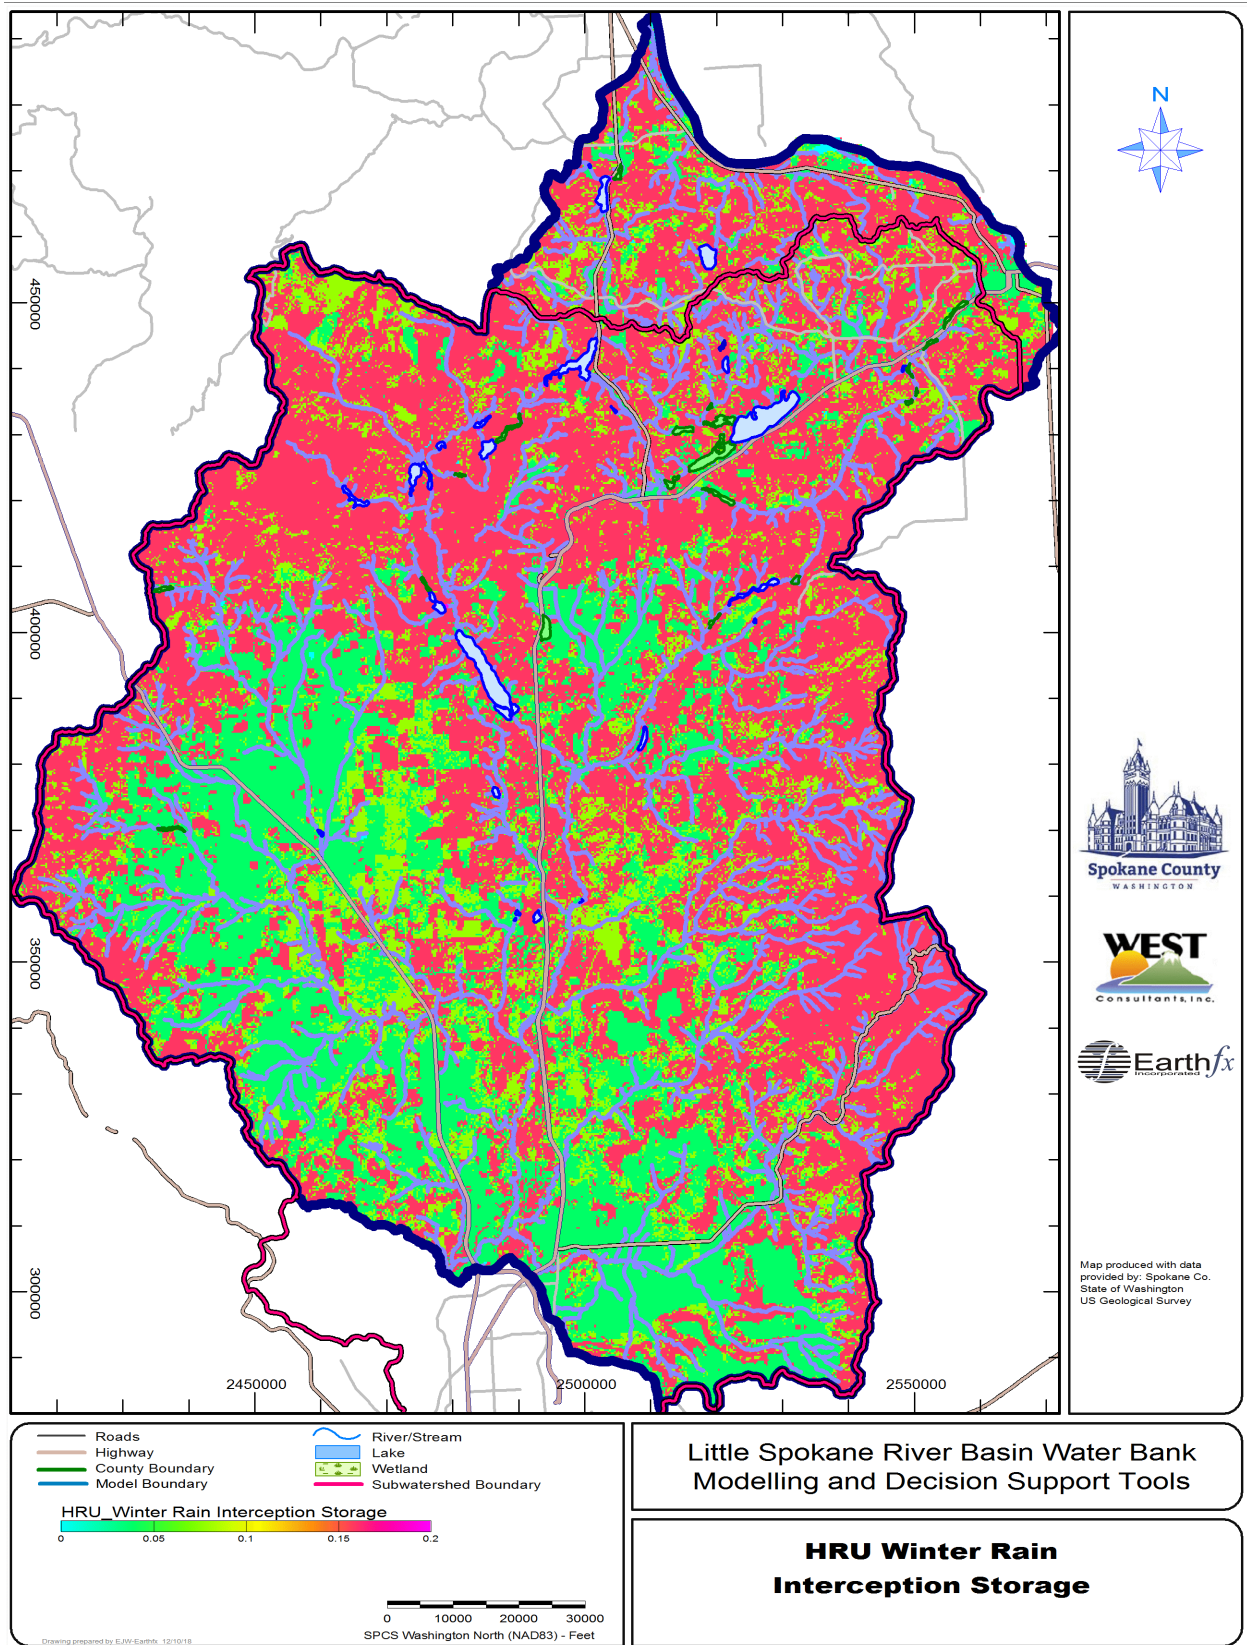
Figure 7.14: Distribution of winter rain interception storage.

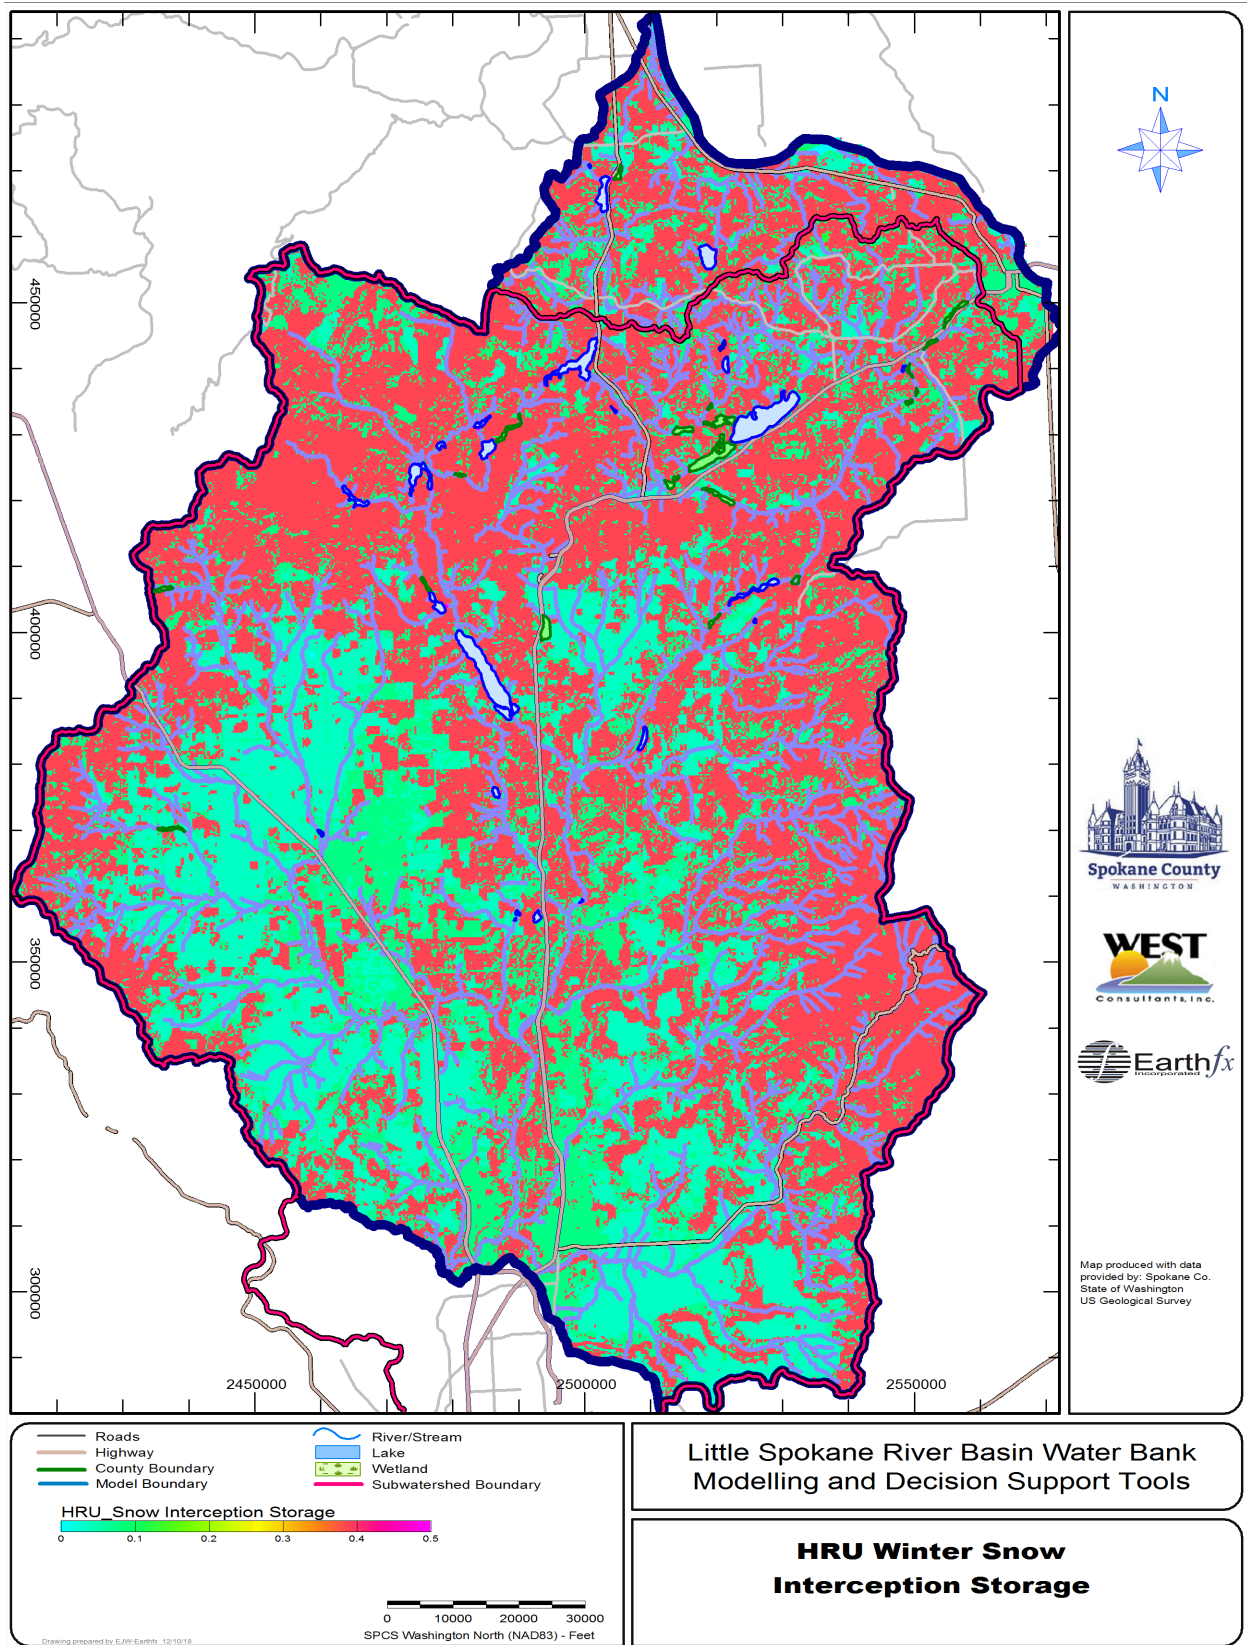
Figure 7.15: Distribution of winter snow interception storage.
