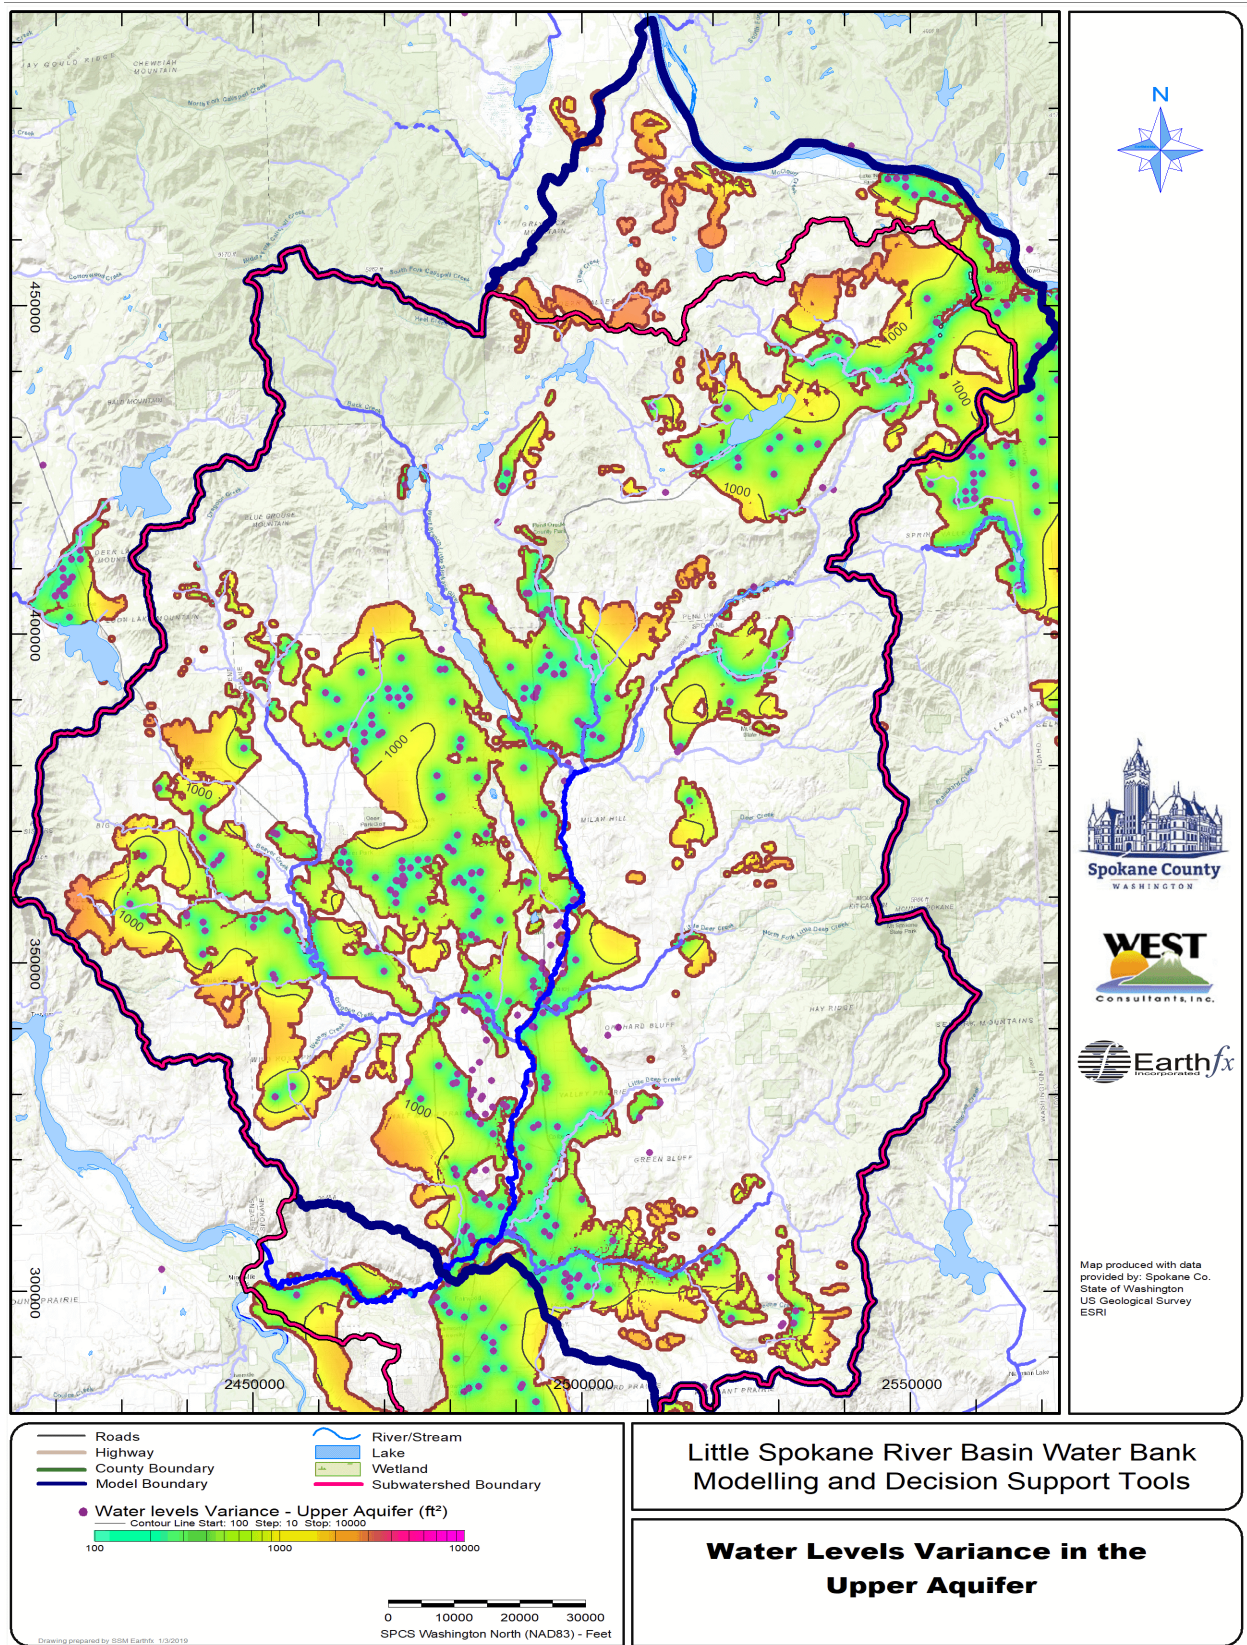
Figure 3.30: Estimation variance for water levels in the Upper Aquifer.

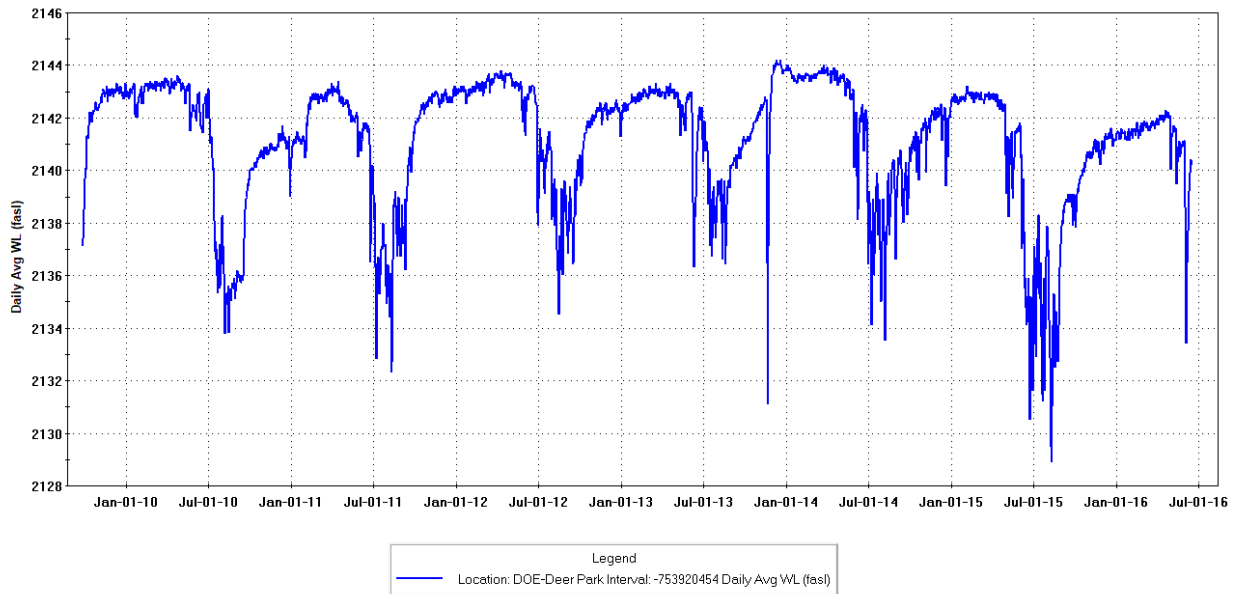
Figure 3.35: Groundwater elevation hydrograph for the DOE-Deer Park Grand Ronde Basalt aquifer well.

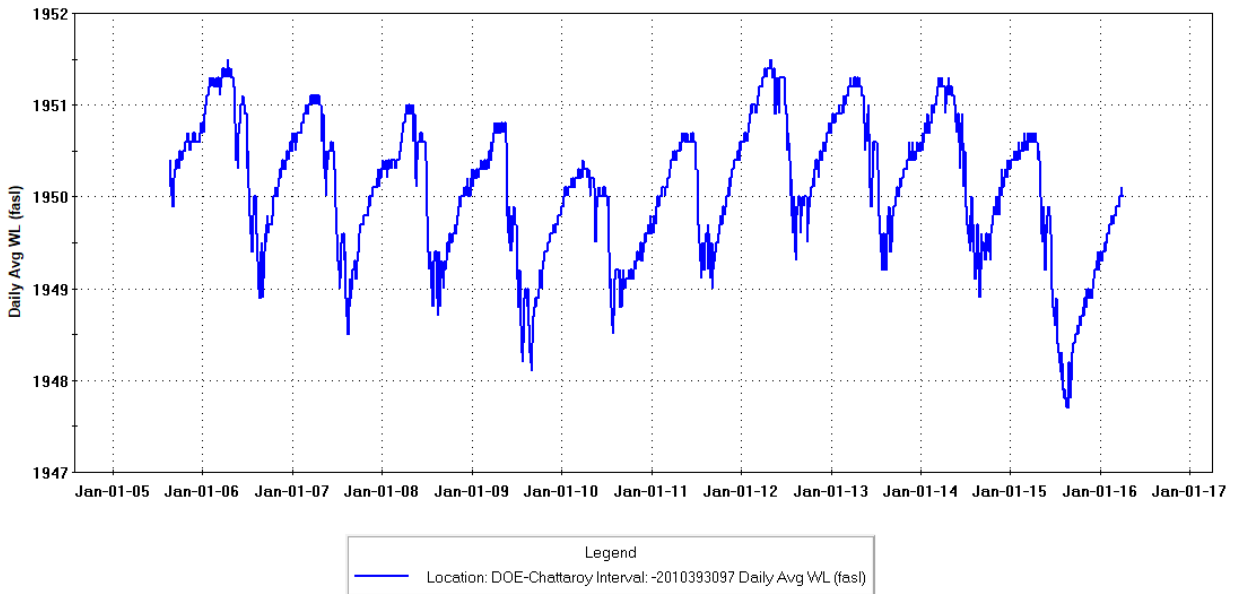
Figure 3.36: Groundwater elevation hydrograph for the DOE-Chattaroy bedrock aquifer well.

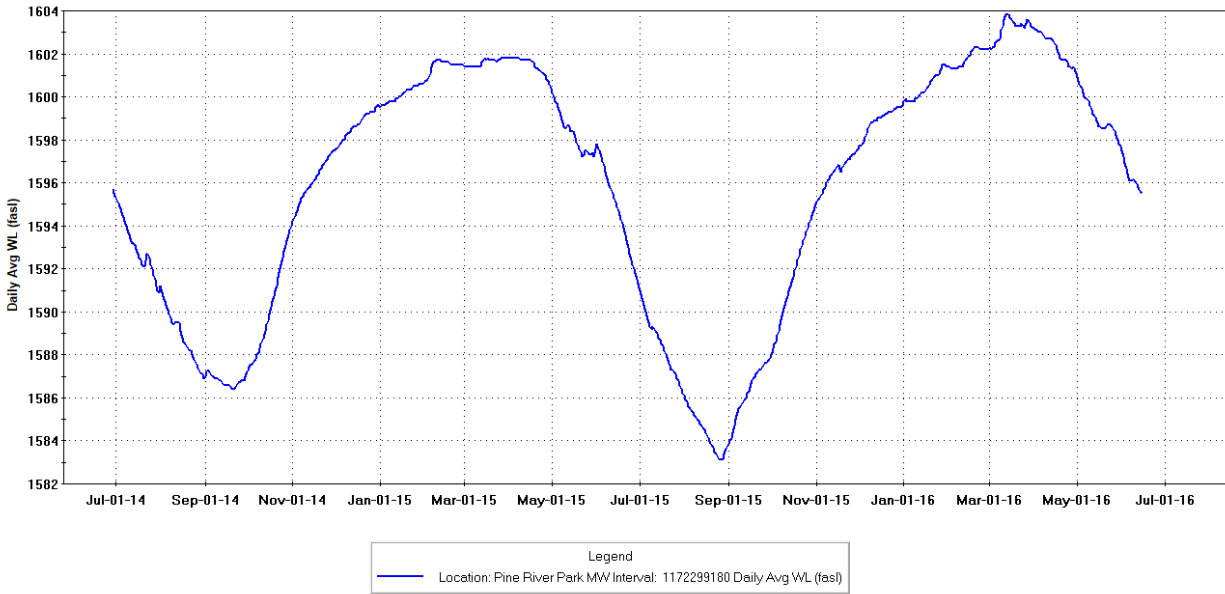
Figure 3.39: Groundwater elevation hydrograph at Pine River Park.

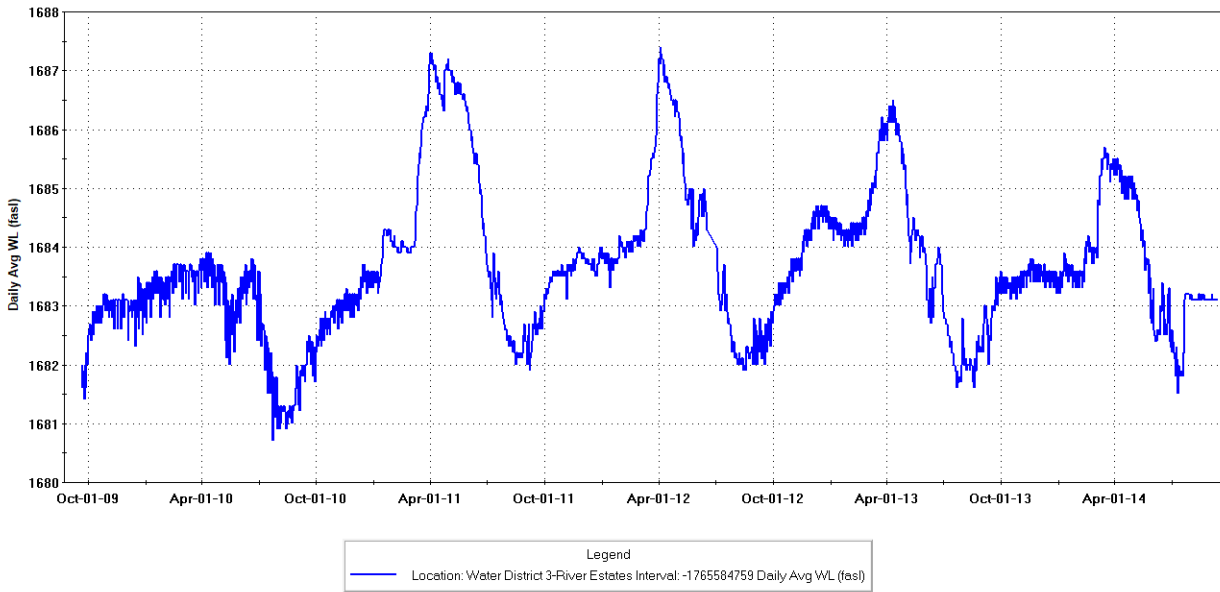
Figure 3.40: Groundwater elevation hydrograph for the SCWD#3 River Estates Upper Aquifer well.

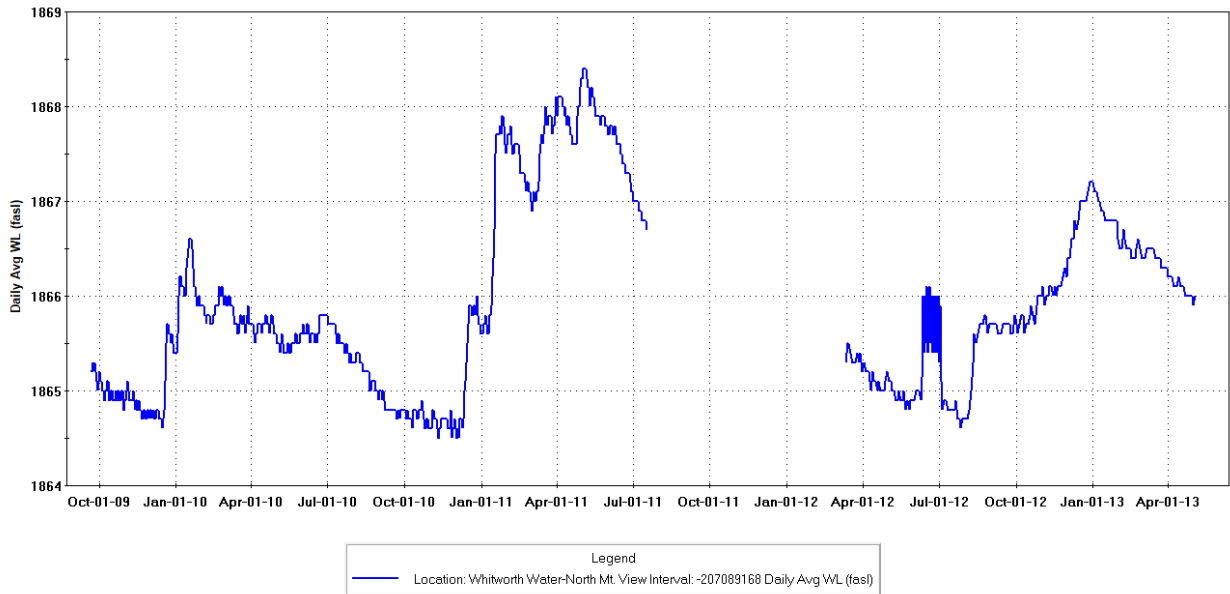
Figure 3.42: Groundwater elevation hydrograph at Whitworth Water – North Mt. View.

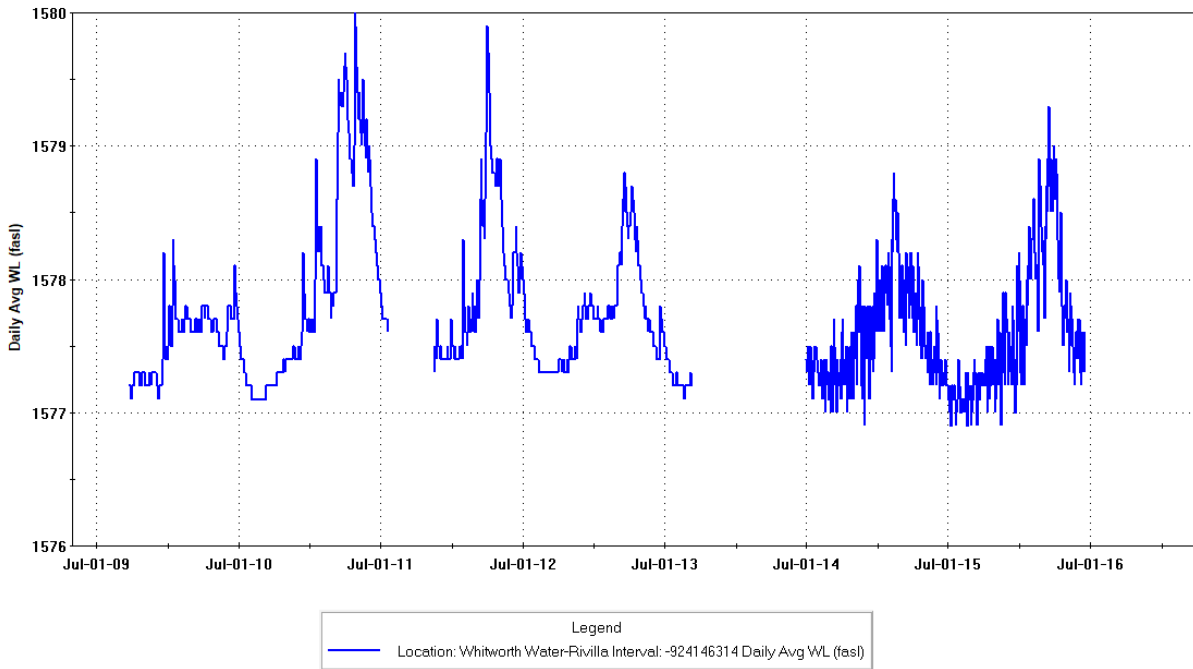
Figure 3.43: Groundwater elevation hydrograph for Whitworth Water – Rivilla.
