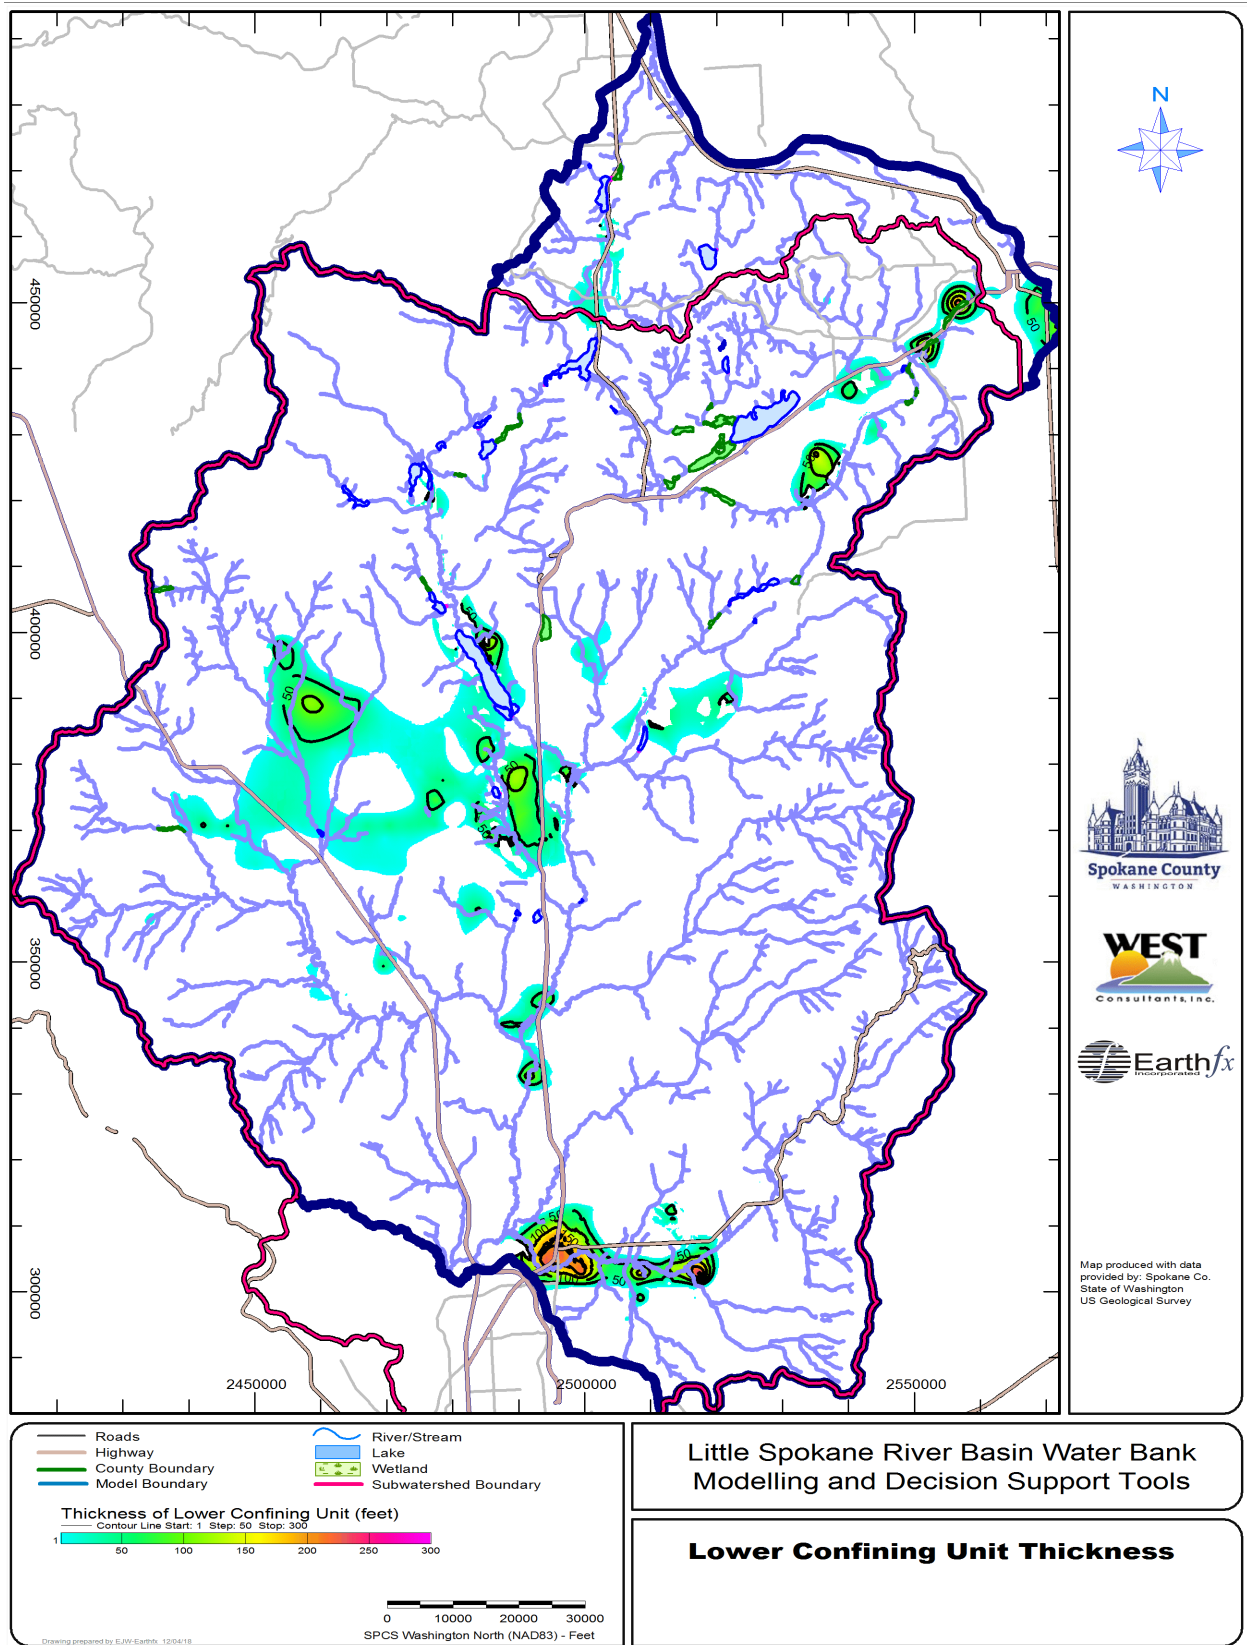
Figure 3.12: Interpreted thickness of the Lower Confining unit within the study area.

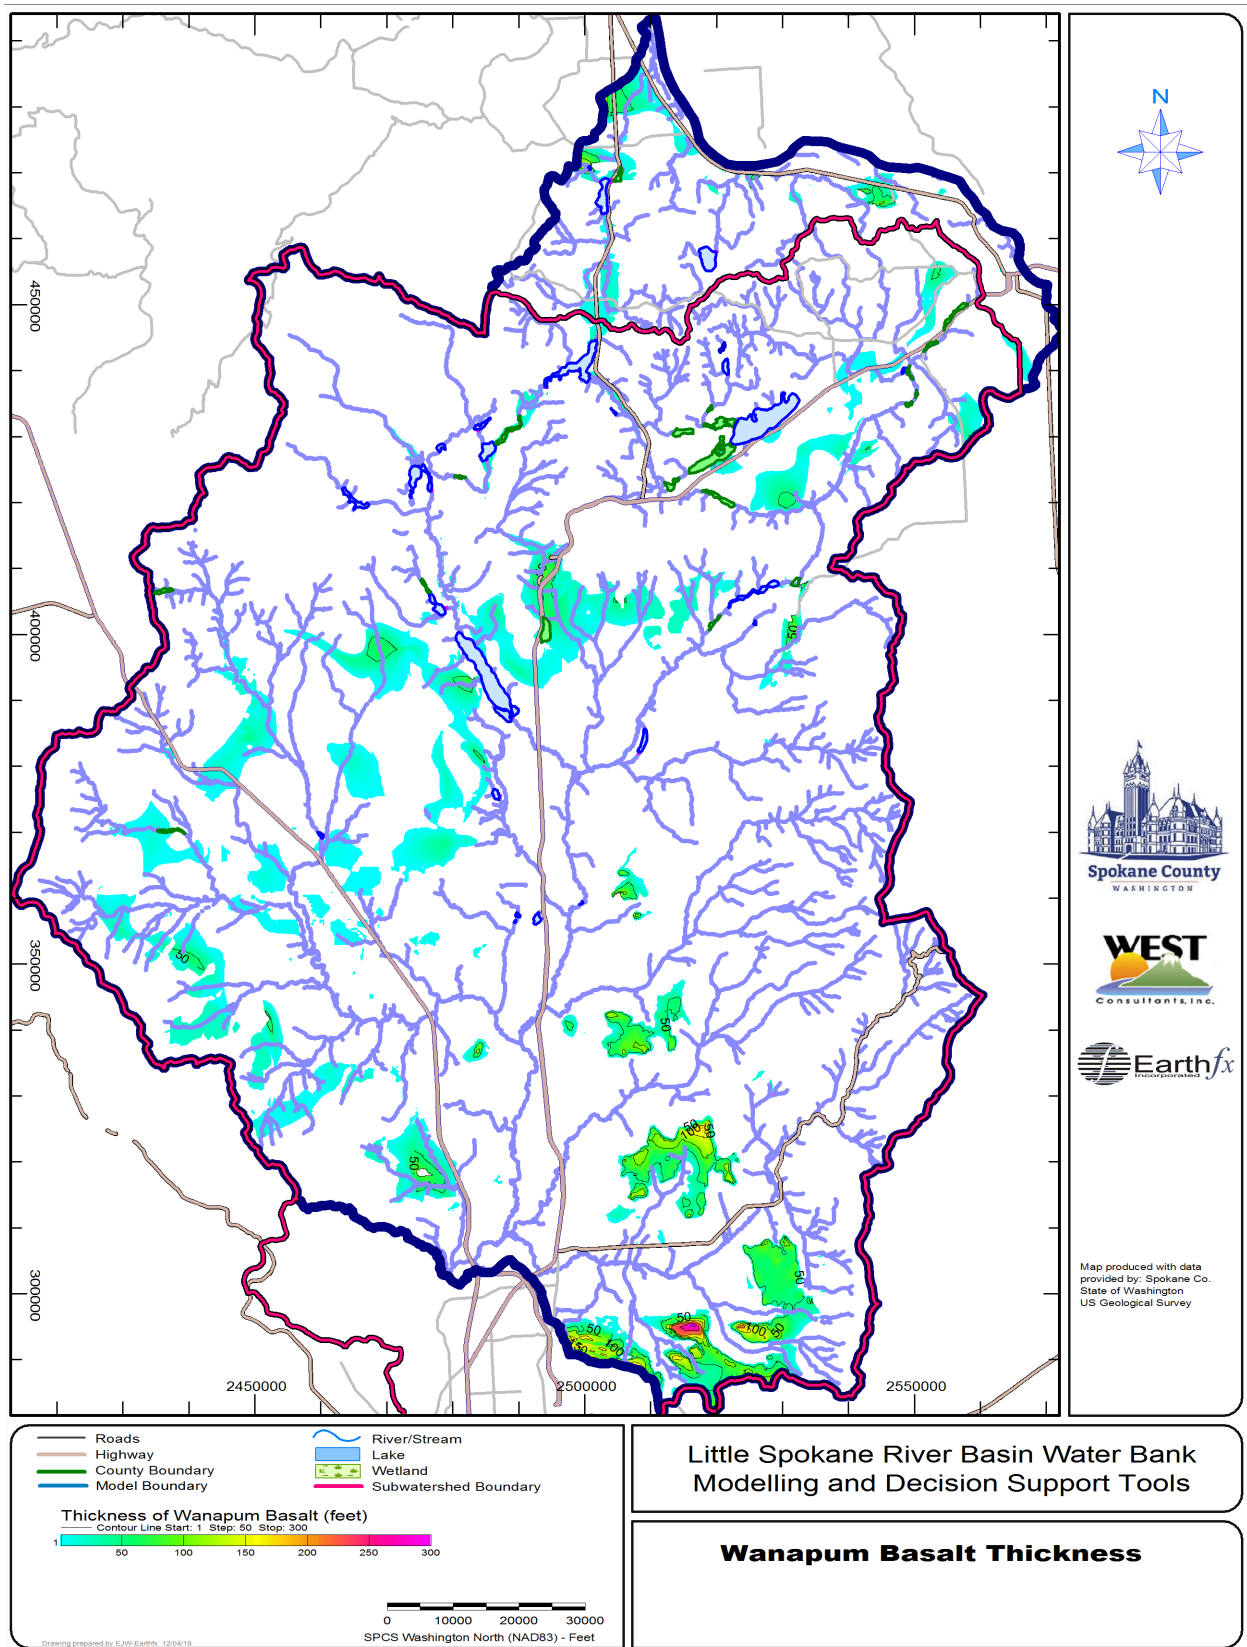
Figure 3.13: Interpreted thickness of the Wanapum Basalt within the study area.

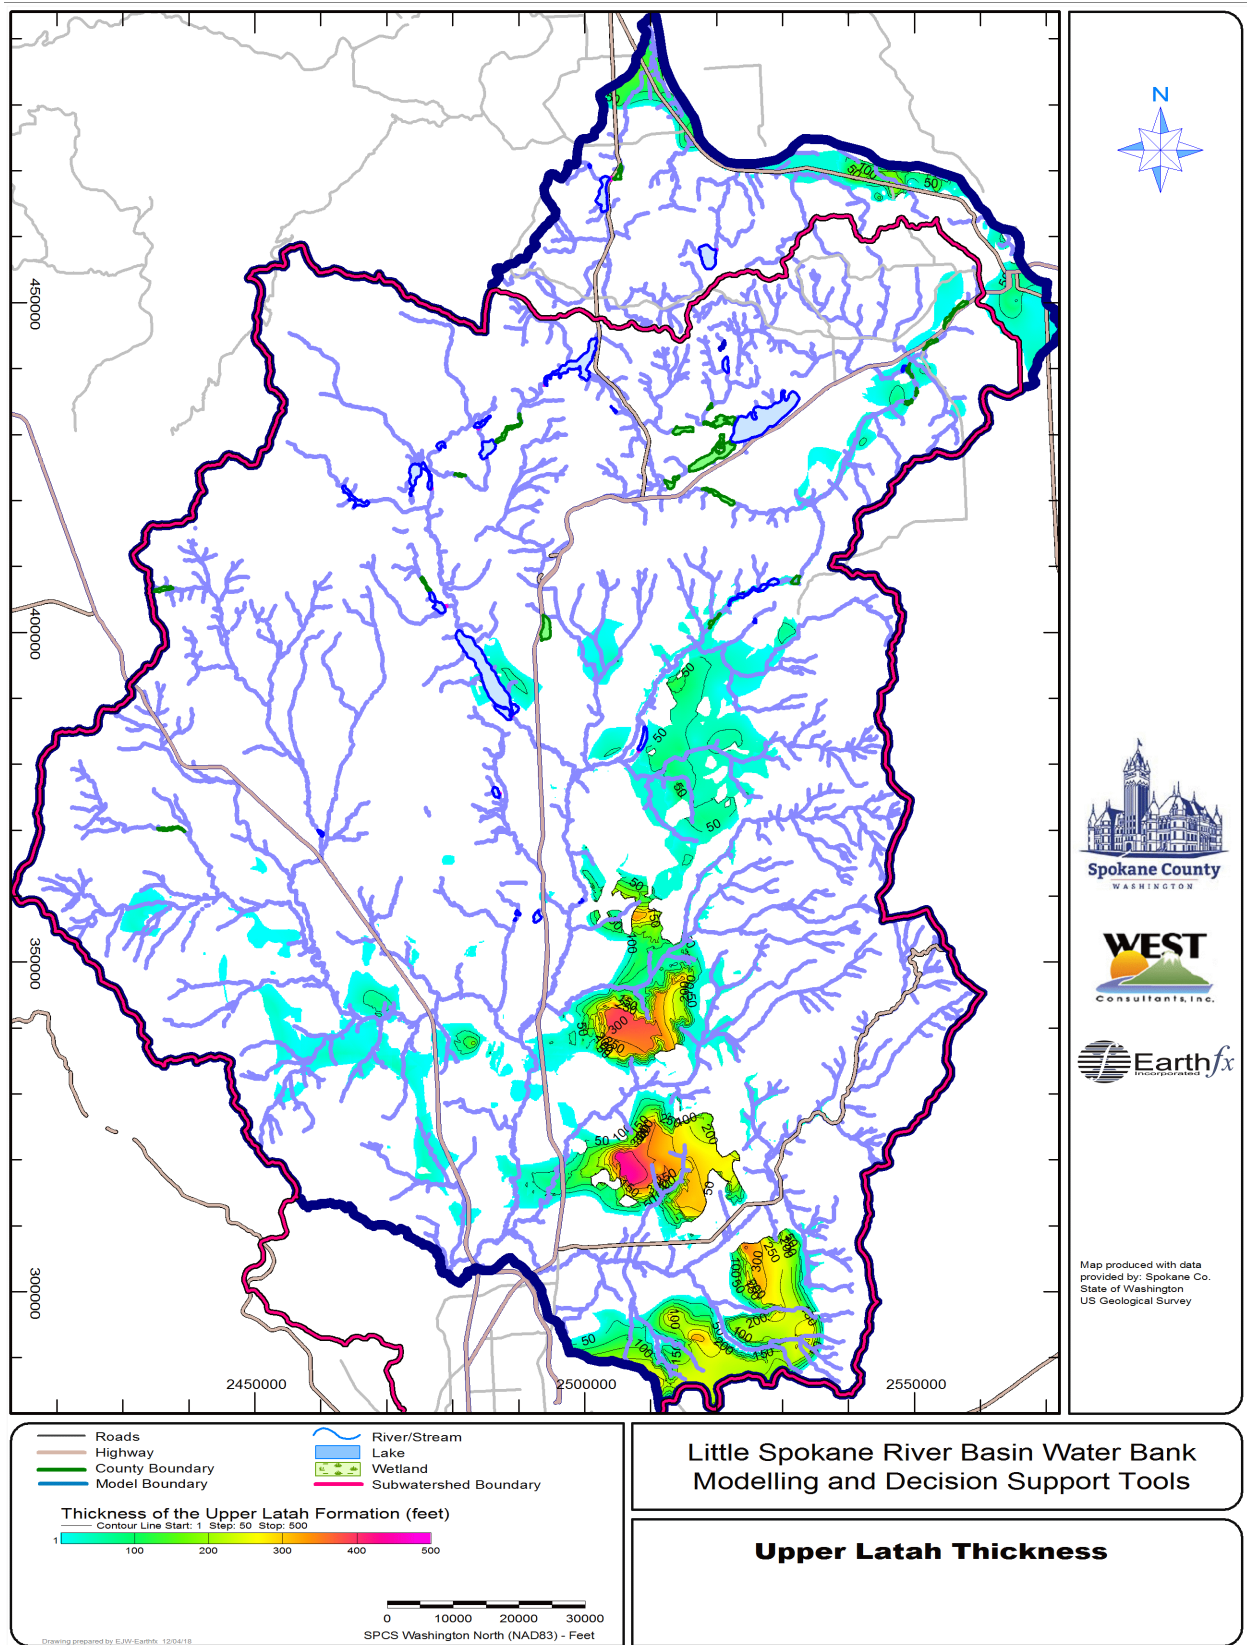
Figure 3.14: Interpreted thickness of the Upper Latah Formation within the study area.

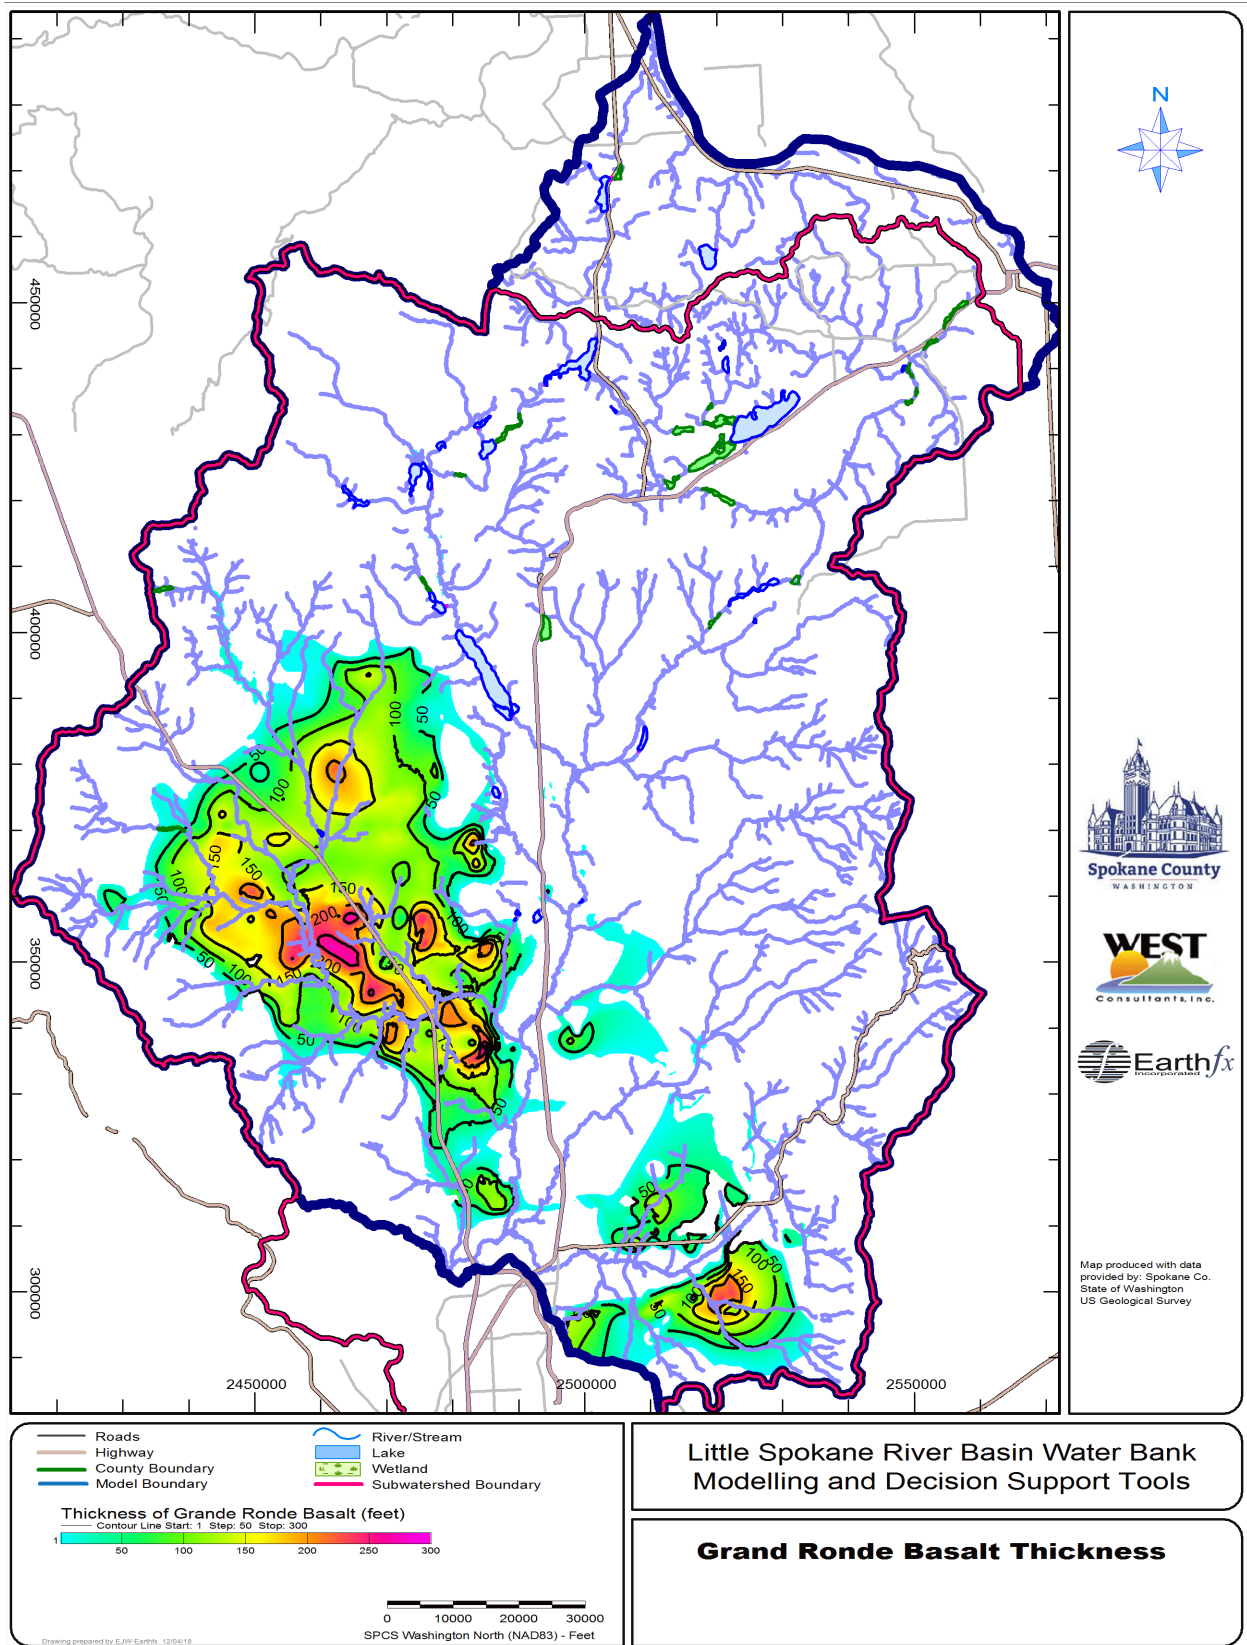
Figure 3.15: Interpreted thickness of the Grande Ronde Basalt within the study area.

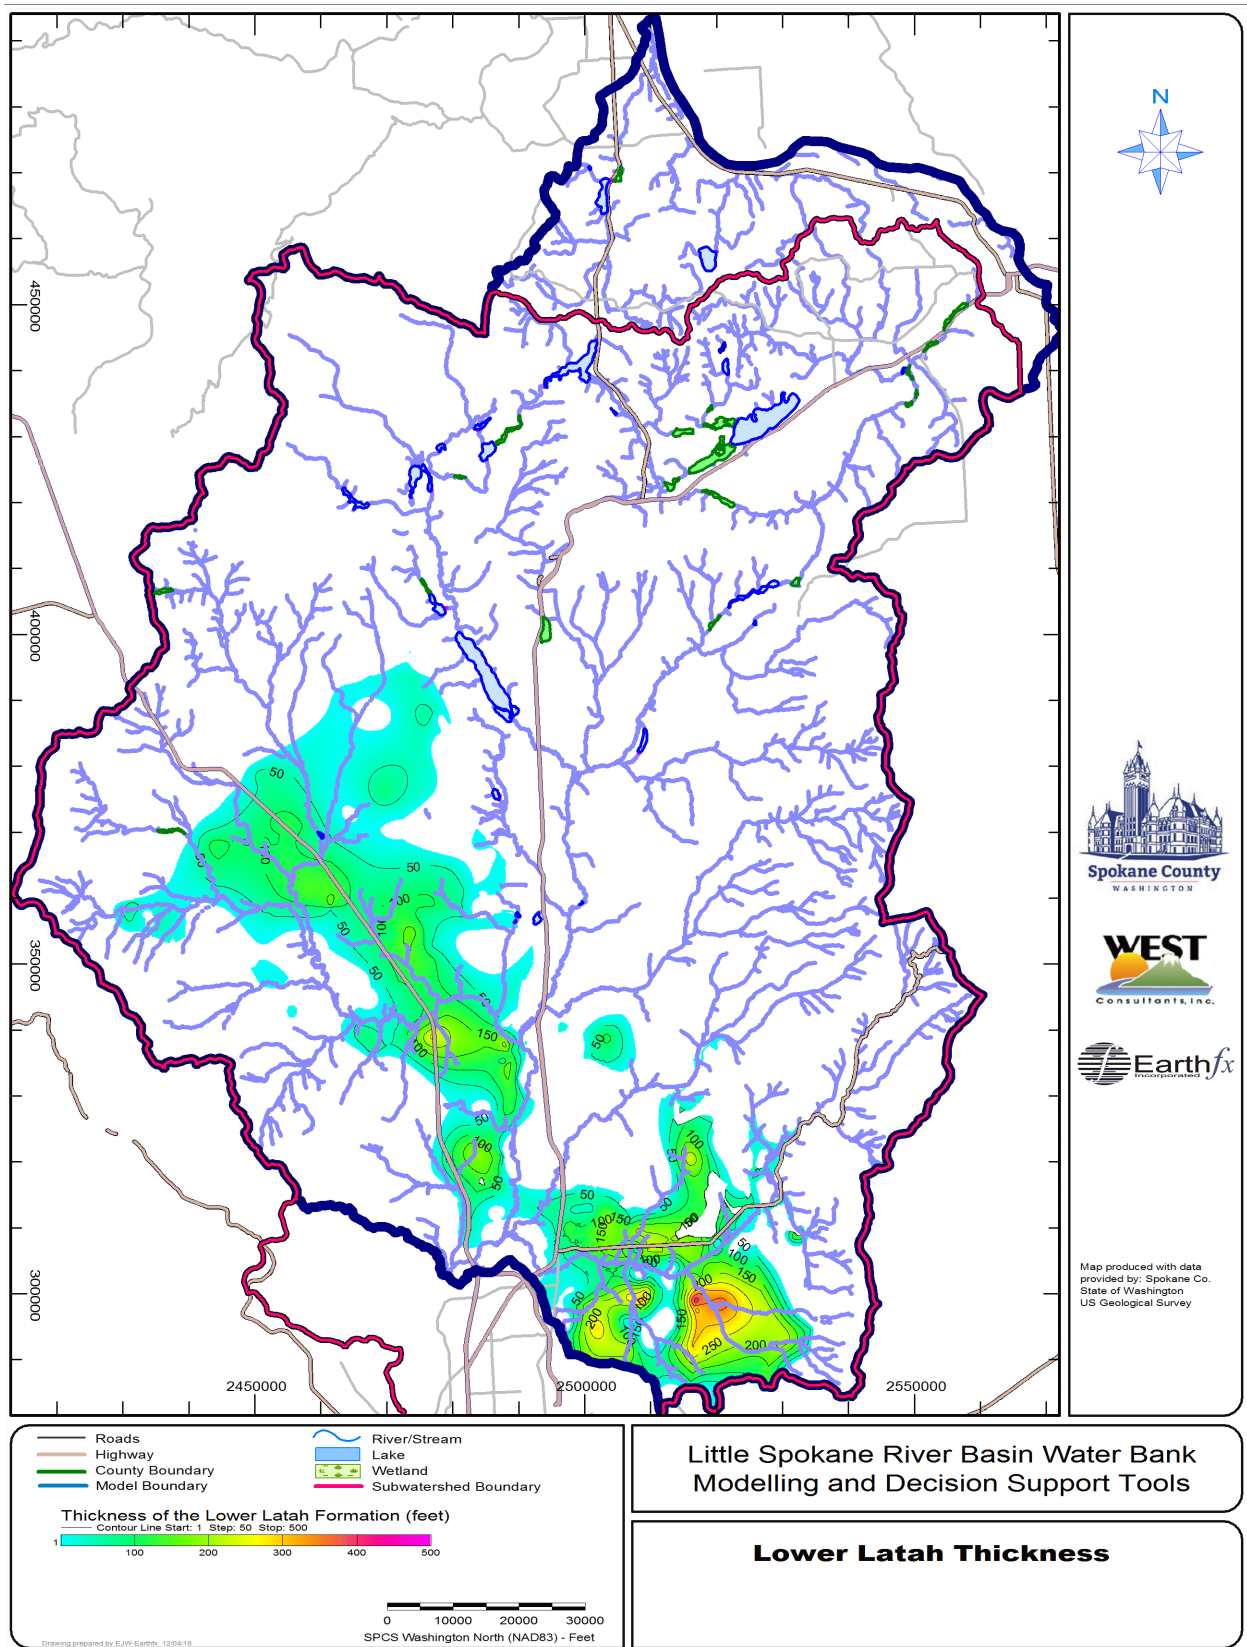
Figure 3.16: Interpreted thickness of the Lower Latah Formation within the study area.

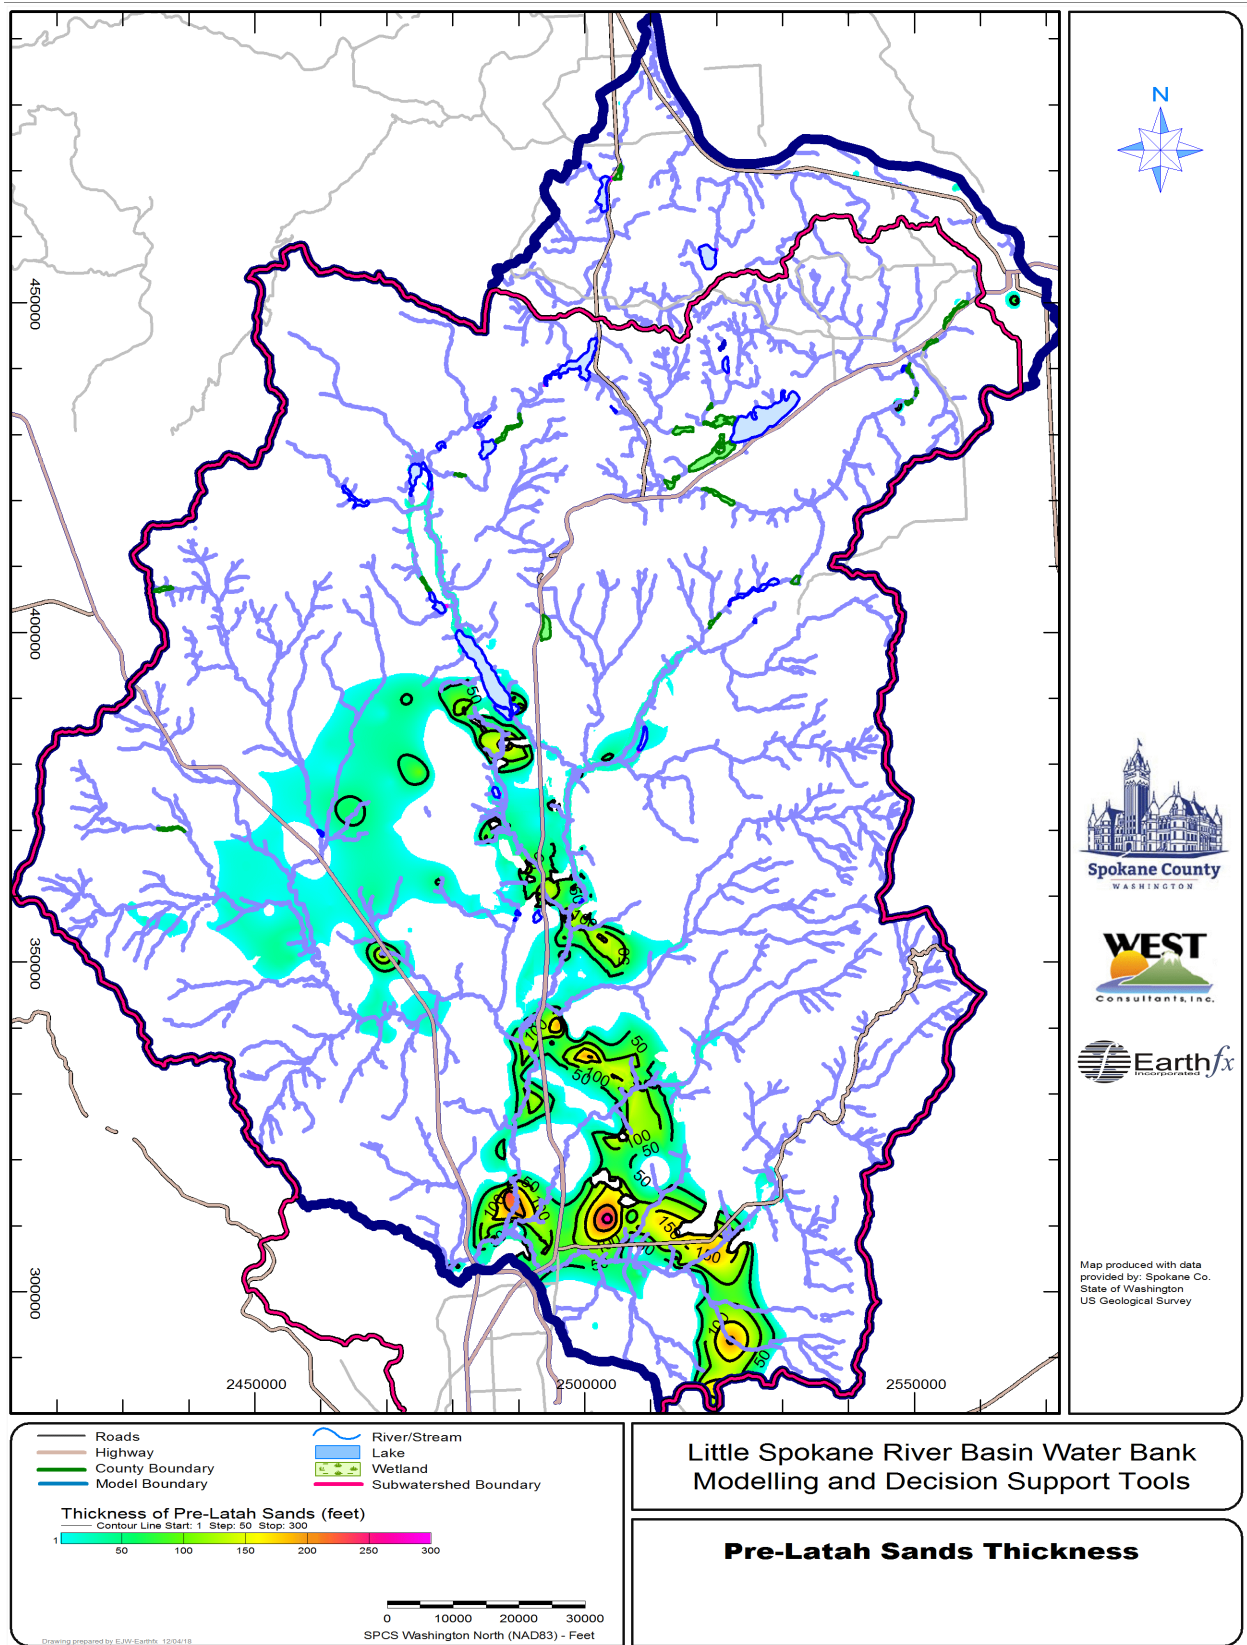
Figure 3.17: Interpreted thickness of the Pre-Latah Sands within the study area.

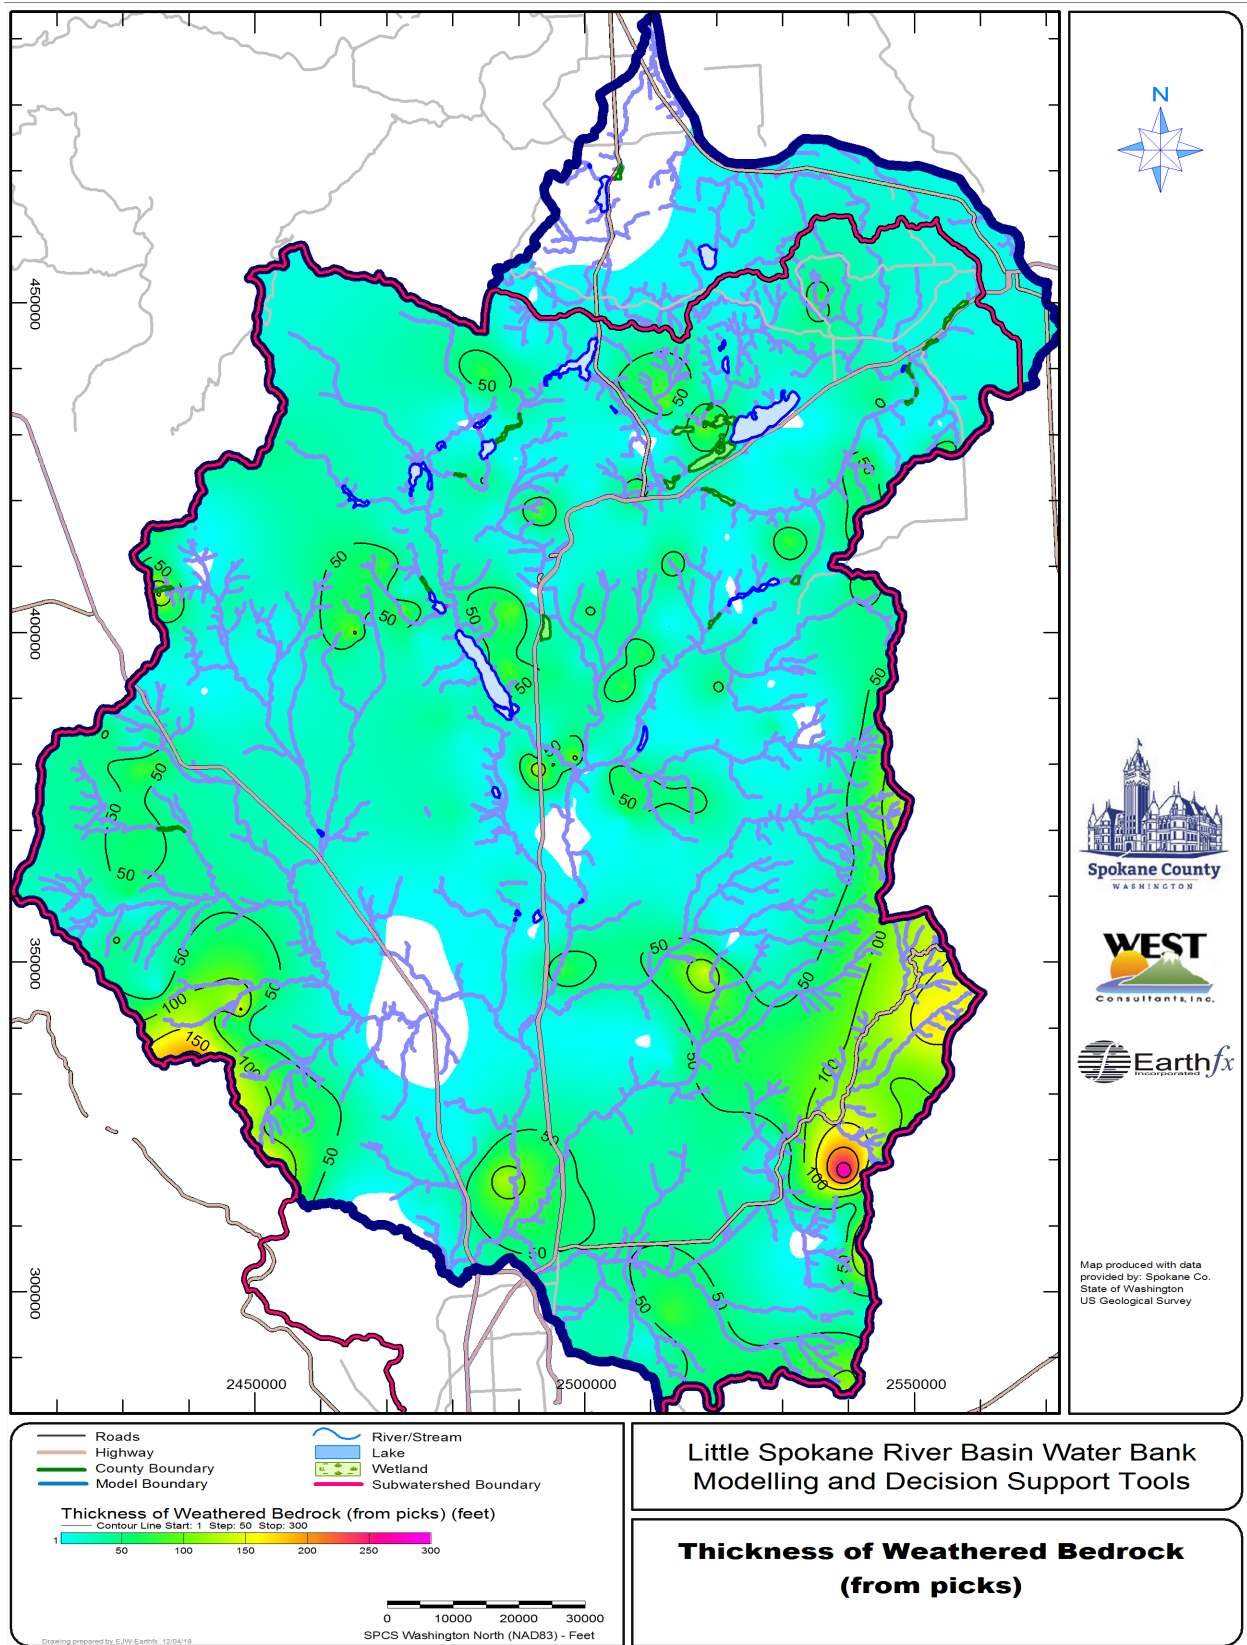
Figure 3.18: Interpreted thickness of the weathered bedrock based on borehole logs.

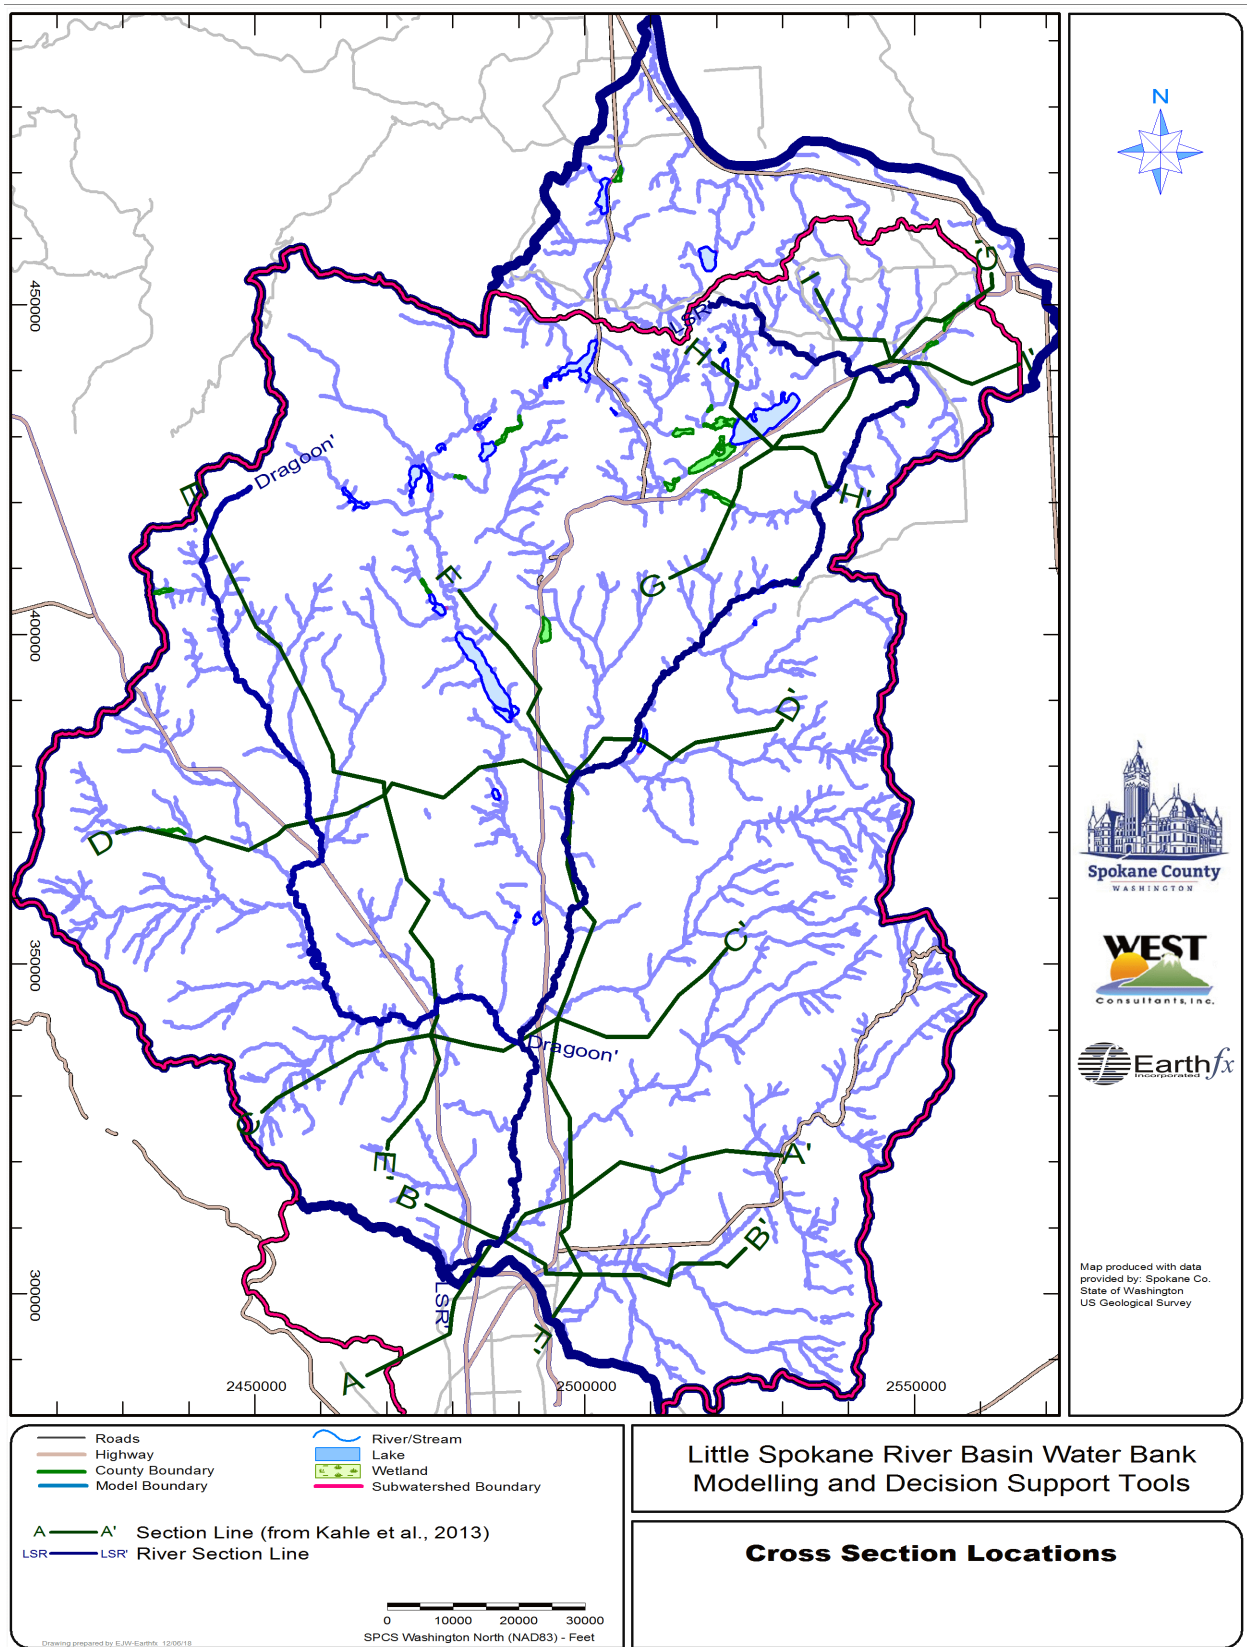
Figure 3.19: Locations of cross sections from Kahle *et al.* (2013) and river sections.

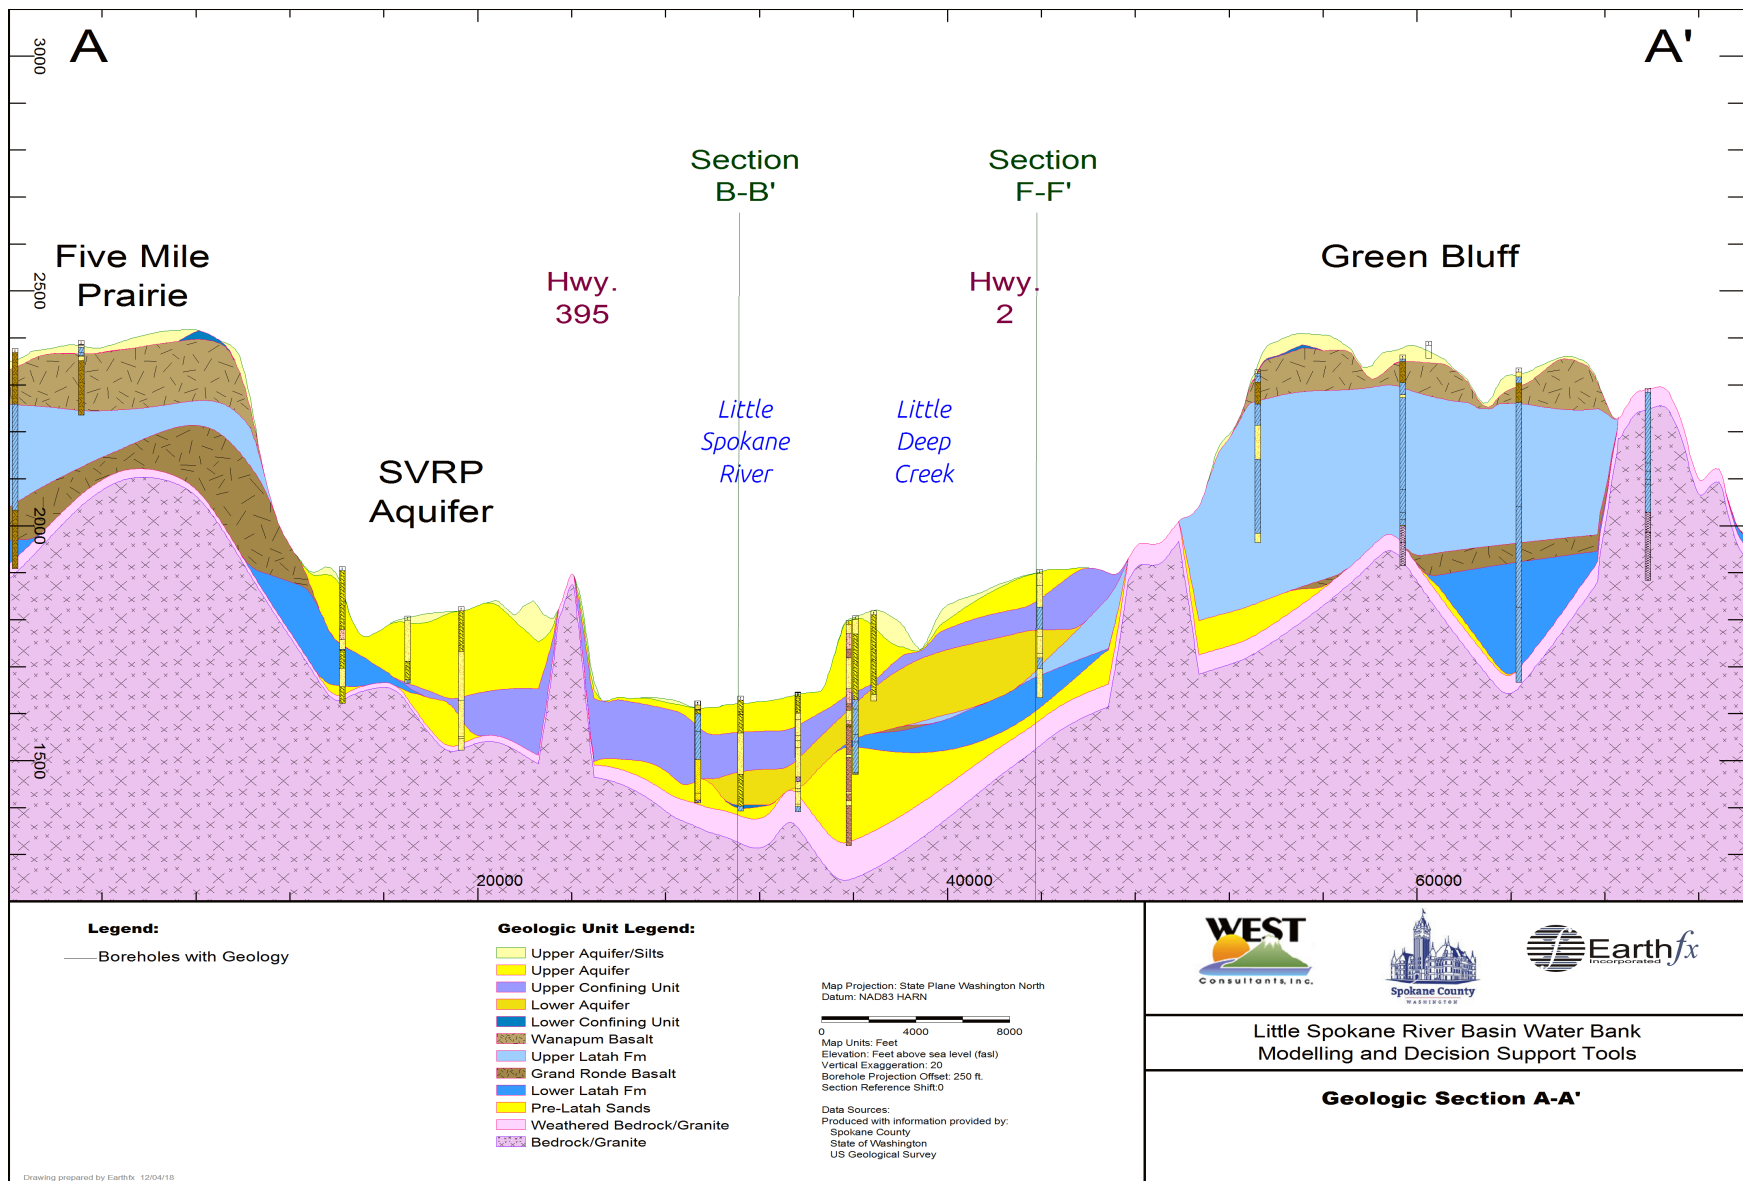
Figure 3.20: Geologic cross section A-A'.
